11.6 Conducted RF Spurious Emission

APPENDIX A: PHOTOGRAPHS OF TEST SETUP

APPENDIX B: PHOTOGRAPHS OF EUT

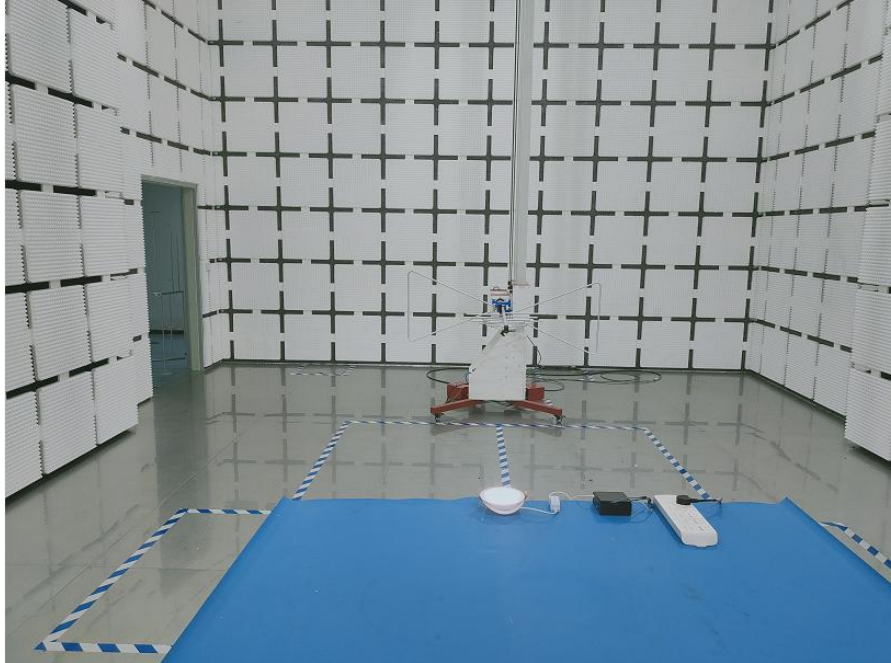
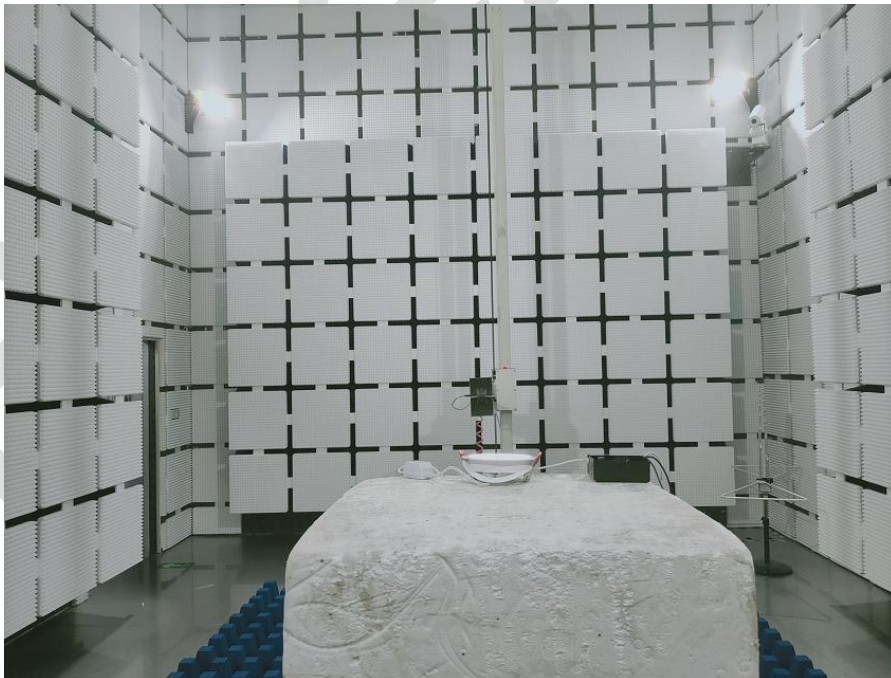
Radiated Spurious Emissions

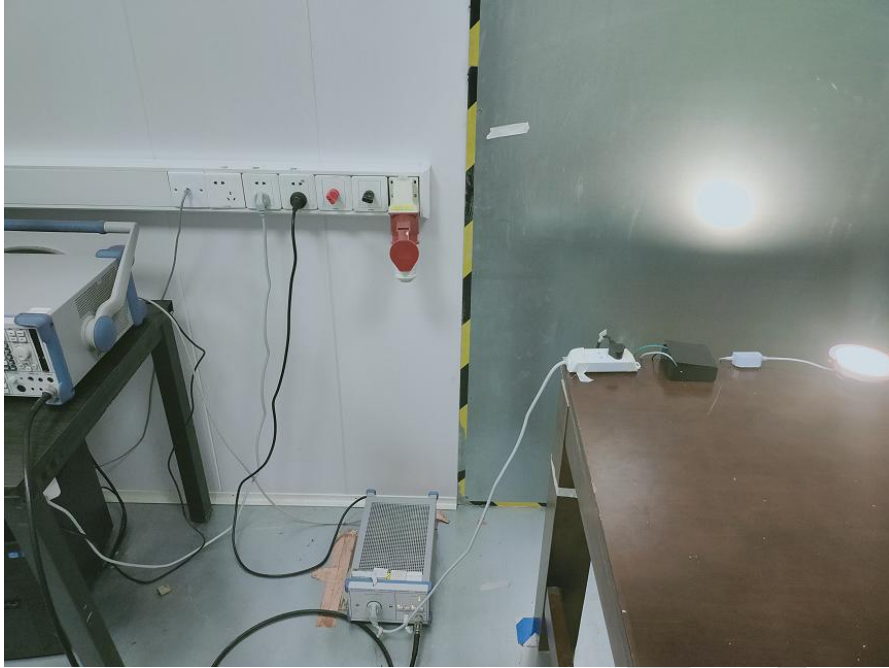
Conducted Emissions at AC Power Line (150kHz-30MHz)
