APPENDIX A: PHOTOGRAPHS OF TEST SETUP

APPENDIX B: PHOTOGRAPHS OF EUT

Reference to the test report No. BLA-EMC-202402-A3401

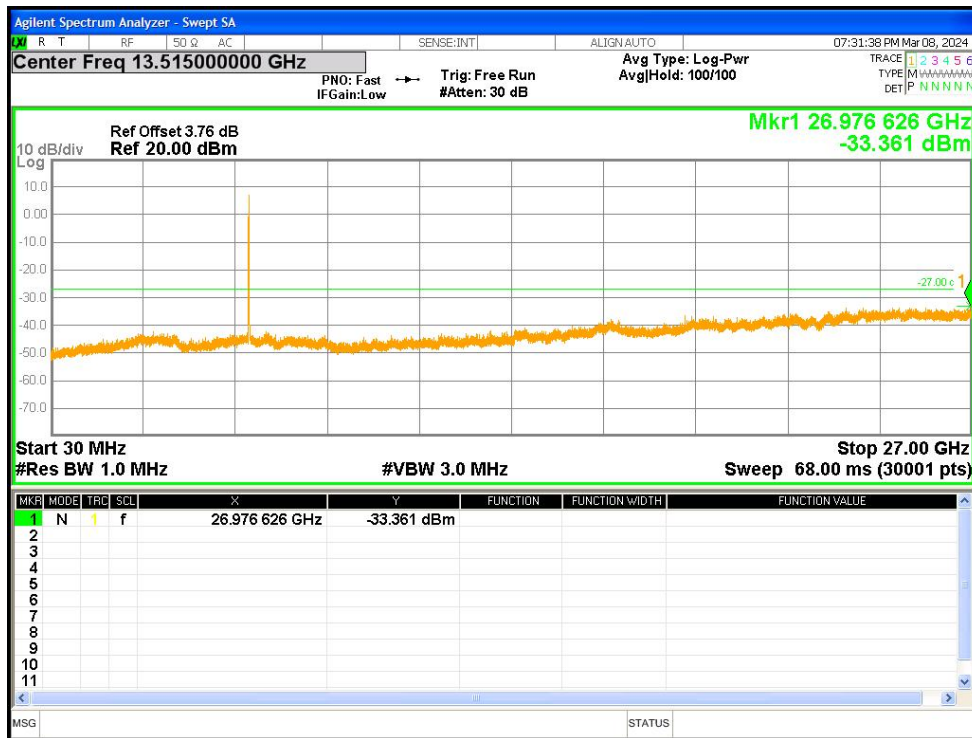
Tx. Spurious NVNT n20 5825MHz Ant2 Emission

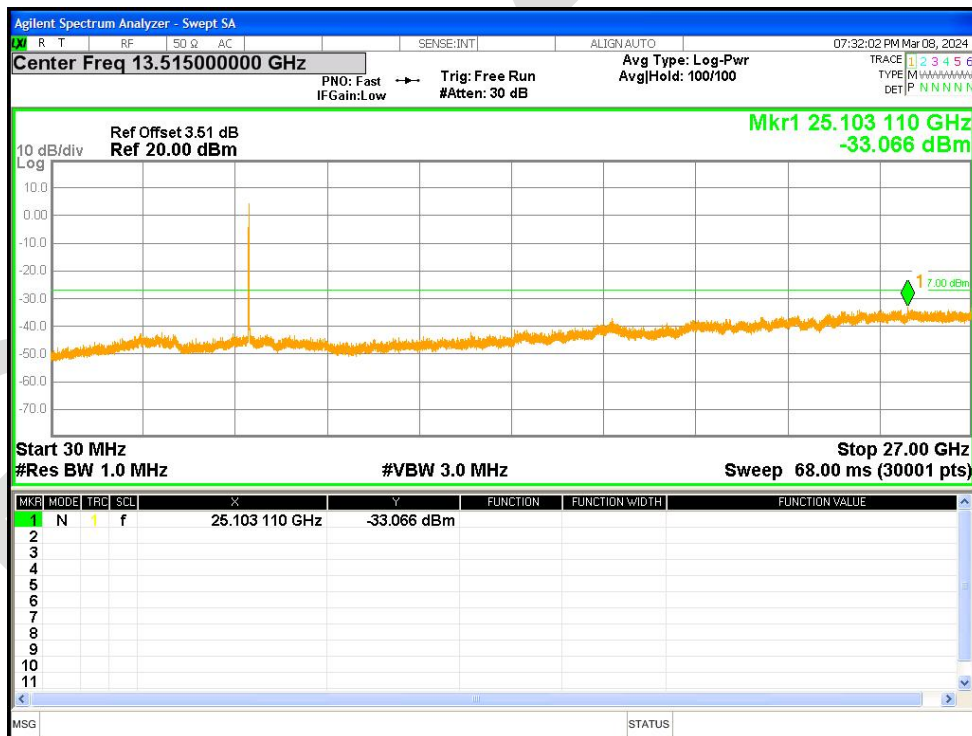
Tx. Spurious NVNT n40 5755MHz Ant1 Emission

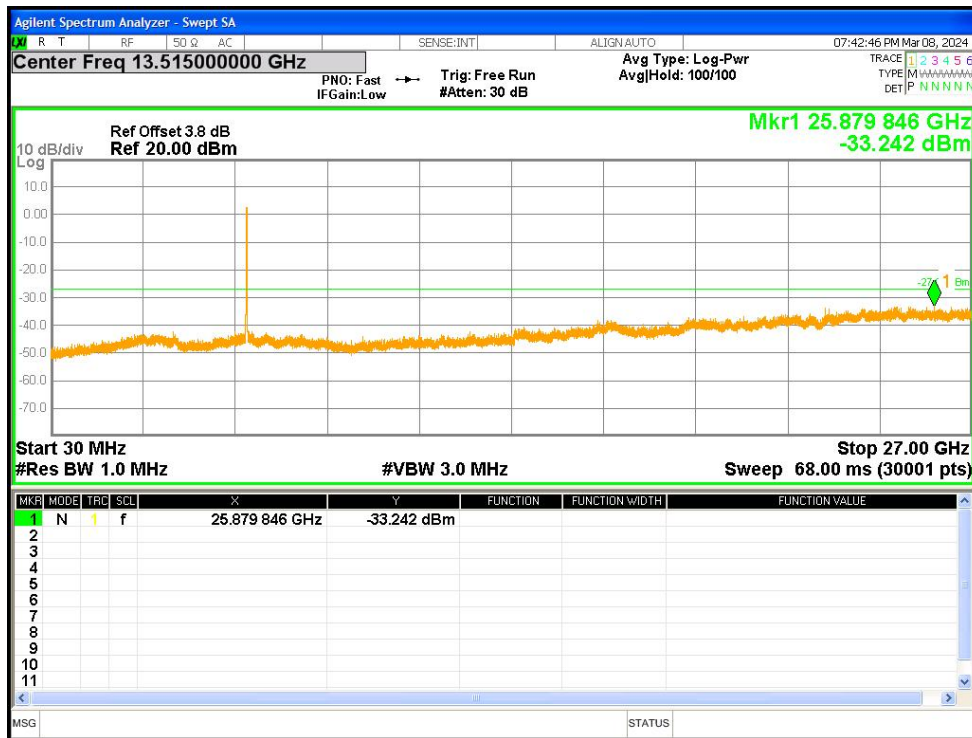
Tx. Spurious NVNT n40 5755MHz Ant2 Emission

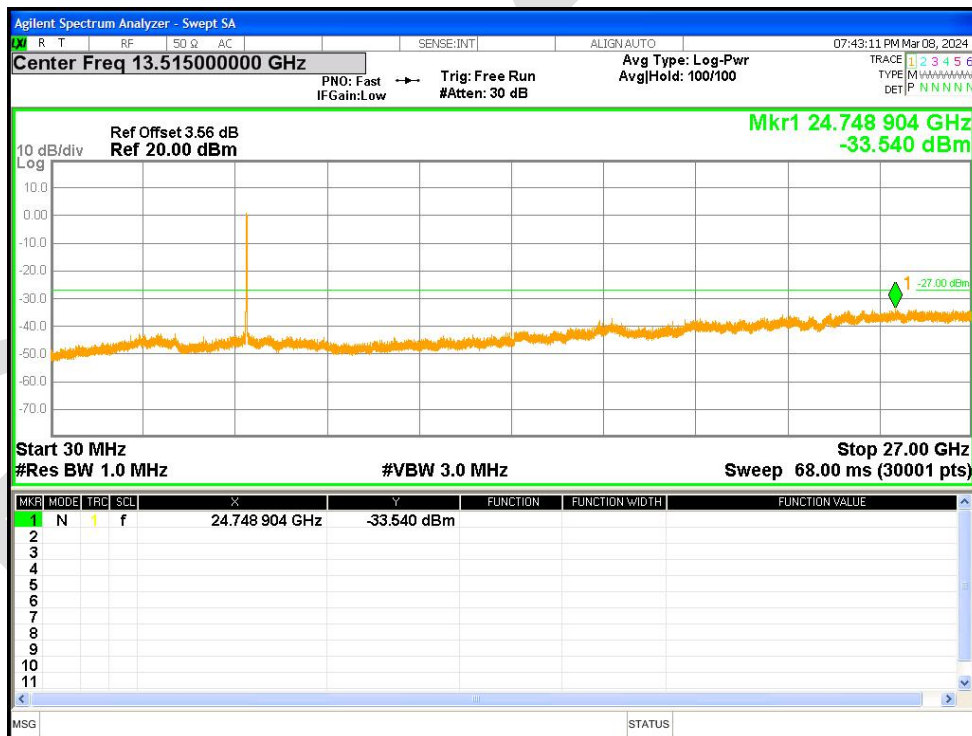
Tx. Spurious NVNT n40 5795MHz Ant1 Emission

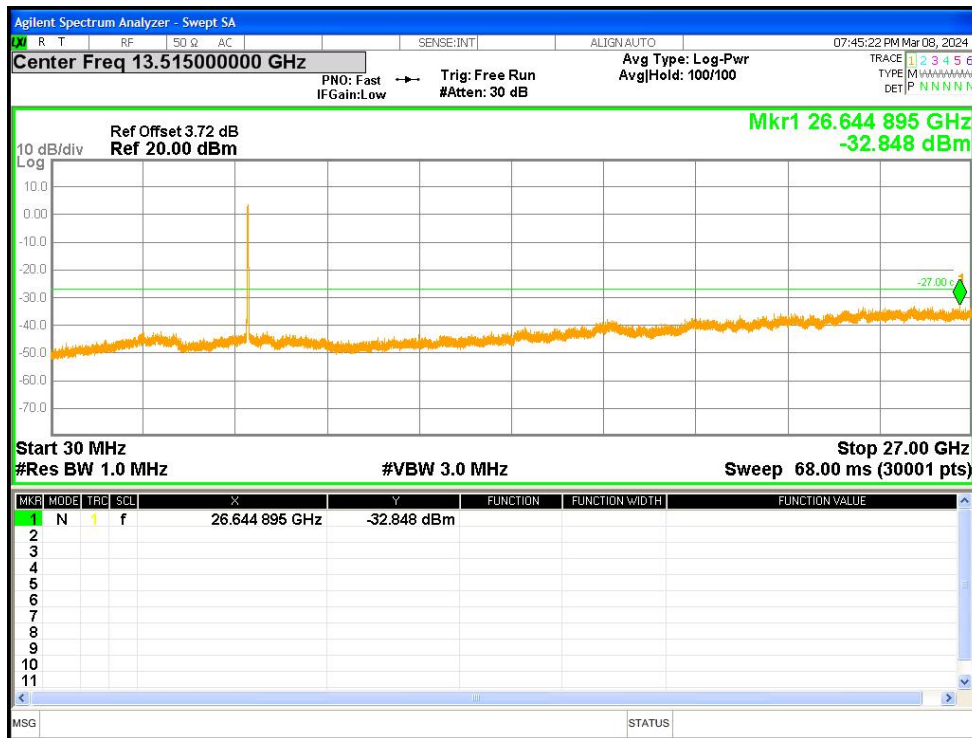
Tx. Spurious NVNT n40 5795MHz Ant2 Emission

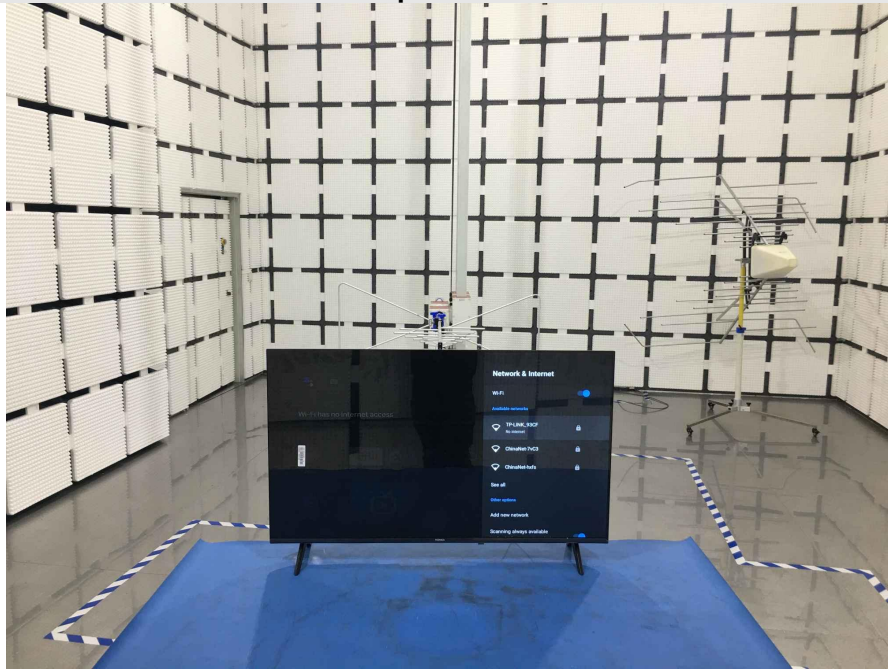
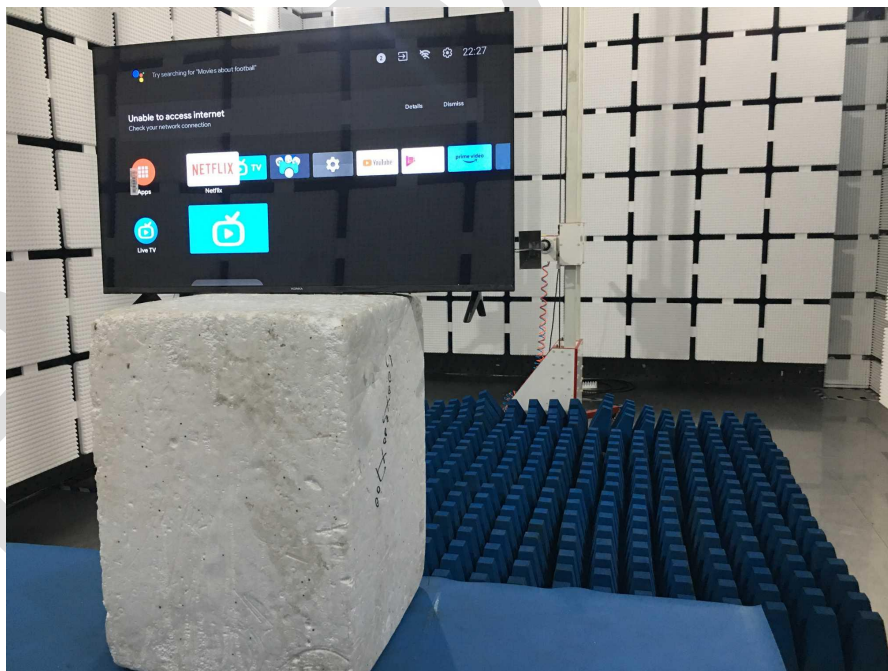
Radiated Spurious Emissions
