## APPENDIX A: PHOTOGRAPHS OF TEST SETUP

**APPENDIX B: PHOTOGRAPHS OF EUT**

Reference to the test report No. BLA-EMC-202402-A3501

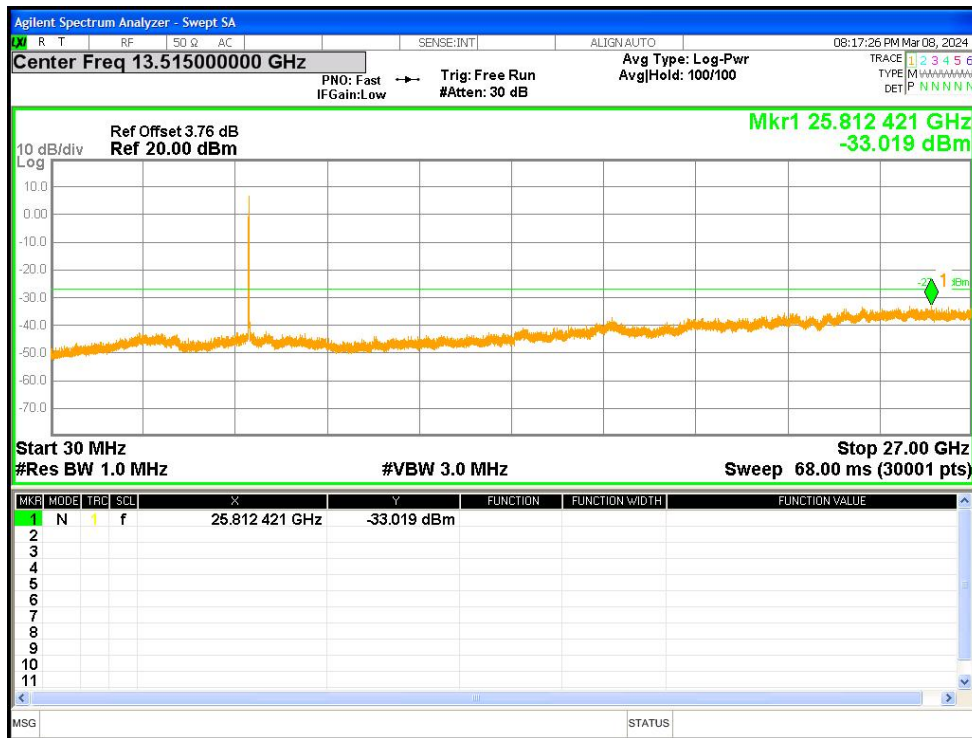
Tx. Spurious NVNT n20 5825MHz Ant2 Emission

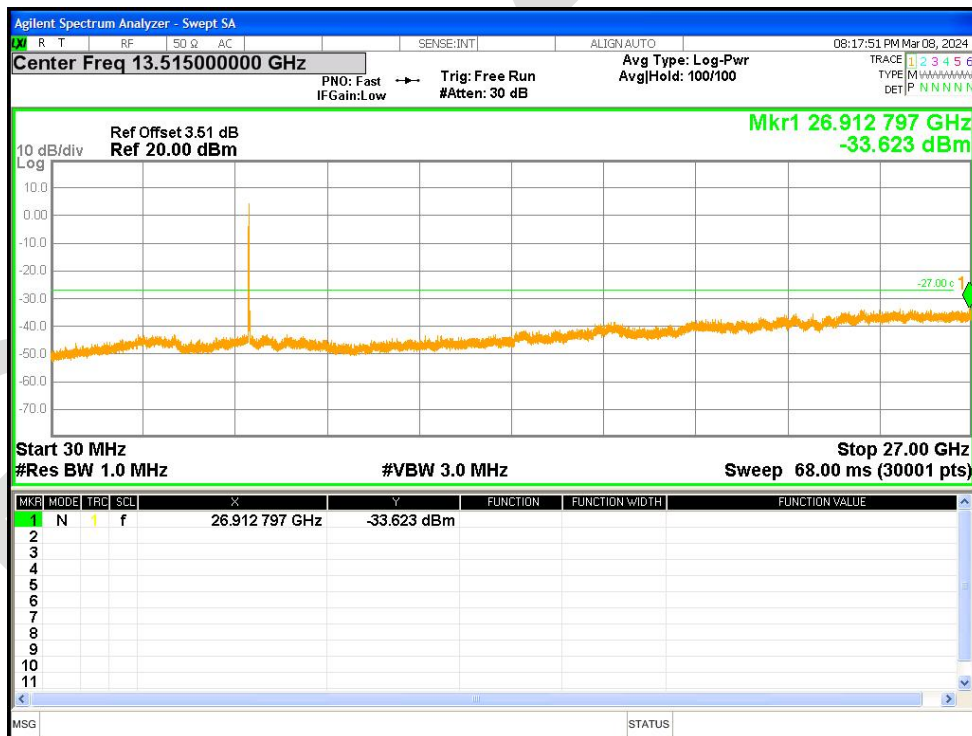
Tx. Spurious NVNT n40 5755MHz Ant1 Emission

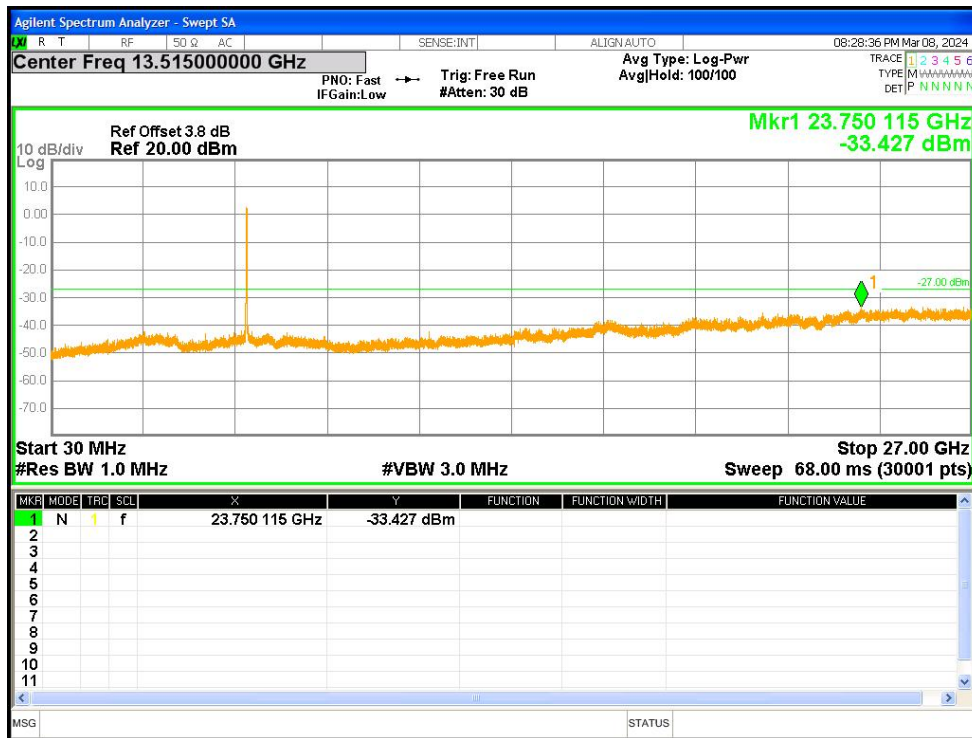
Tx. Spurious NVNT n40 5755MHz Ant2 Emission

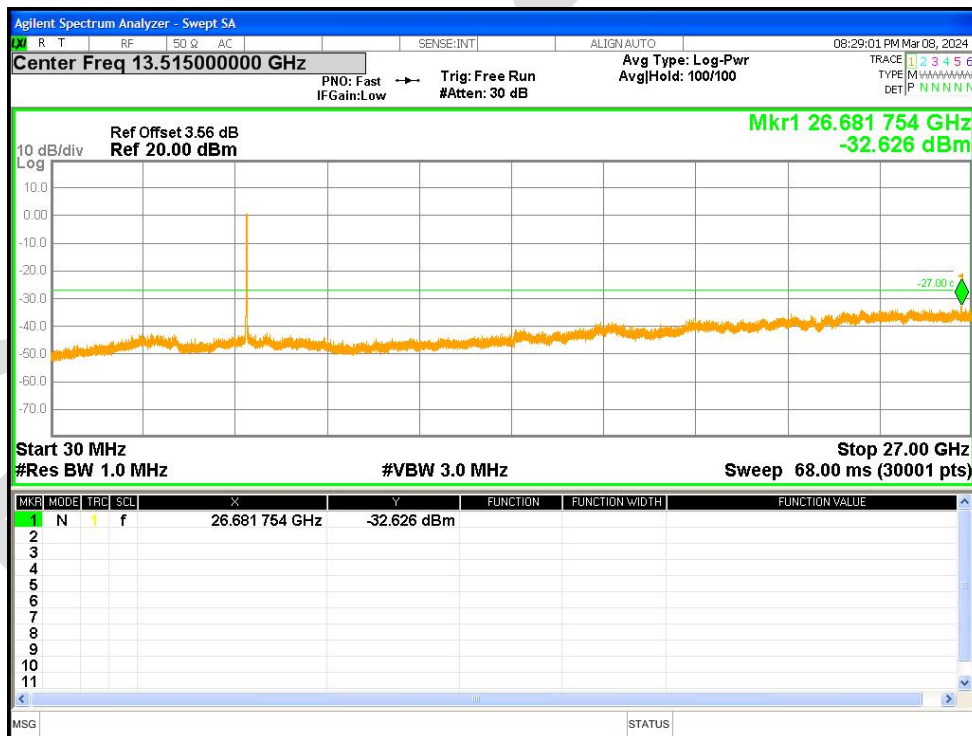
Tx. Spurious NVNT n40 5795MHz Ant1 Emission

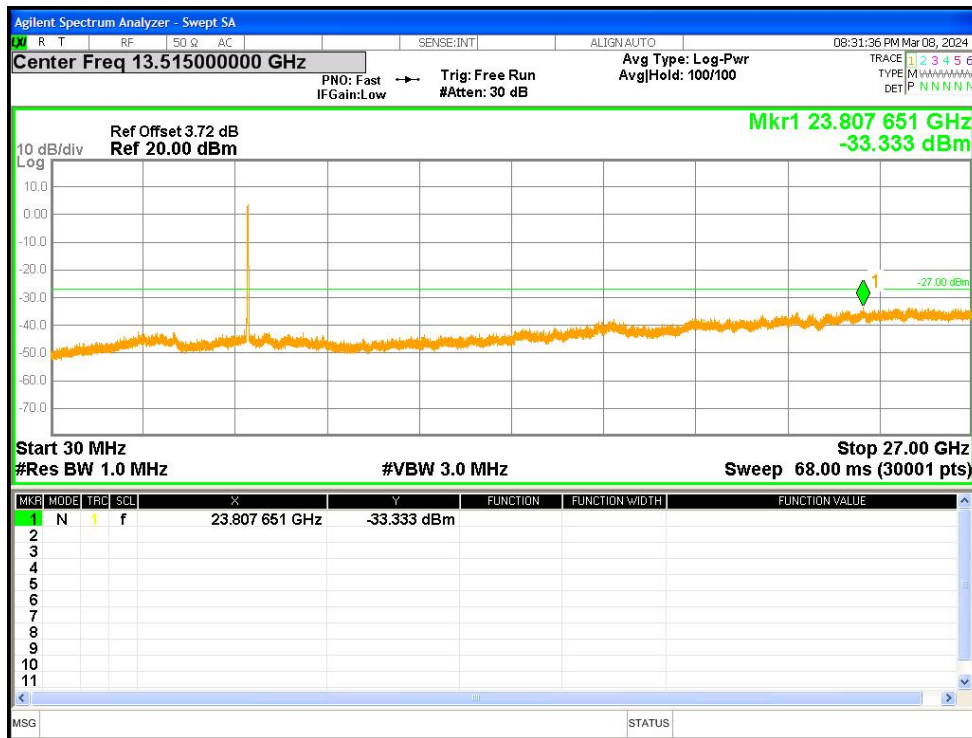
Tx. Spurious NVNT n40 5795MHz Ant2 Emission

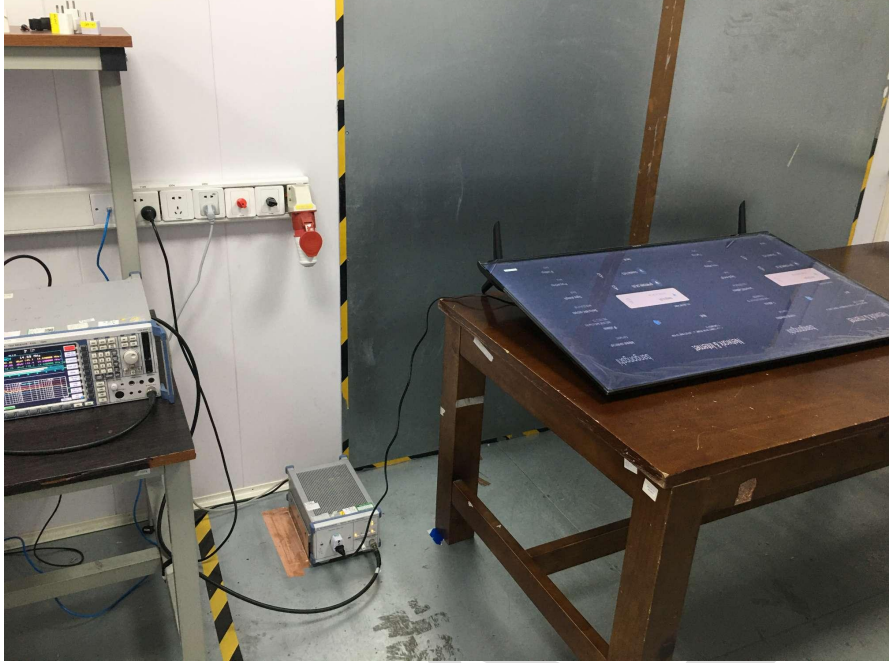
**Conducted Emissions at AC Power Line (150kHz-30MHz)**
