Registration number: W6M22211-22321-C-54
FCC ID: 2ARGX-NGAP

Measurement diagrams

Spurious Emissions radiated

Radiated Emission Measurement

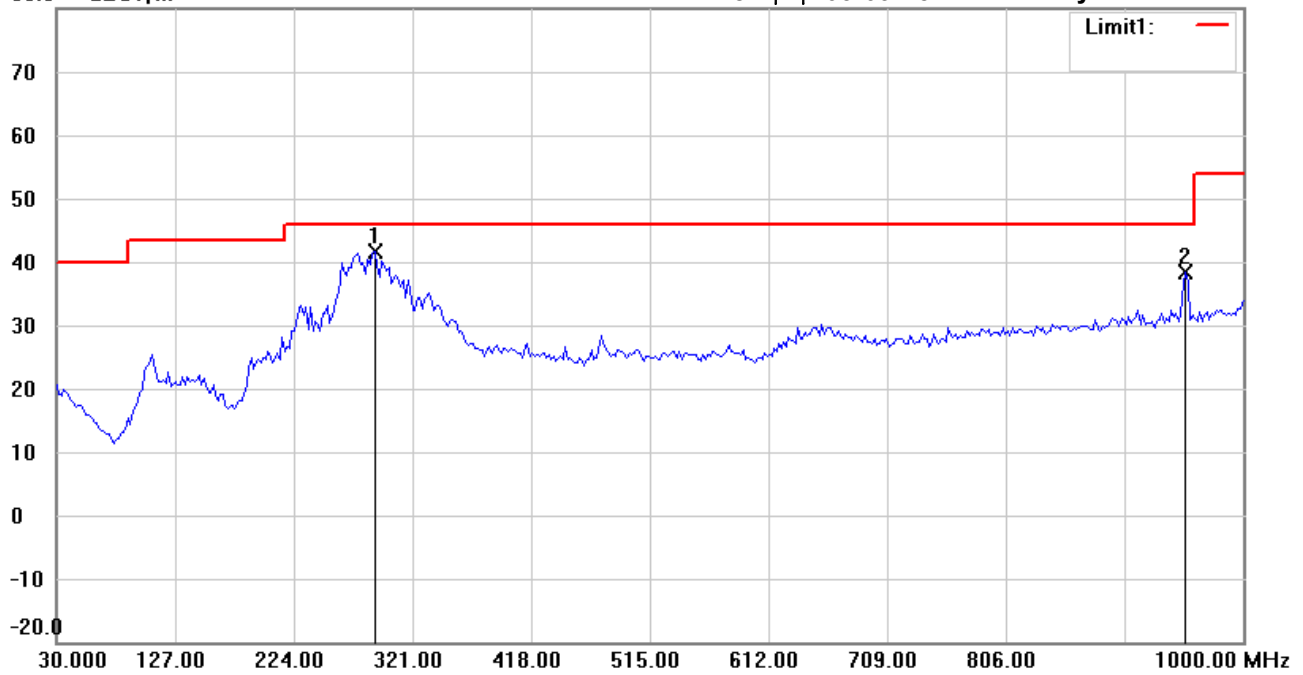
Condition : FCC_part 15 RE-Class C_30-1000MHz

Polarization: *Horizontal*

Test Mode : TX 802.11a CH36

Mk.	Frequency (MHz)	Reading (dBuV)	Detector	Corr. factor (dB/m)	Result (dBuV/m)	Limit (dBuV/m)	Ant.Pos (cm)	Tab.Pos (deg.)	Margin (dB)	Comment
*	290.4810	47.65	peak	-5.95	41.70	46.00	100	152	-4.30	
	953.3467	33.67	peak	4.66	38.33	46.00	100	84	-7.67

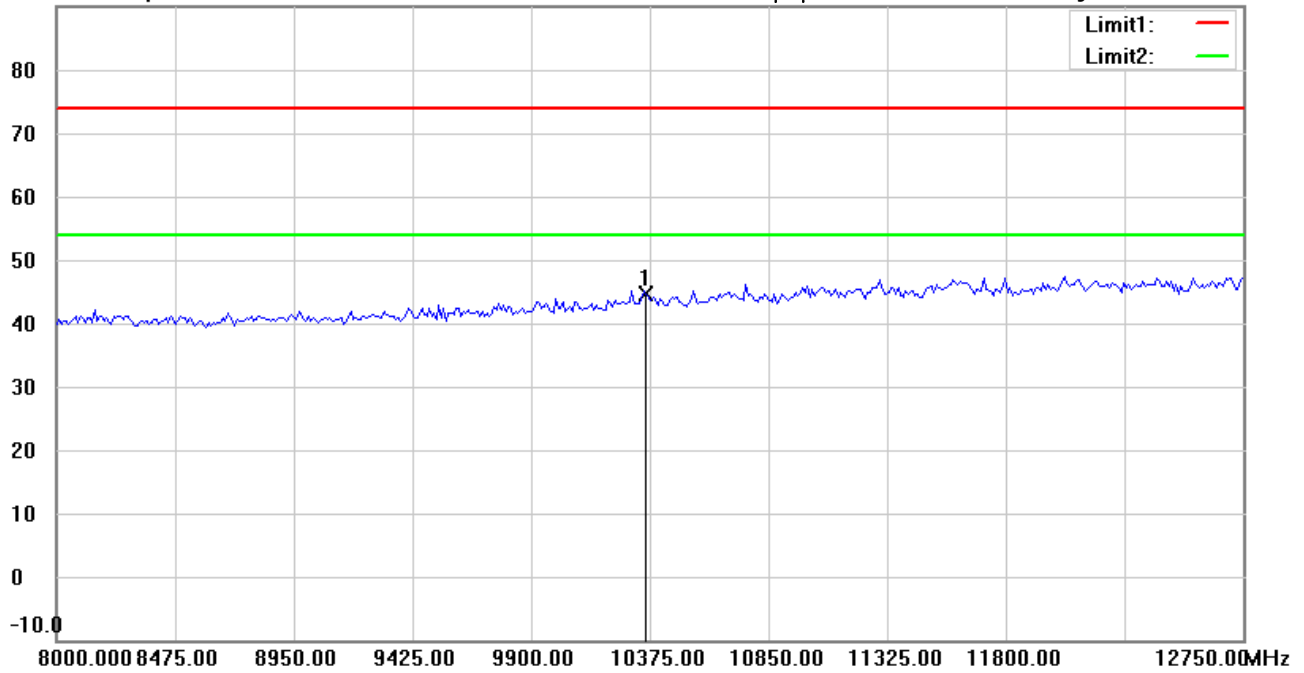
Condition : FCC_part 15E RE_Above 1GHz_PK

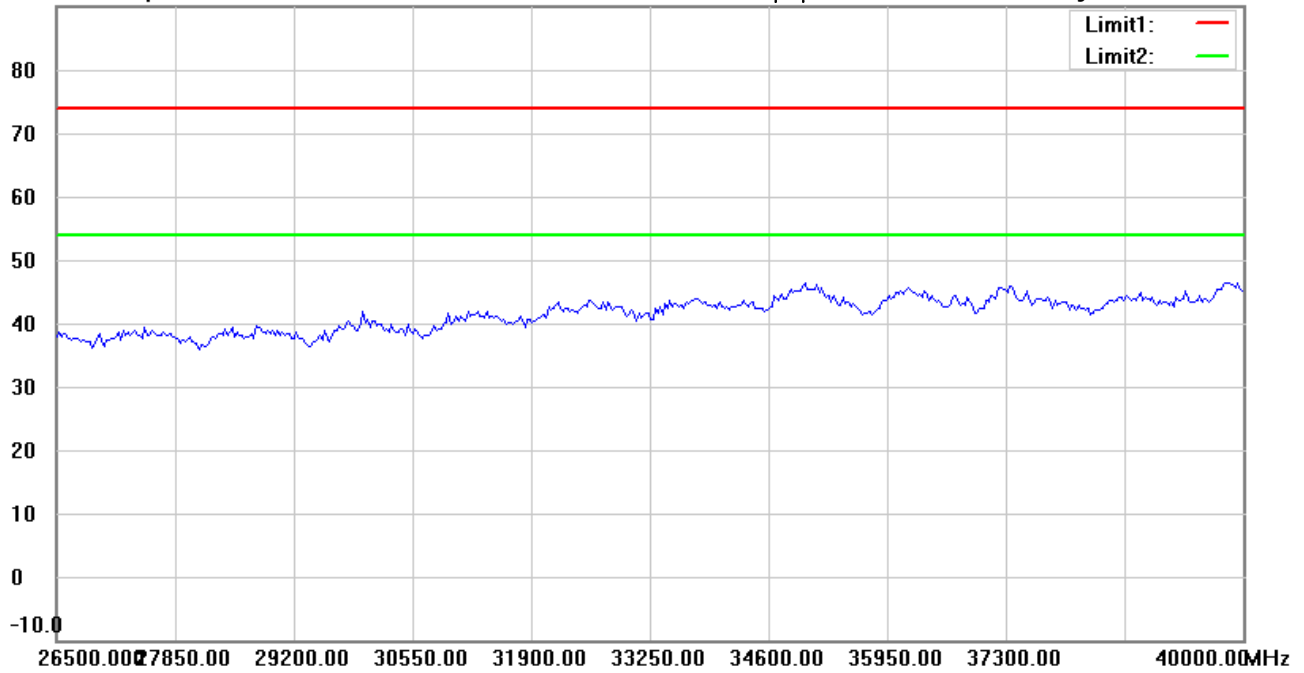
Condition : FCC_part 15E RE_Above 1GHz_PK

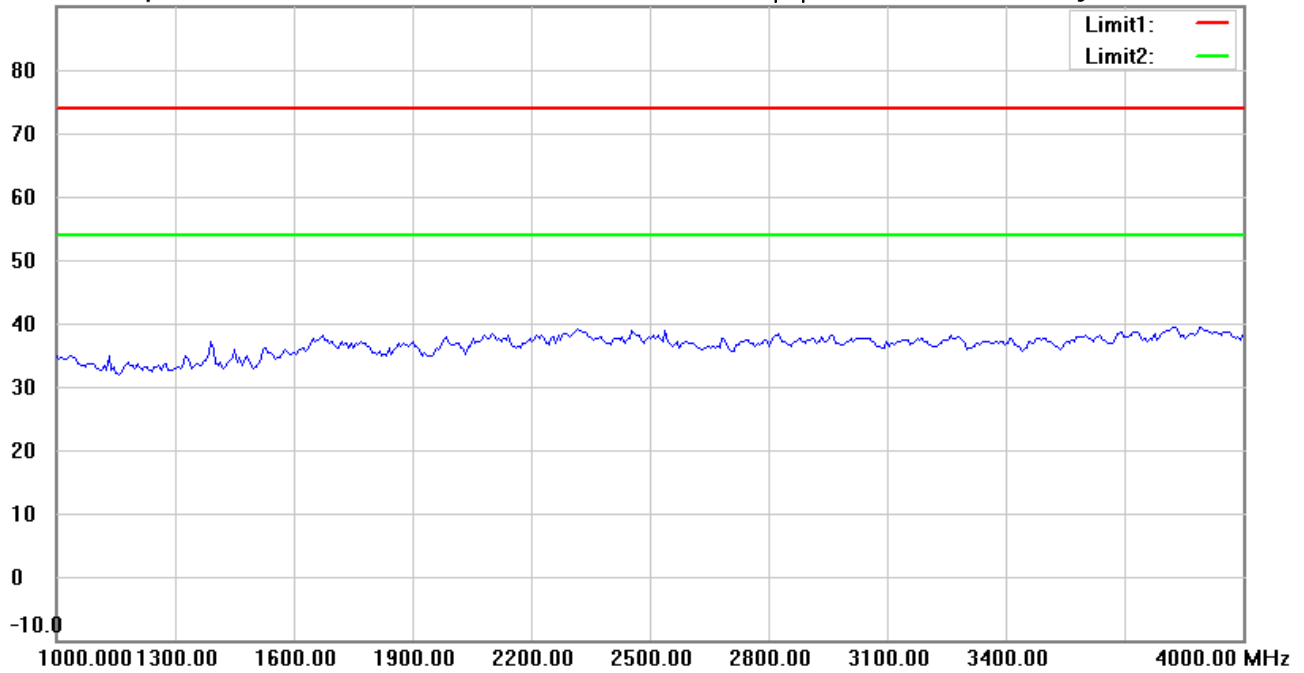
Condition : FCC_part 15E RE_Above 1GHz_PK

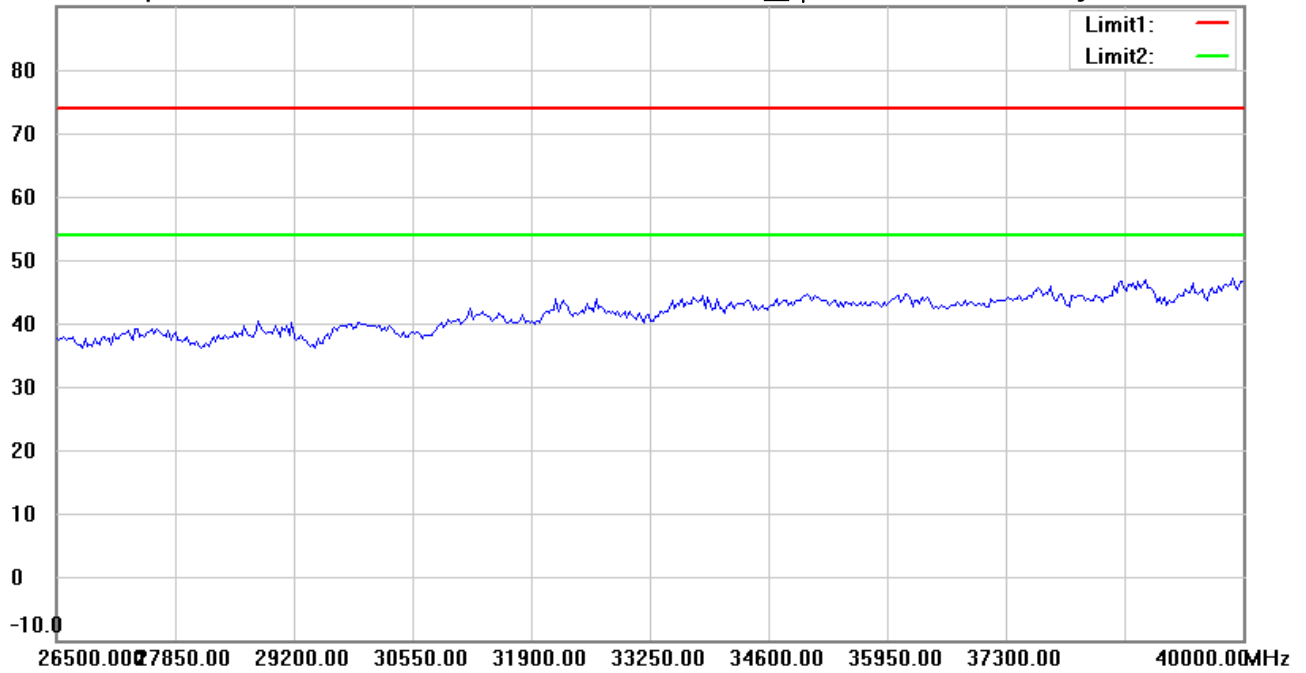
Condition : FCC_part 15E RE_Above 1GHz_PK
