Radiated Emission Measurement

Condition : FCC_part 15E RE_Above 1GHz_PK

EUT : W6M22211-22321

Test Mode : TX 802.11ac80 CH42

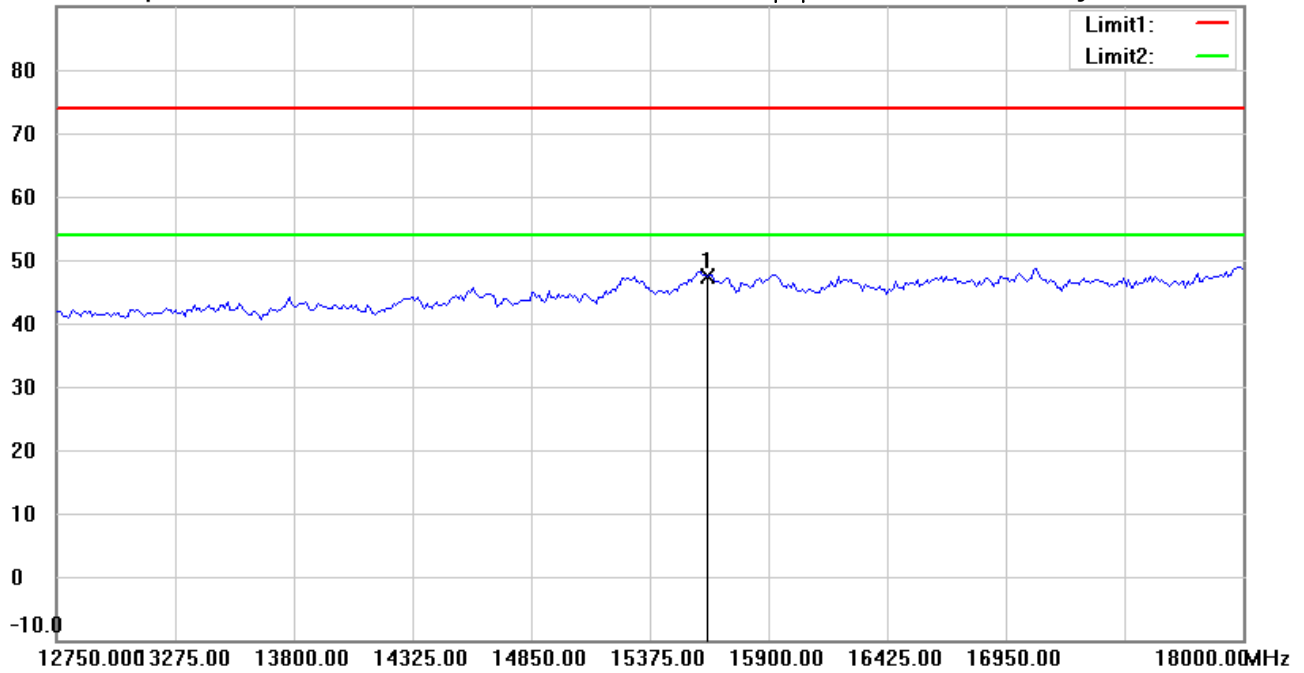
Polarization: *Vertical*

Mk.	Frequency (MHz)	Reading (dBuV)	Detector	Corr. factor (dB/m)	Result (dBuV/m)	Limit (dBuV/m)	Ant.Pos (cm)	Tab.Pos (deg.)	Margin (dB)	Comment
*	15630.000	28.56	peak	18.85	47.41	74.00	150	201	-26.59
