EUT	Teton Router 750	Model Name	TR750
Temperature	25°C	Relative Humidity	55.4%
Pressure	960hPa	Test Voltage	Normal Voltage
Test Mode	802.11n 40 with data rate 13.5 2452MHZ	Antenna	Vertical

13. FCC LINE CONDUCTED EMISSION TEST

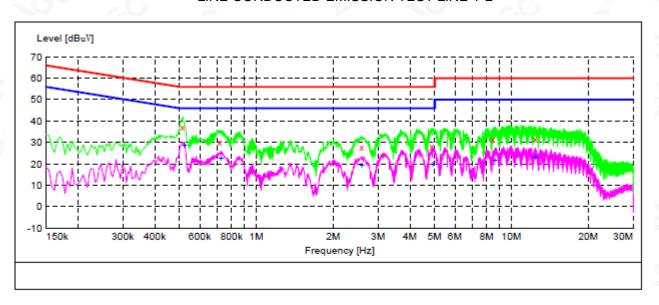
LINE CONDUCTED EMISSION TEST LINE 1-L

MEASUREMENT RESULT: "TESTL1 fin"

Frequency MHz	Level dBuV	Transd dB	Limit dBuV	Margin dB	Detector	Line	PE
0.514000 0.718000 2.586000 4.862000 8.474000	37.30 30.20 27.60 28.30 31.50	10.3 10.4 10.4 10.7	56 56 56 60	18.7 25.8 28.4 27.7 28.5 28.5	QP QP QP	L1 L1 L1 L1 L1 L1	FLO FLO FLO FLO FLO

MEASUREMENT RESULT: "TESTL1 fin2"

Frequency MHz	Level dBuV	Transd dB	Limit dBuV	Margin dB	Detector	Line	PE
0.522000	28.50	10.3	46	17.5	AV	L1	FLO
0.726000	22.50	10.3	46	23.5	AV	L1	FLO
2.586000	19.50	10.4	46	26.5	AV	L1	FLO
4.922000	19.90	10.4	46	26.1	AV	L1	FLO
8.618000	21.60	10.7	50	28.4	AV	L1	FLO
12.402000	23.10	10.8	50	26.9	AV	L1	FLO

RESULT: PASS

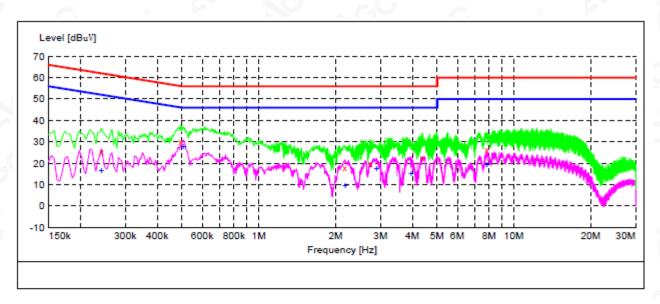
Line Conducted Emission Test Line 2-N

MEASUREMENT RESULT: "TESTL1 fin"

Fr	equency MHz	Level dBuV	Transd dB	Limit dBuV	Margin dB	Detector	Line	PE
0	.242000	25.60	10.3	62	36.4	QP	N	FLO
0	.494000	30.20	10.3	56	25.9	QP	N	FLO
2	.170000	18.00	10.4	56	38.0	QP	N	FLO
2	.730000	19.70	10.4	56	36.3	QP	N	FLO
4	.382000	22.60	10.4	56	33.4	QP	N	FLO
7	.822000	26.30	10.7	60	33.7	OP	N	FLO

MEASUREMENT RESULT: "TESTL1_fin2"

Frequency MHz	Level dBuV	Transd dB	Limit dBuV	Margin dB	Detector	Line	PE
0.242000	16.50 27.80	10.3	52 46	35.5 18.2	AV AV	N N	FLO FLO
2.178000	9.50	10.4	46	36.5	AV	N	FLO
2.898000 3.954000	17.50 15.00	10.4 10.4	46 46	28.5 31.0	AV AV	N N	FLO FLO
7.834000	19.40	10.7	50	30.6	AV	N	FLO

RESULT: PASS
