5 TEST CONDITIONS AND RESULTS

5.1 EBW and OBW

5.1.2 Photo documentation of the test set-up

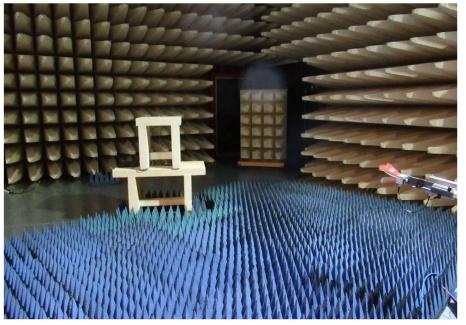
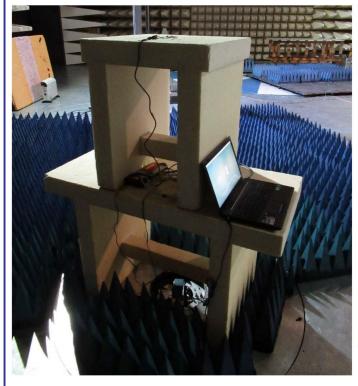
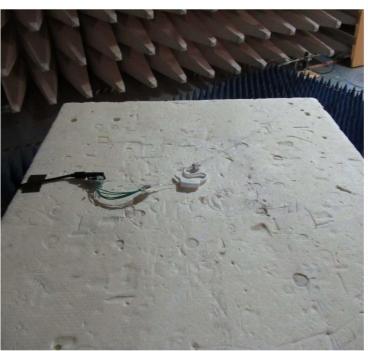
Test location: Anechoic chamber 1
