APPENDIX A: PHOTOGRAPHS OF TEST SETUP

APPENDIX B: PHOTOGRAPHS OF EUT

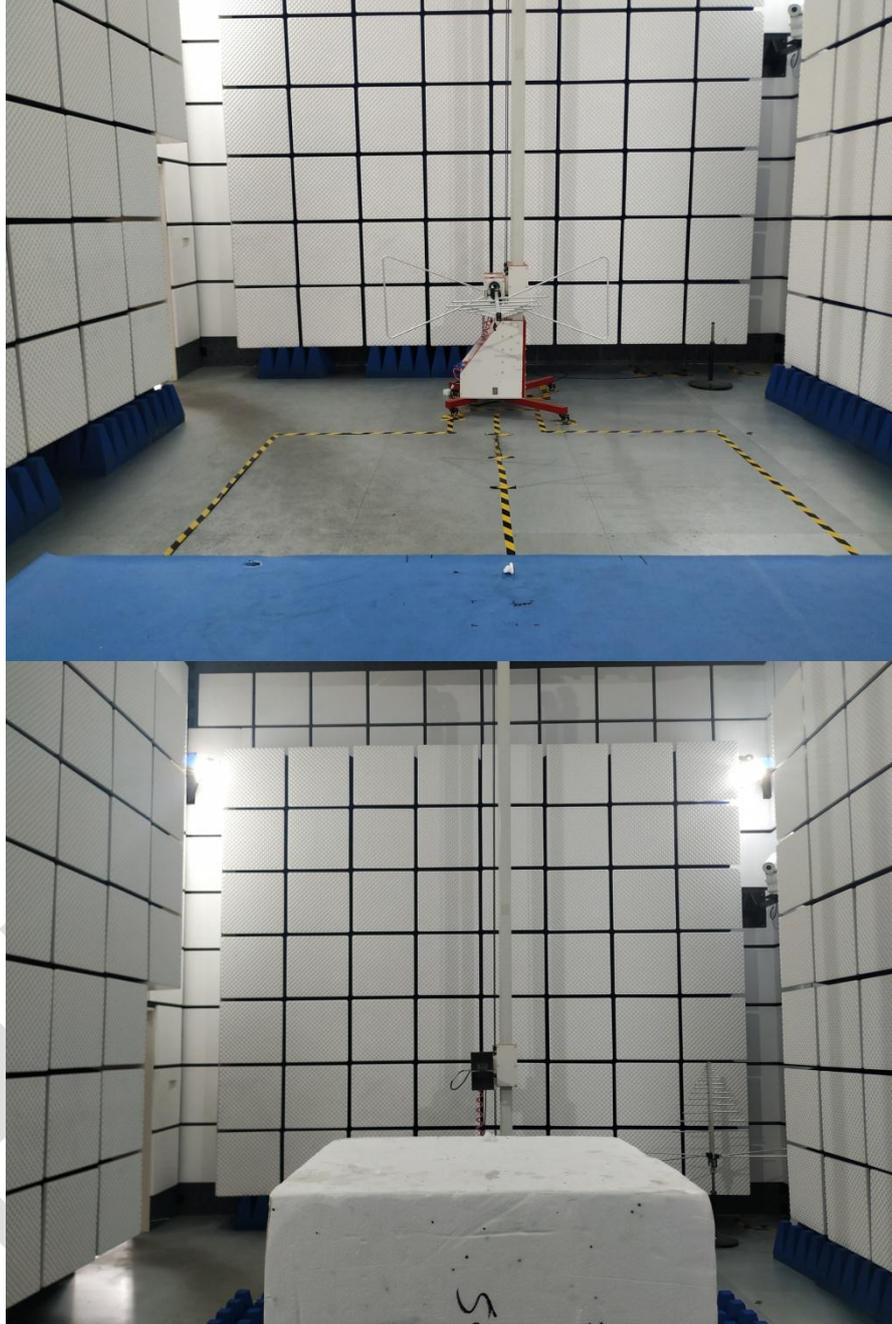
Radiated Spurious Emissions

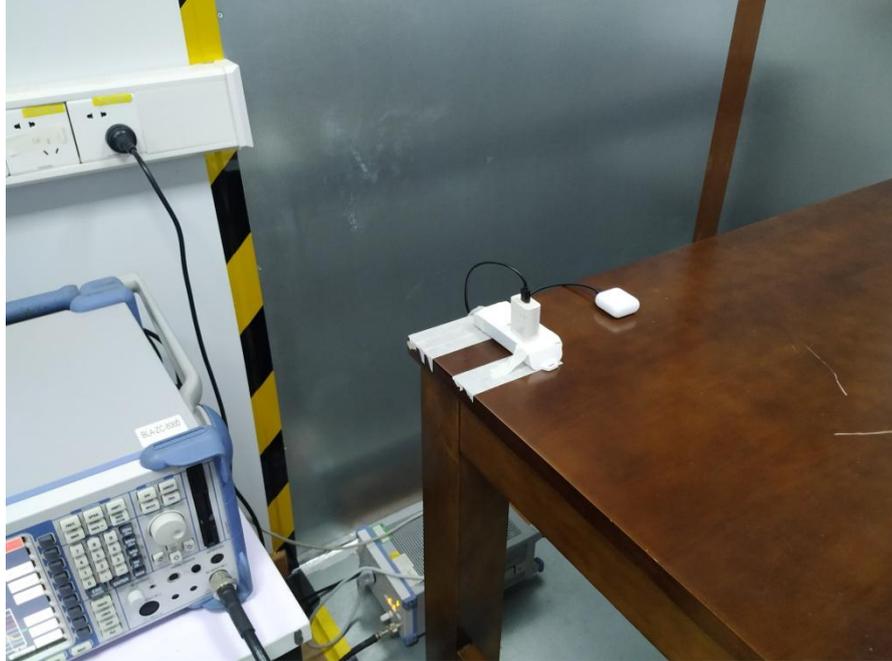
Conducted Emissions at AC Power Line (150kHz-30MHz)
