Report No.: EED32O80874101 Page 37 of 51

9 PHOTOGRAPHS OF TEST SETUP

Test model No.: GZ30

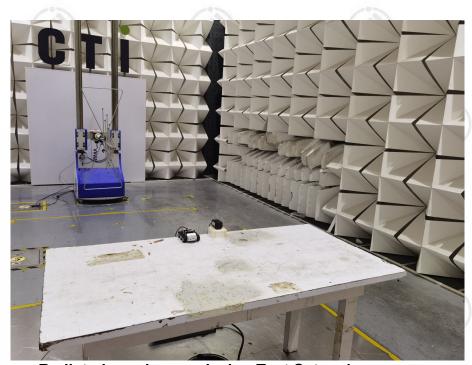
Radiated spurious emission Test Setup-1(Below 1GHz)

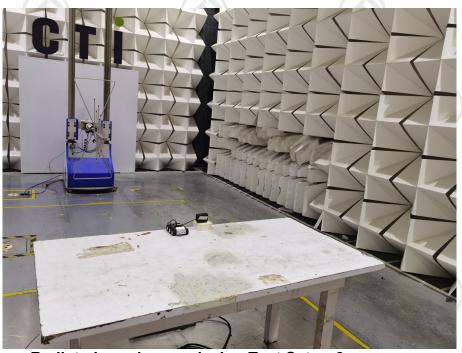
Radiated spurious emission Test Setup-2(Below 1GHz)

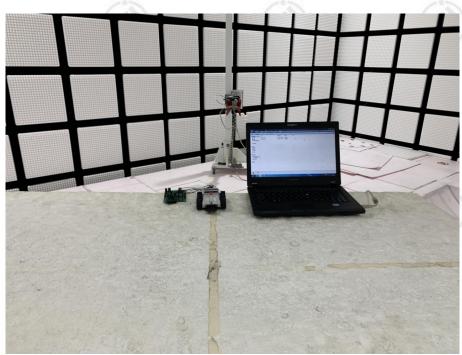
Radiated spurious emission Test Setup-2(Above 1GHz)

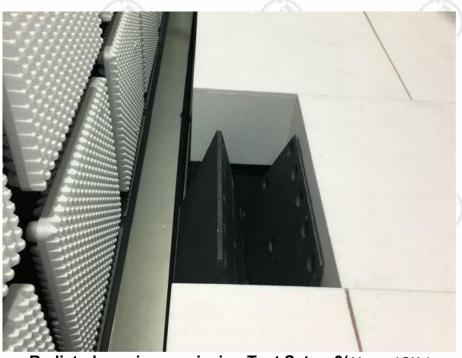
Radiated spurious emission Test Setup-3(Above 1GHz) There are absorbing materials under the ground.

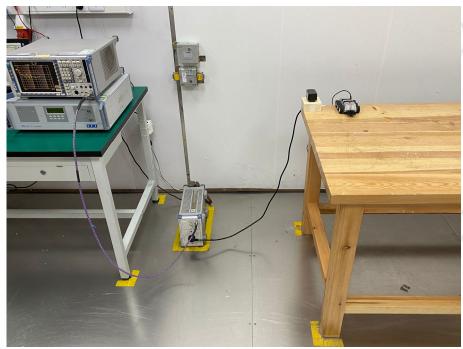
Conducted Emissions Test Setup(adapter 1)

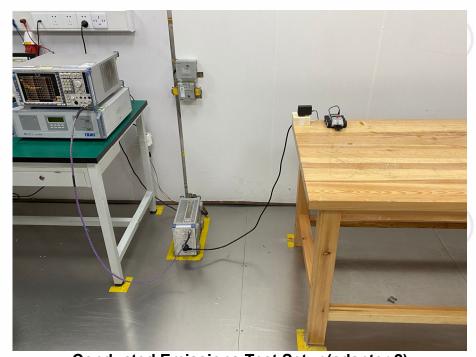
Conducted Emissions Test Setup(adapter 2)
