Report No.: EED32N80049701 Page 30 of 45

PHOTOGRAPHS OF TEST SETUP

Test model No.: QTZ-40-T-01

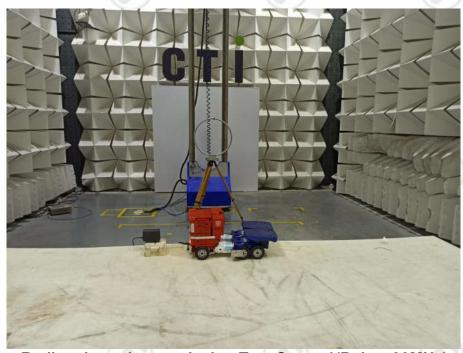
Radiated spurious emission Test Setup-1(Below 30MHz)

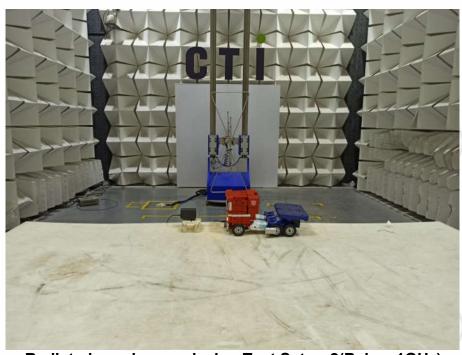
Radiated spurious emission Test Setup-2(Below 1GHz)

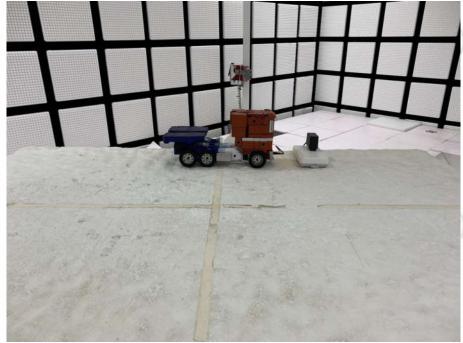
Radiated spurious emission Test Setup-3(Above 1GHz)

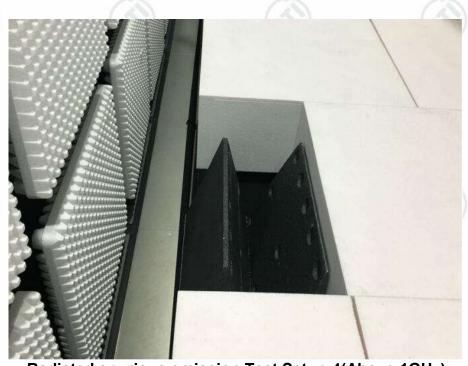
Radiated spurious emission Test Setup-4(Above 1GHz)
There are absorbing materials under the ground.

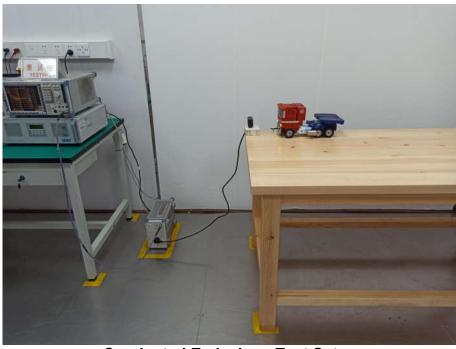
Conducted Emissions Test Setup
