Appendix B: Photographs of Test Setup

Product: Remote Diagnostic Service

Model: TKX11

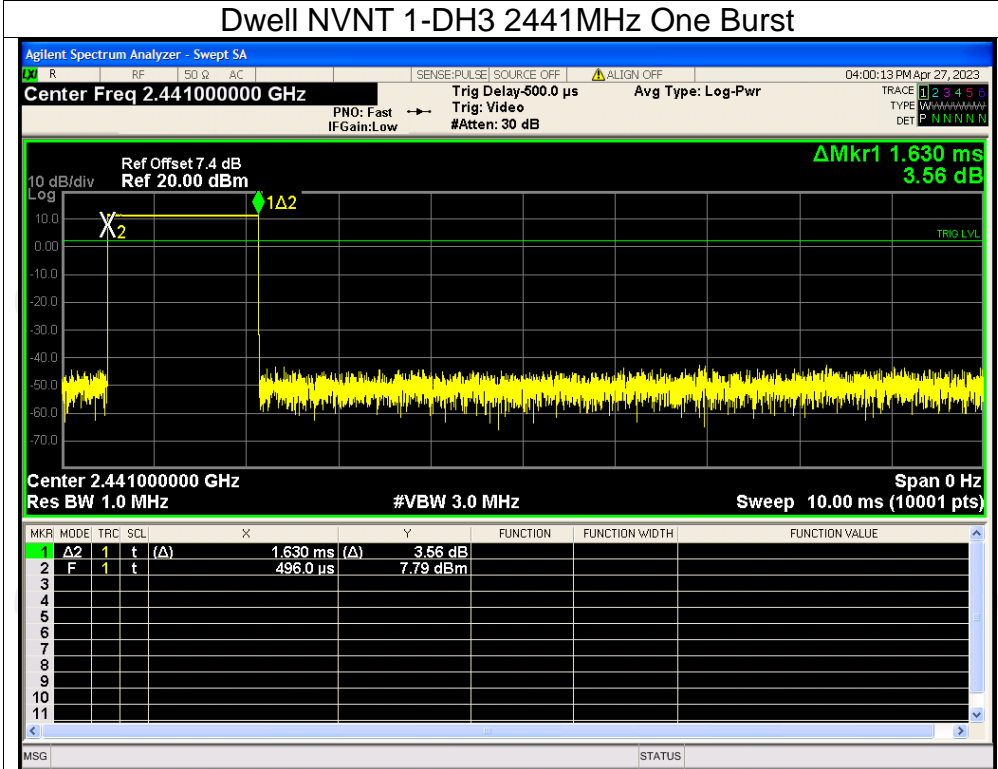
Dwell NVNT 1-DH3 2441MHz One Burst

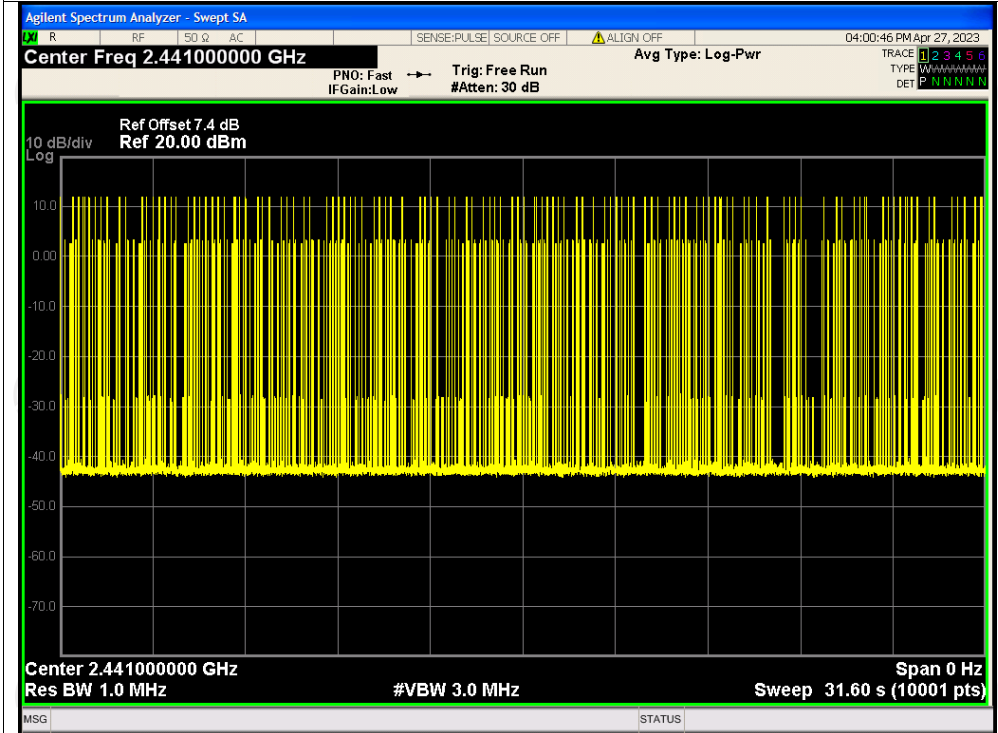
Dwell NVNT 1-DH3 2441MHz Accumulated

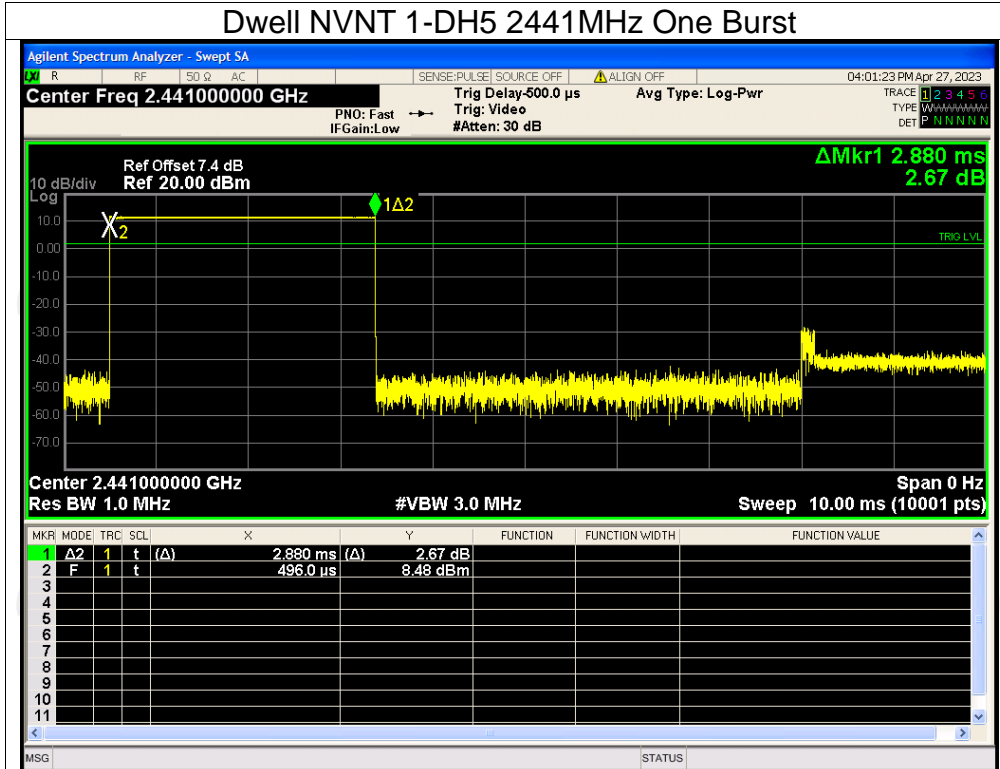
Dwell NVNT 1-DH5 2441MHz One Burst

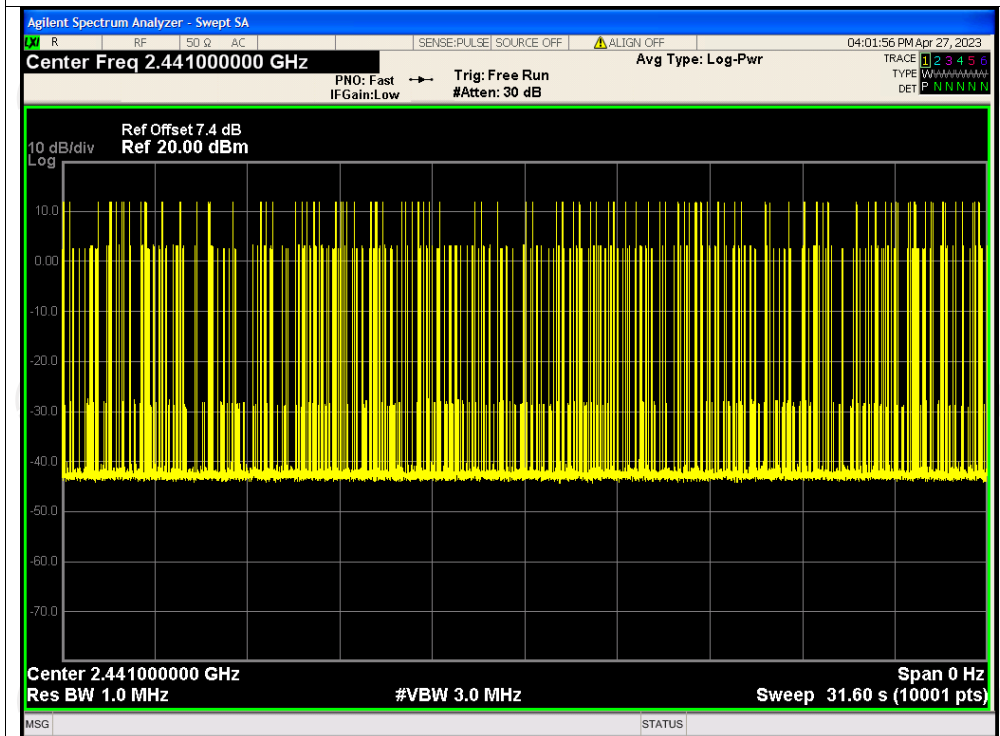
Dwell NVNT 1-DH5 2441MHz Accumulated

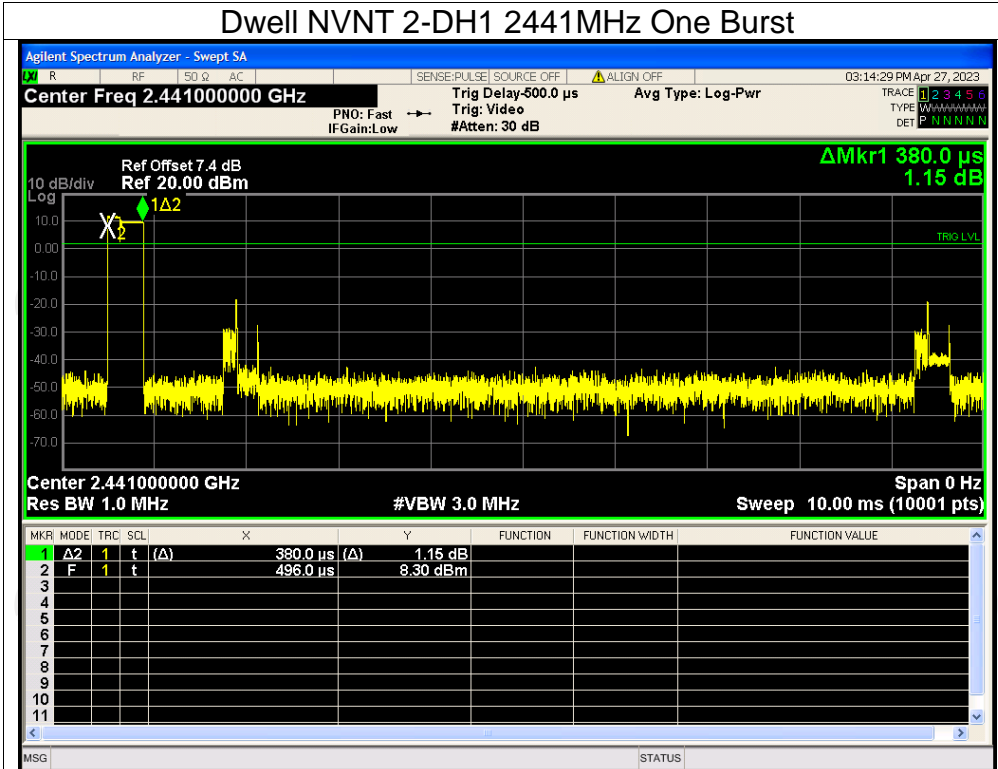
Dwell NVNT 2-DH1 2441MHz One Burst

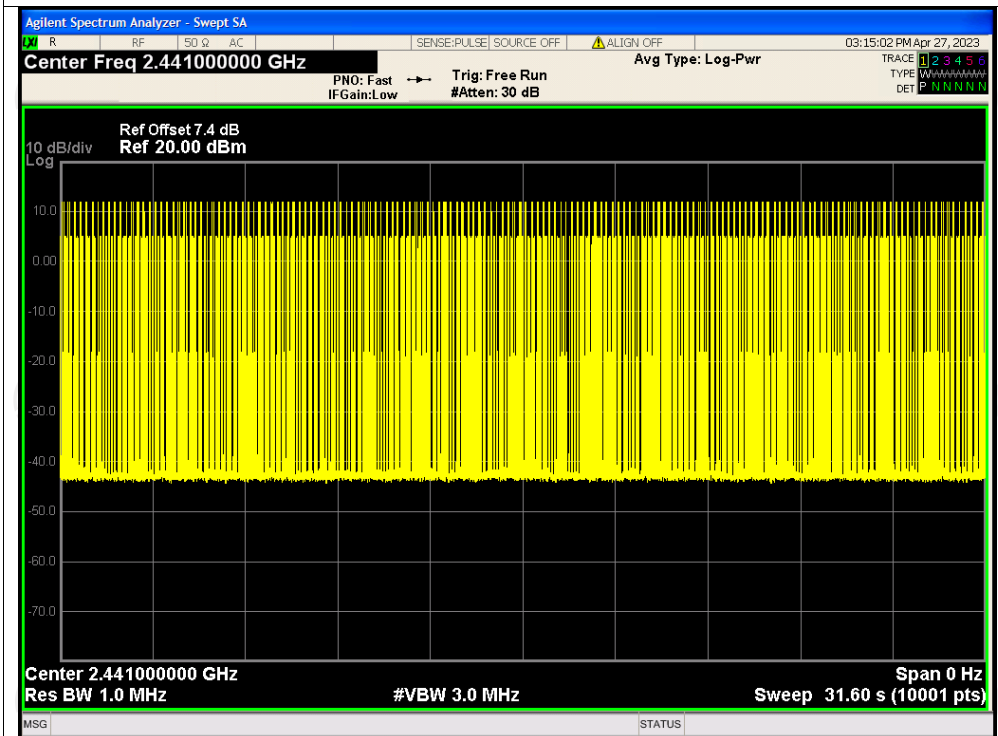
Dwell NVNT 2-DH1 2441MHz Accumulated

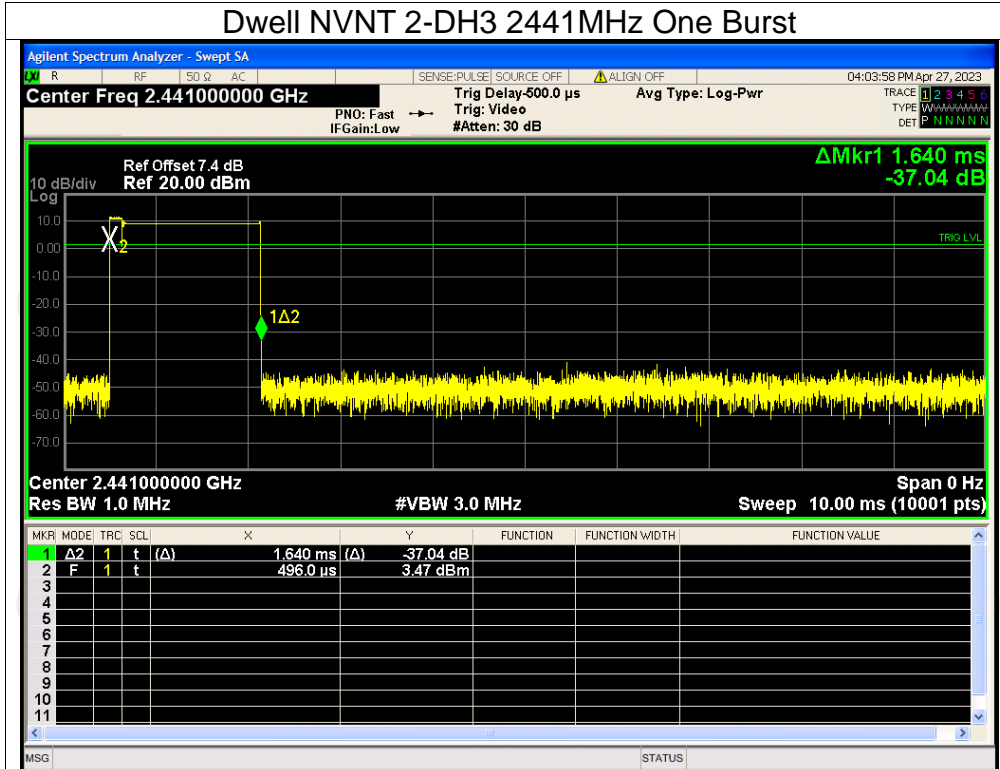
Dwell NVNT 2-DH3 2441MHz One Burst

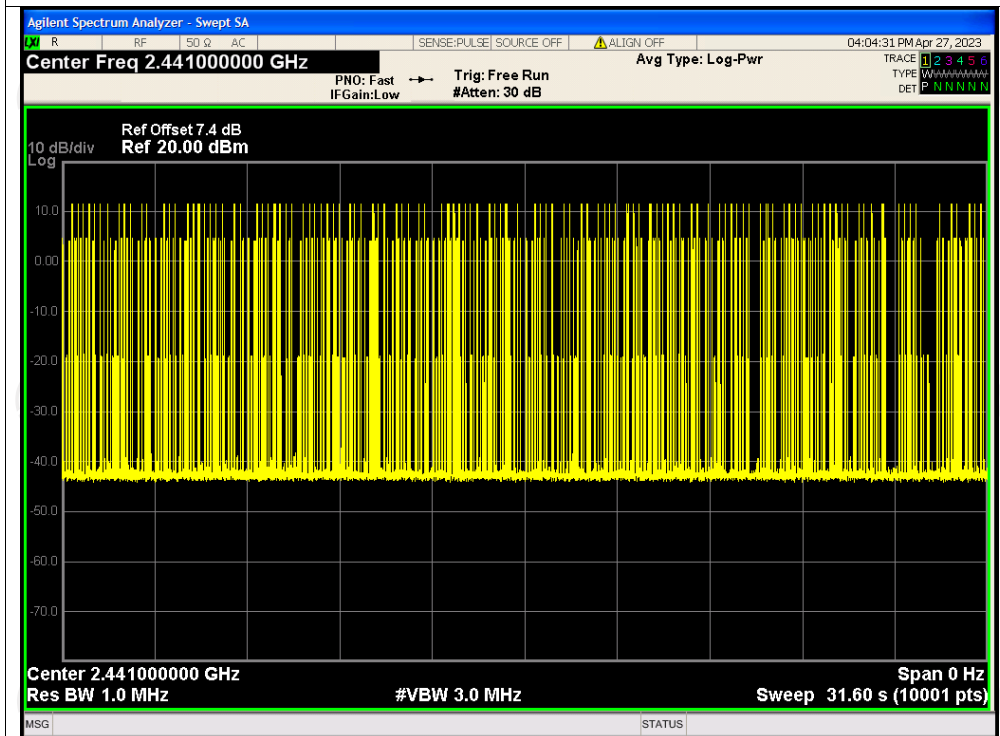
Dwell NVNT 2-DH3 2441MHz Accumulated

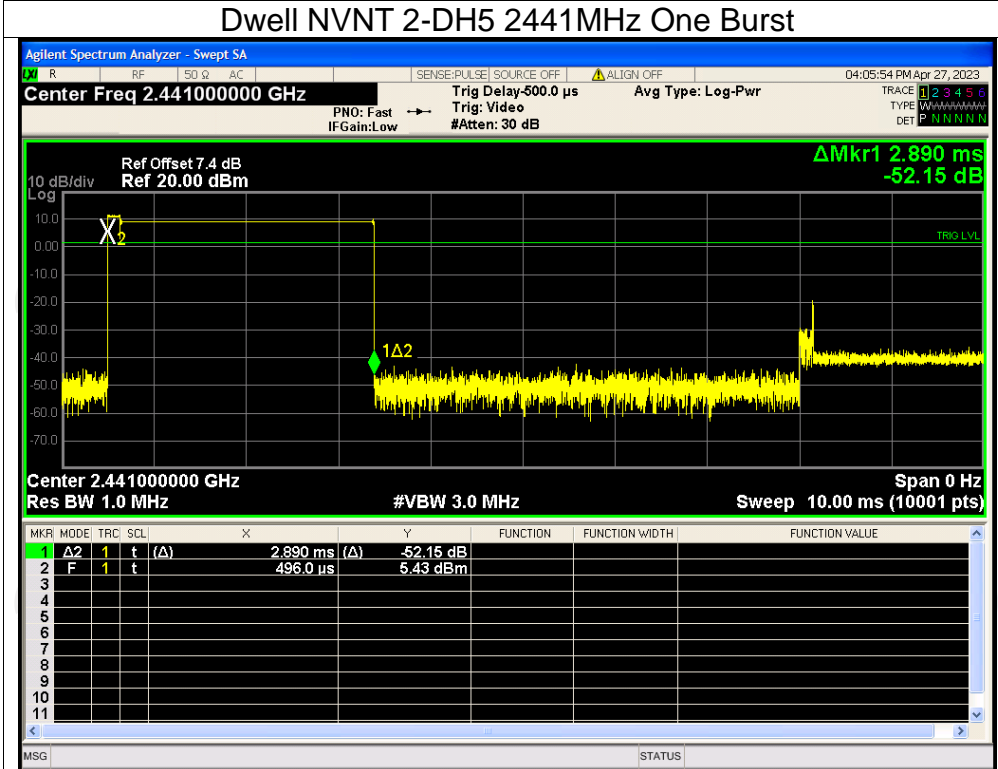
Dwell NVNT 2-DH5 2441MHz One Burst

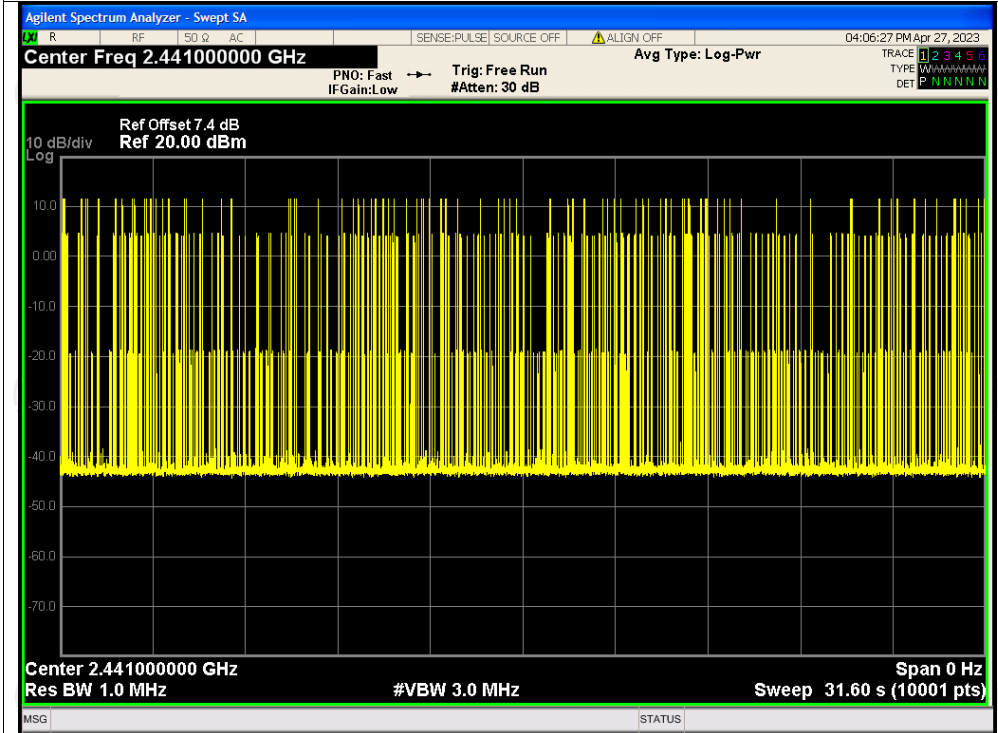
Dwell NVNT 2-DH5 2441MHz Accumulated

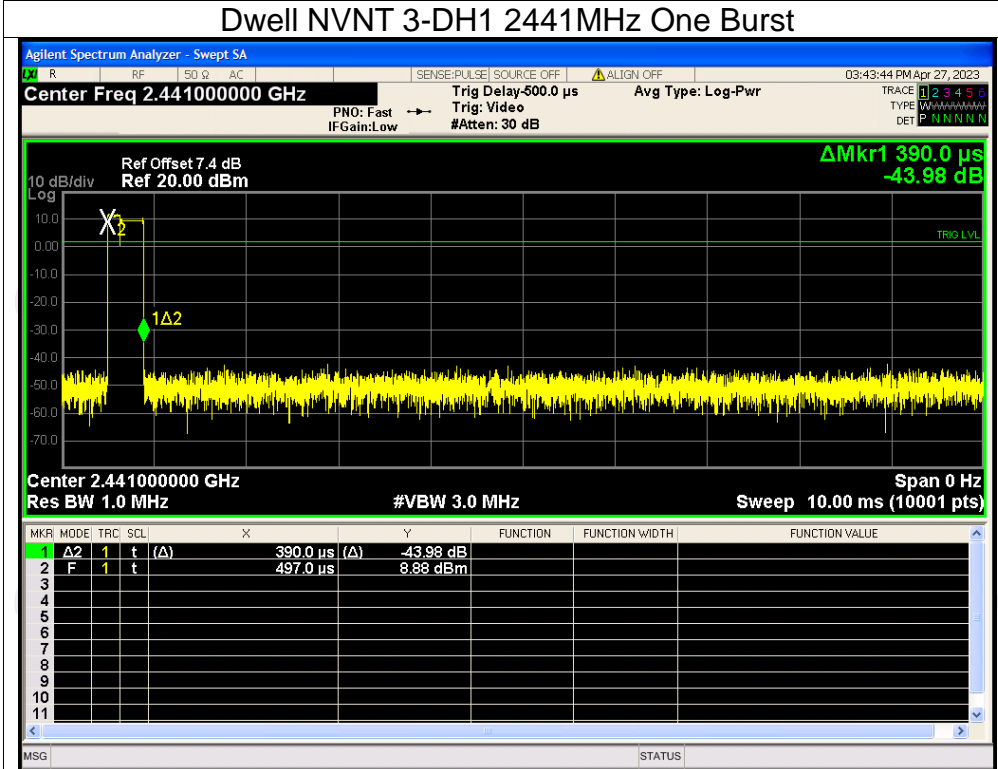
Dwell NVNT 3-DH1 2441MHz One Burst

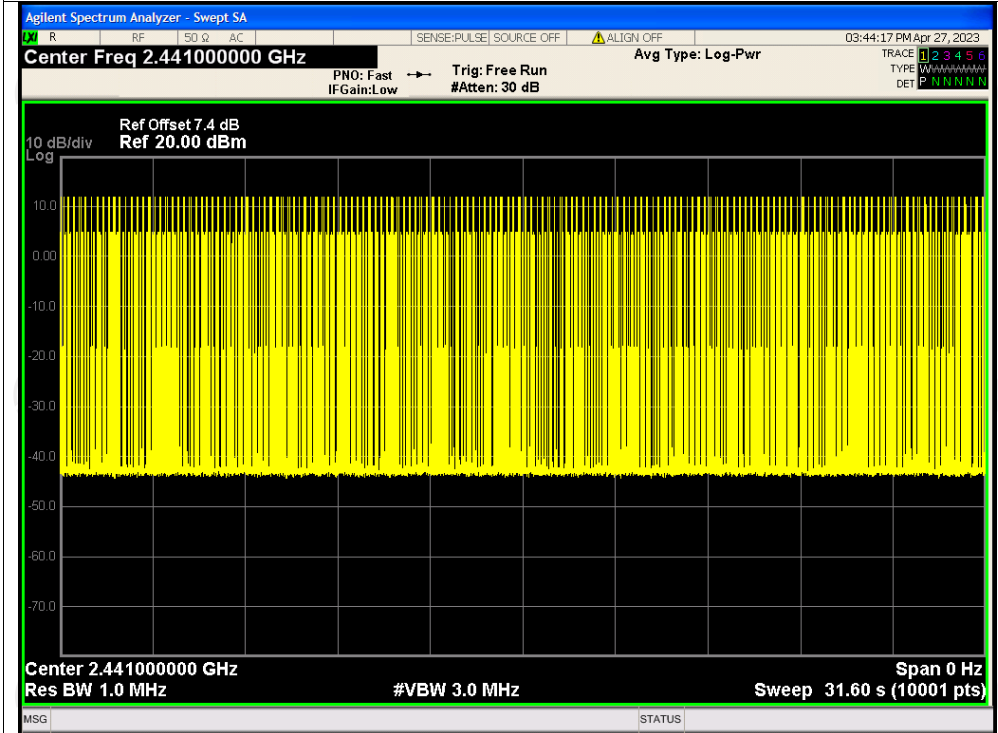
Dwell NVNT 3-DH1 2441MHz Accumulated

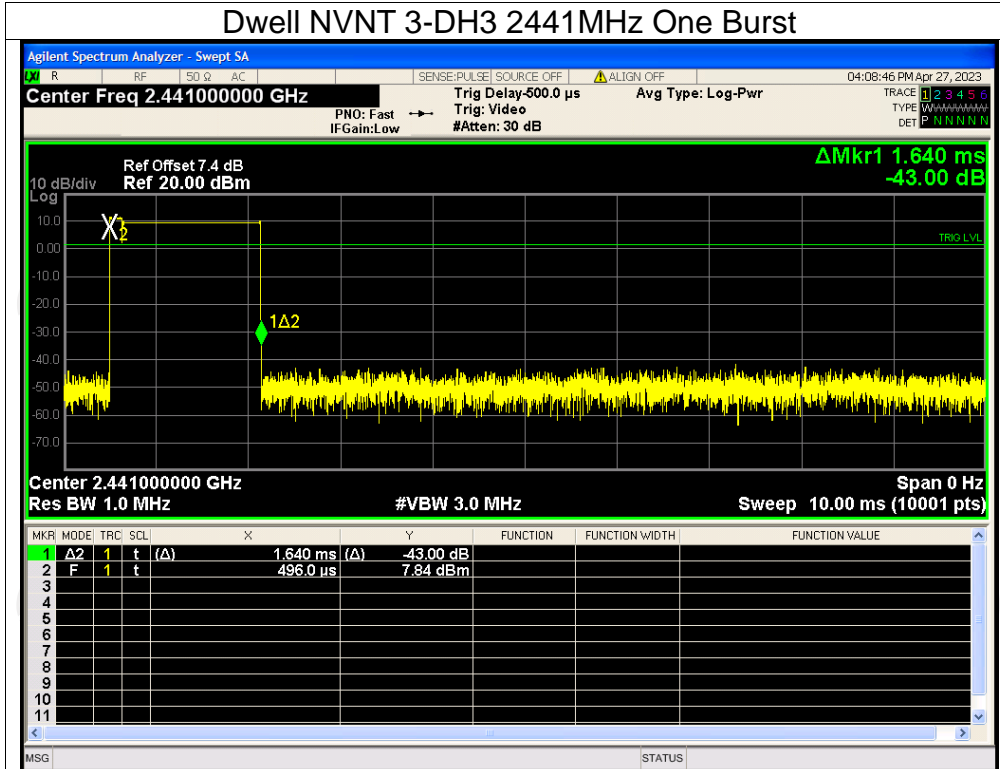
Dwell NVNT 3-DH3 2441MHz One Burst

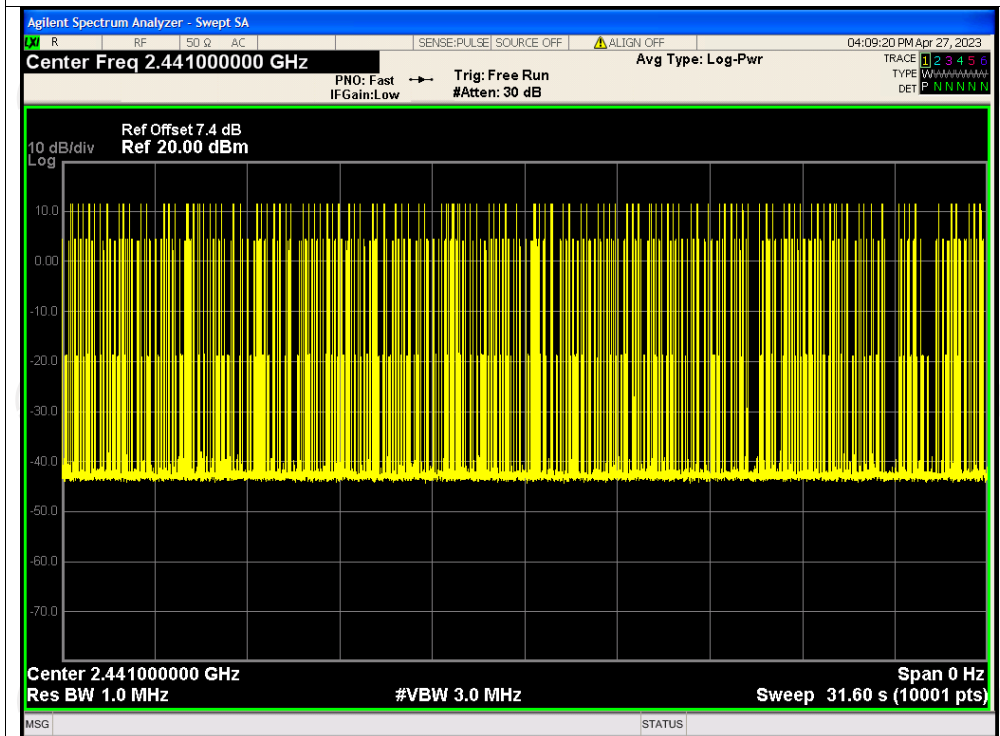
Dwell NVNT 3-DH3 2441MHz Accumulated

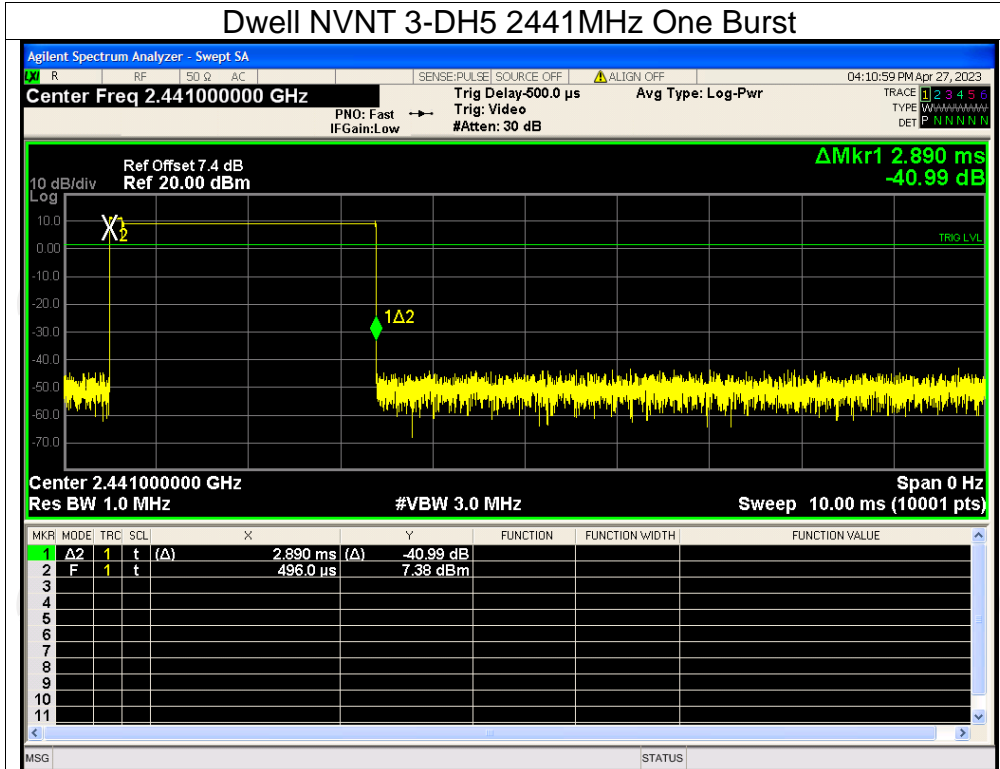
Dwell NVNT 3-DH5 2441MHz One Burst

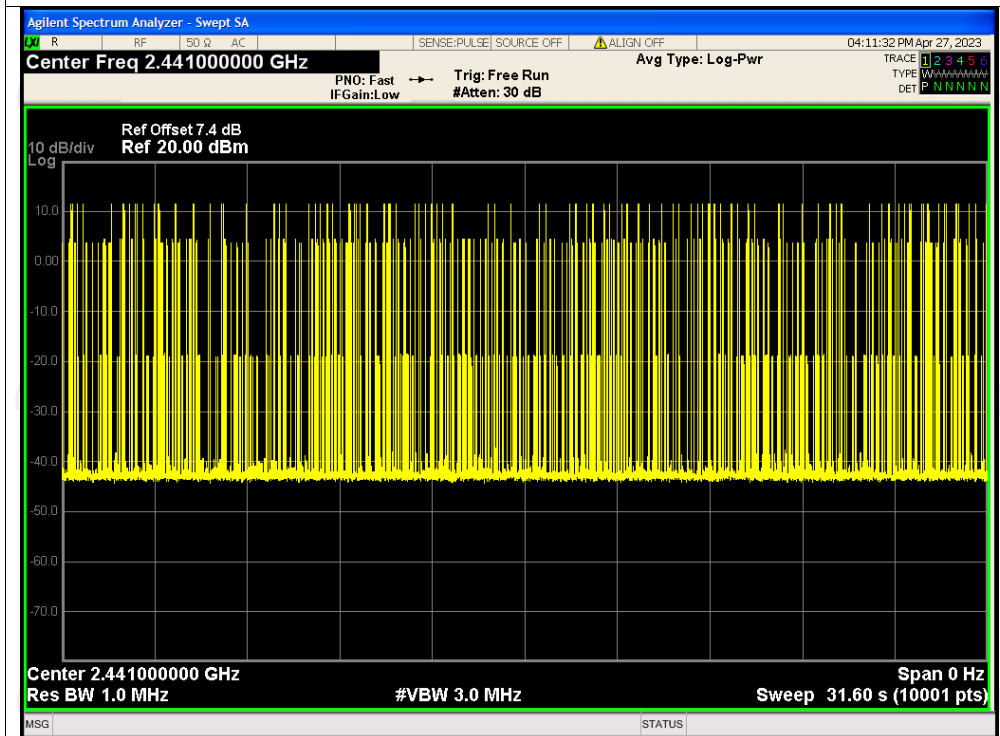
Dwell NVNT 3-DH5 2441MHz Accumulated

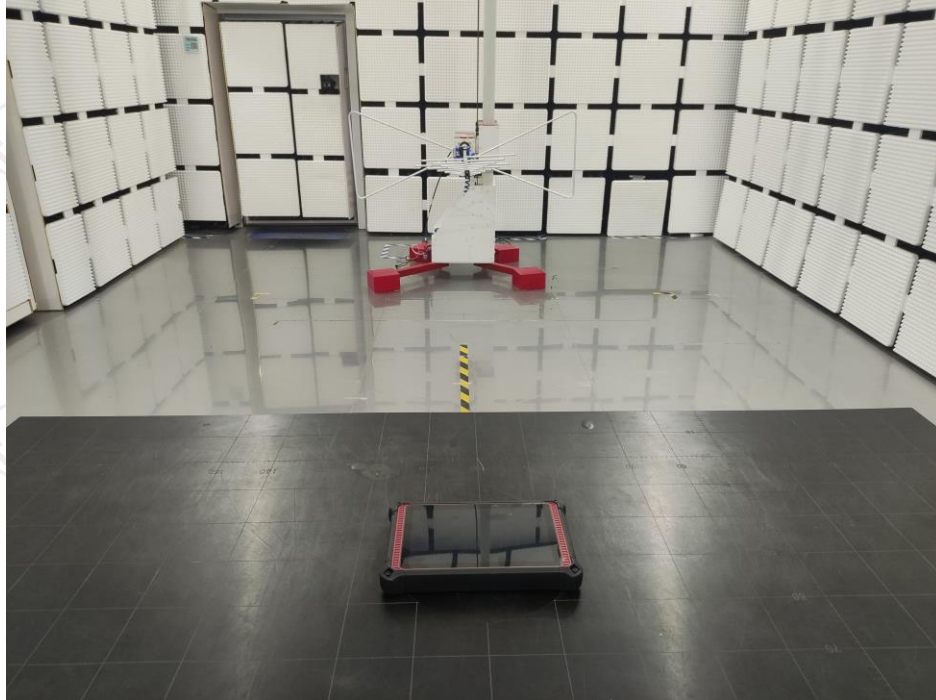
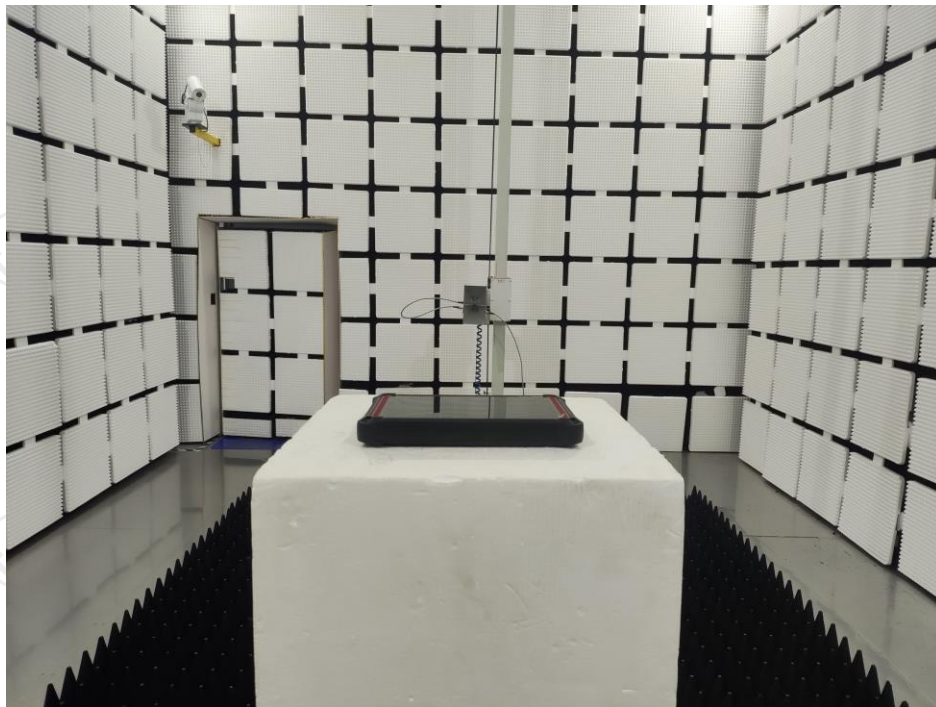
Radiated Emission

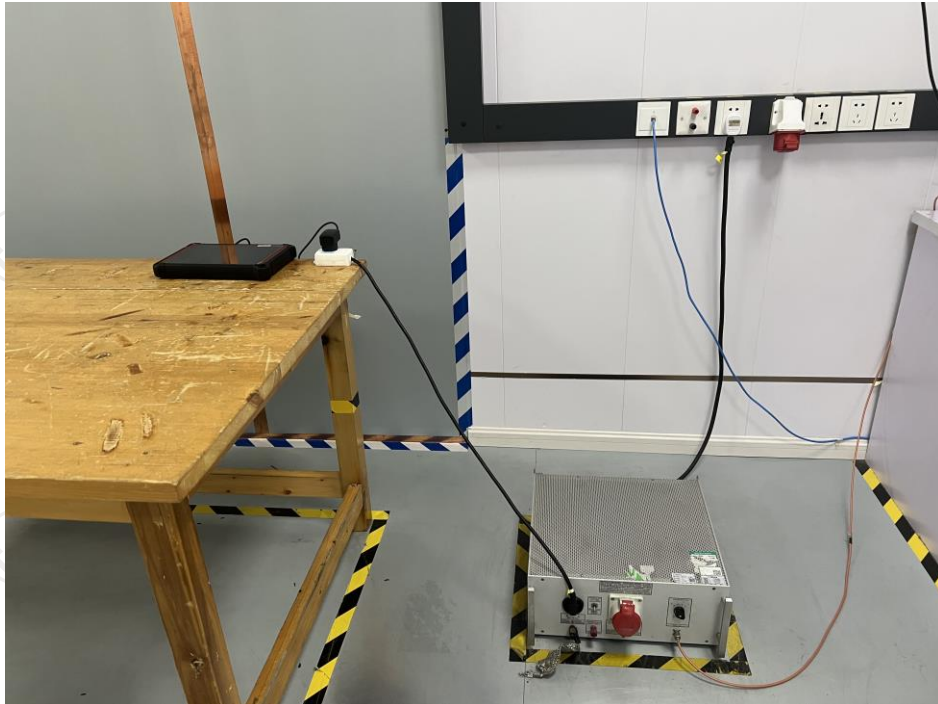
Conducted Emission
