9 PHOTOGRAPHS OF TEST SETUP

Report No.: EED32P80467601 Page 31 of 53

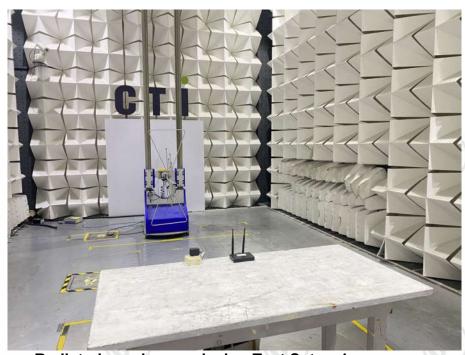
Radiated spurious emission Test Setup-1(Below 1GHz)

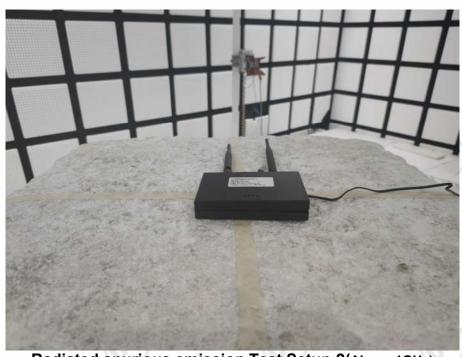
Radiated spurious emission Test Setup-2(Above 1GHz)

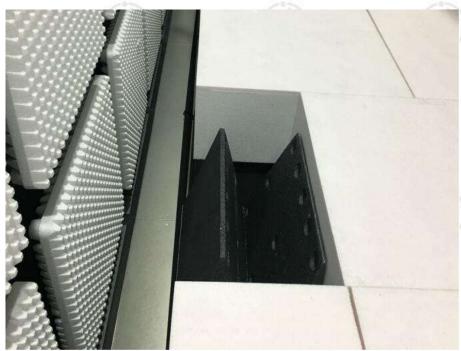
Radiated spurious emission Test Setup-3(Above 1GHz)
There are absorbing materials under the ground.

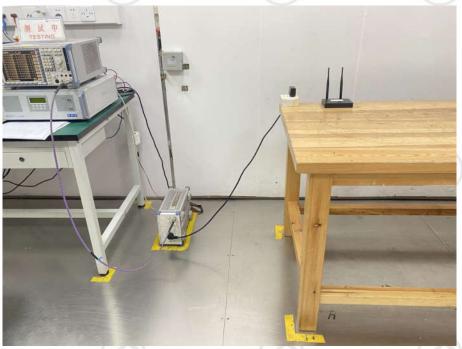
Conducted Emissions Test Setup
