APPENDIX 3: Photographs of test setup

Radiated Emission

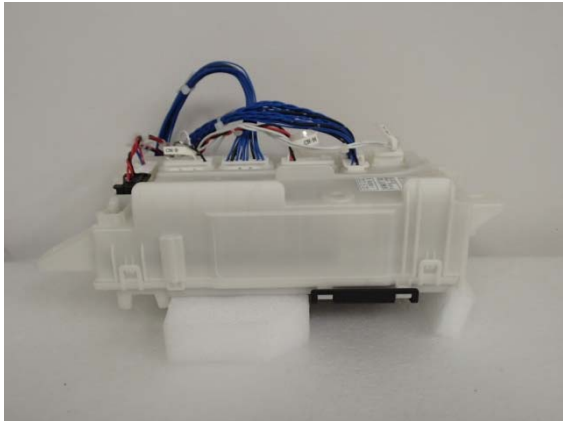
ECU
Below 30 MHz
X-axis
Above 30 MHz
Horizontal: X-axis / Vertical: X-axis

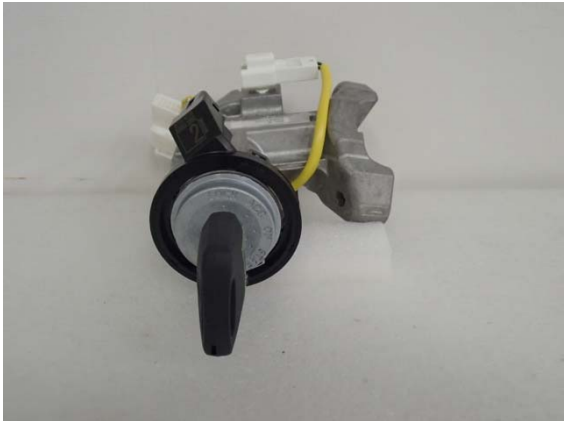
ANT
Below 30 MHz
X-axis
Above 30 MHz
Horizontal: X-axis / Vertical: X-axis

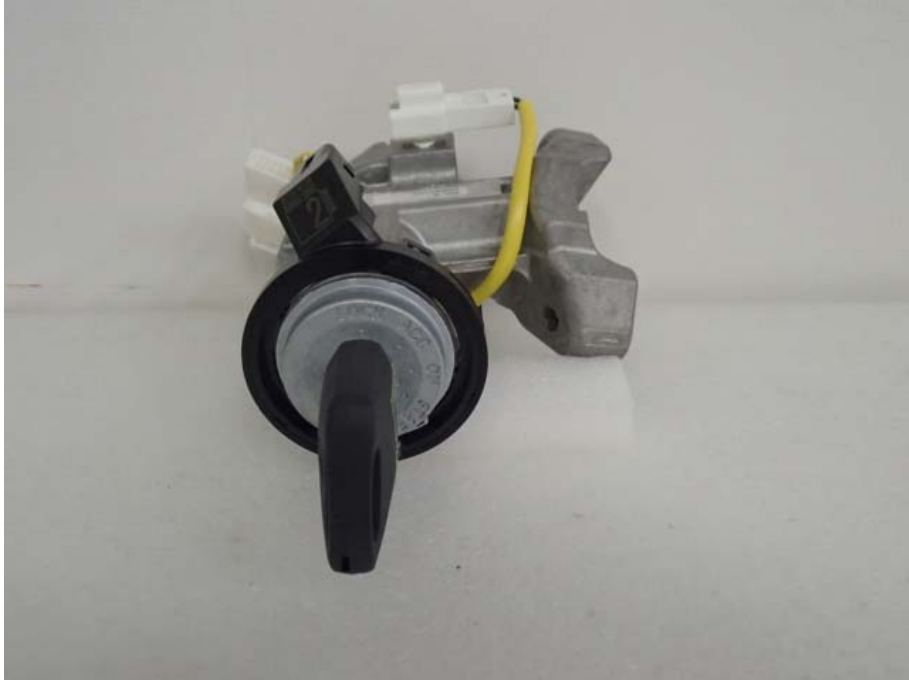
Worst case position

With transponder key inserted (Worst)

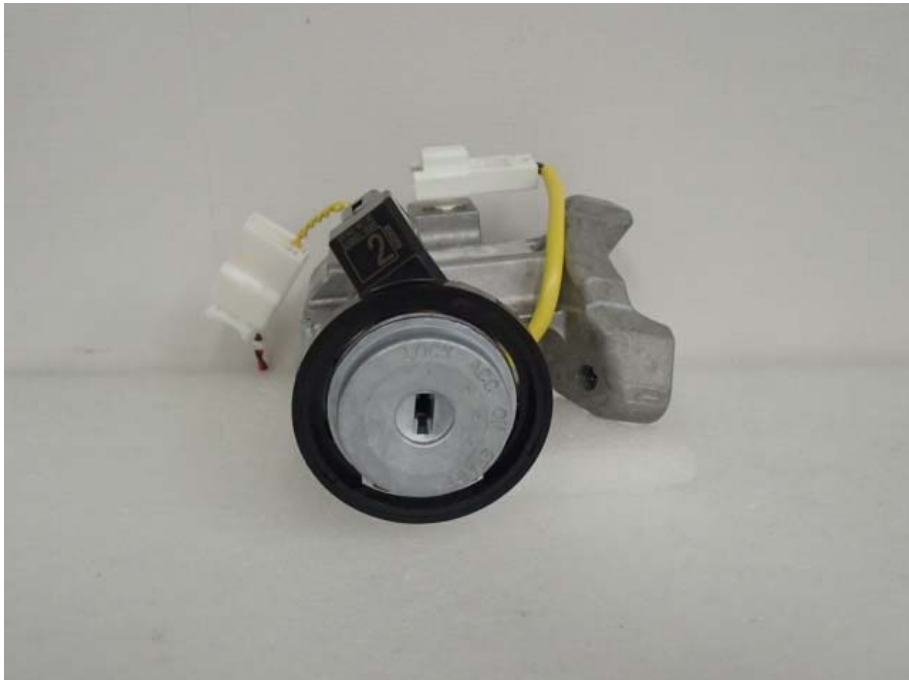
Without transponder key inserted
