Tx. Spurious NVNT BLE 1M 2480MHz Ant1 Ref

APPENDIX A: PHOTOGRAPHS OF TEST SETUP

Reference to the test report No. BLA-EMC-202210-A8901

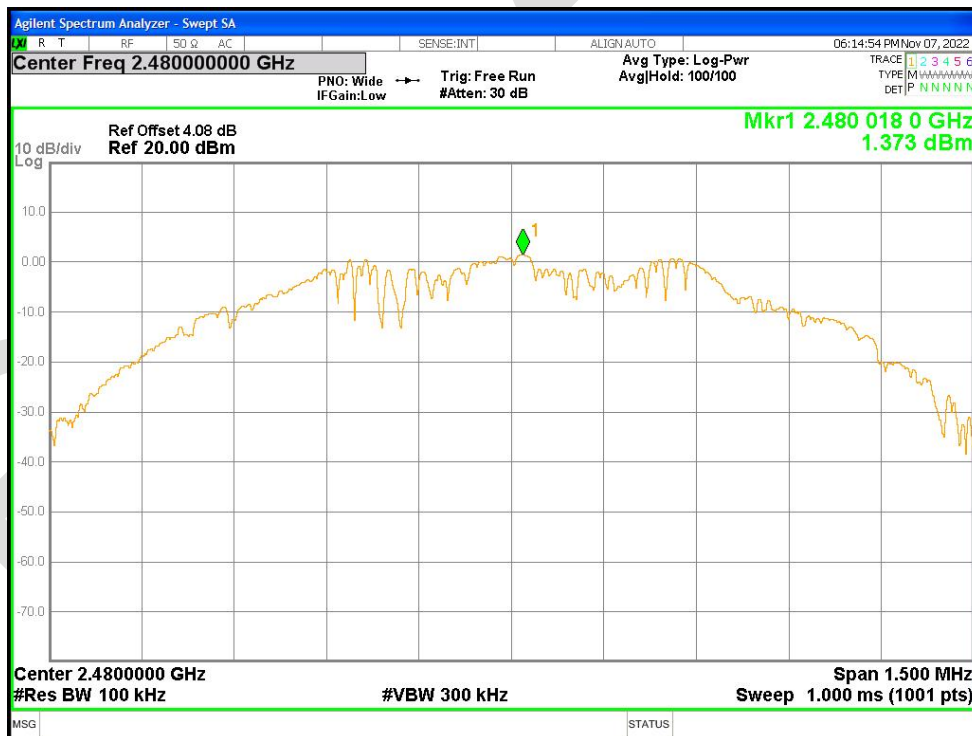
Tx. Spurious NVNT BLE 1M 2480MHz Ant1 Emission

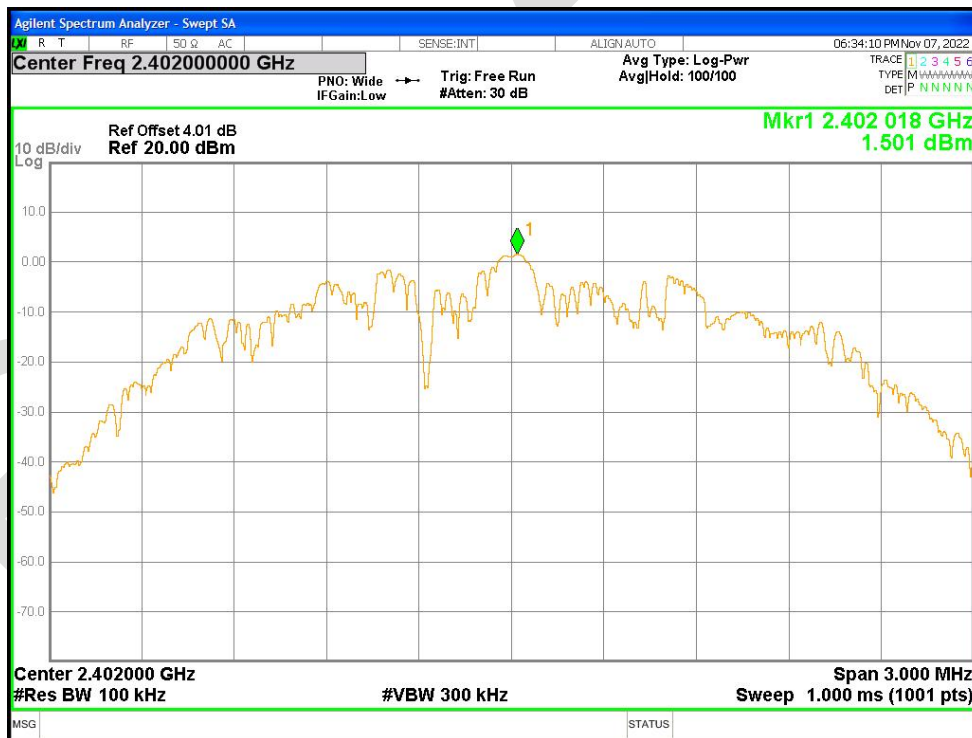
Tx. Spurious NVNT BLE 2M 2402MHz Ant1 Emission

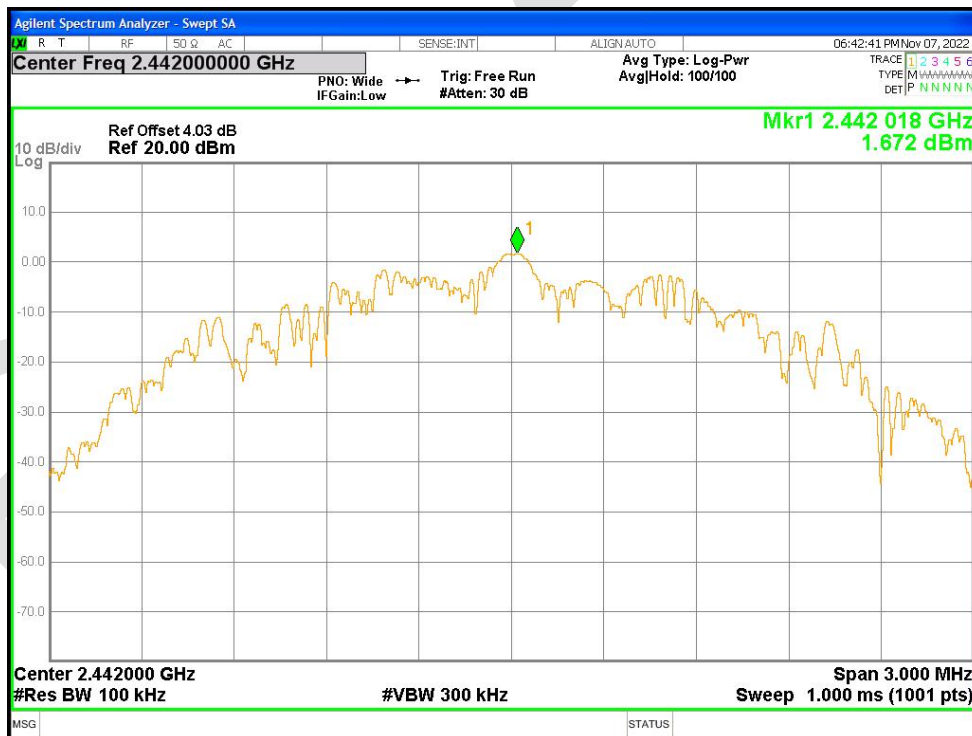
Tx. Spurious NVNT BLE 2M 2442MHz Ant1 Emission

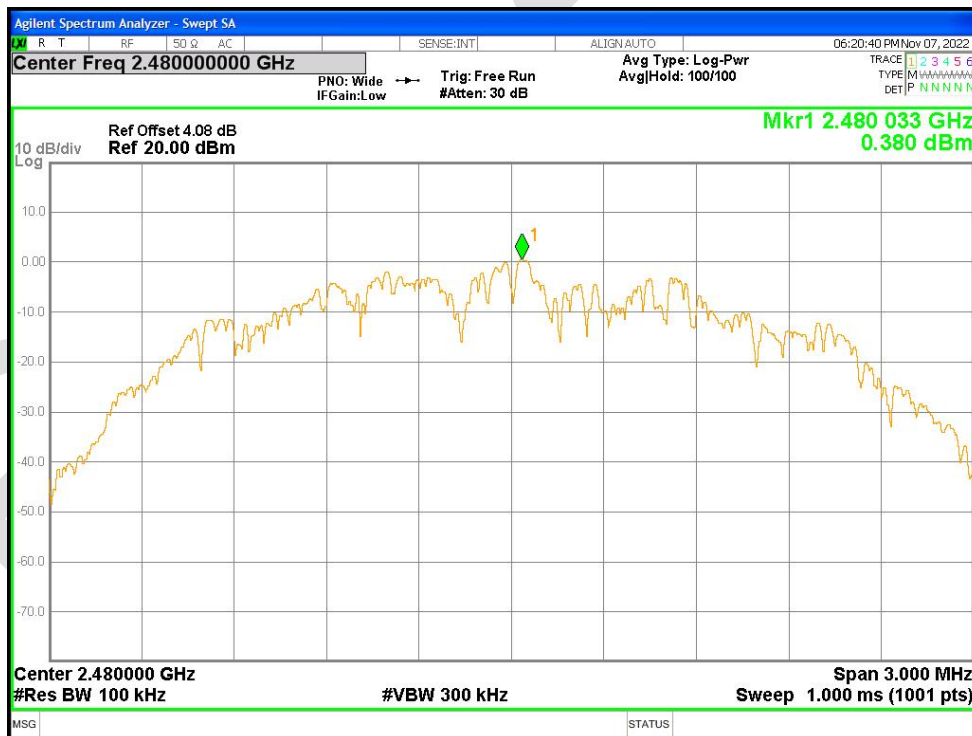
Tx. Spurious NVNT BLE 2M 2480MHz Ant1 Emission
