Reference to the test report No. BLA-EMC-202303-A3901

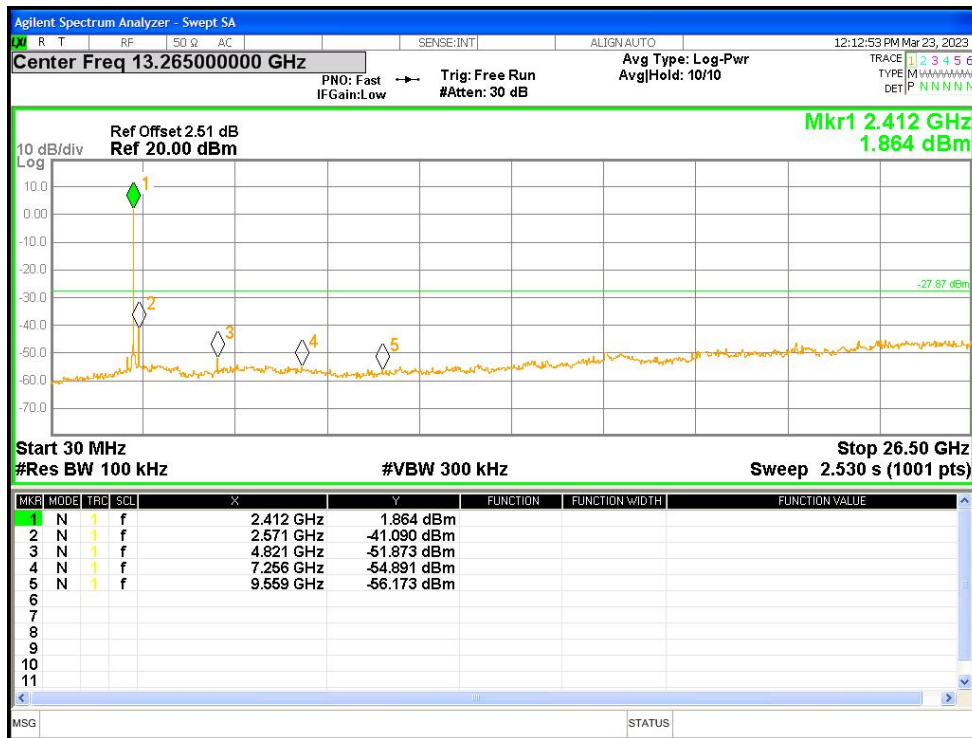
Tx. Spurious NVNT b 2437MHz Ant1 Ref

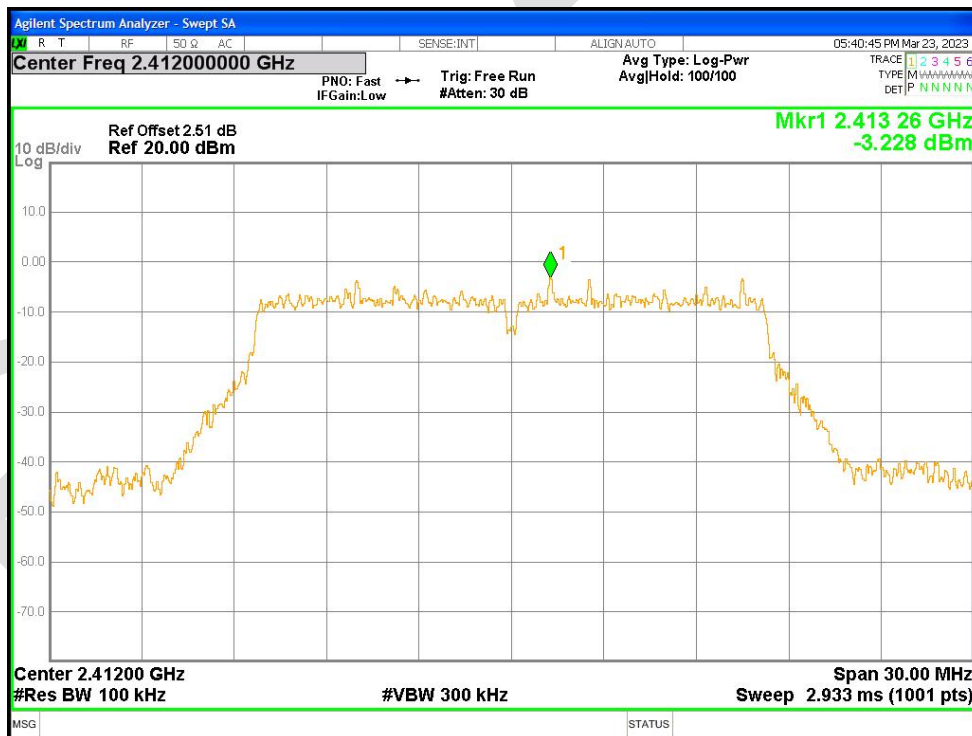
Tx. Spurious NVNT g 2412MHz Ant1 Emission

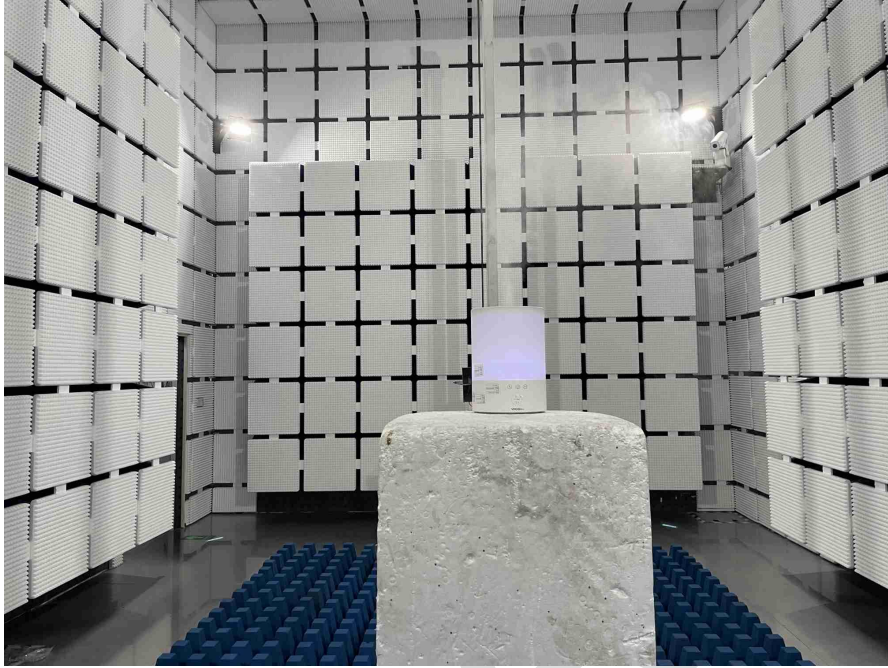
Radiated Spurious Emissions

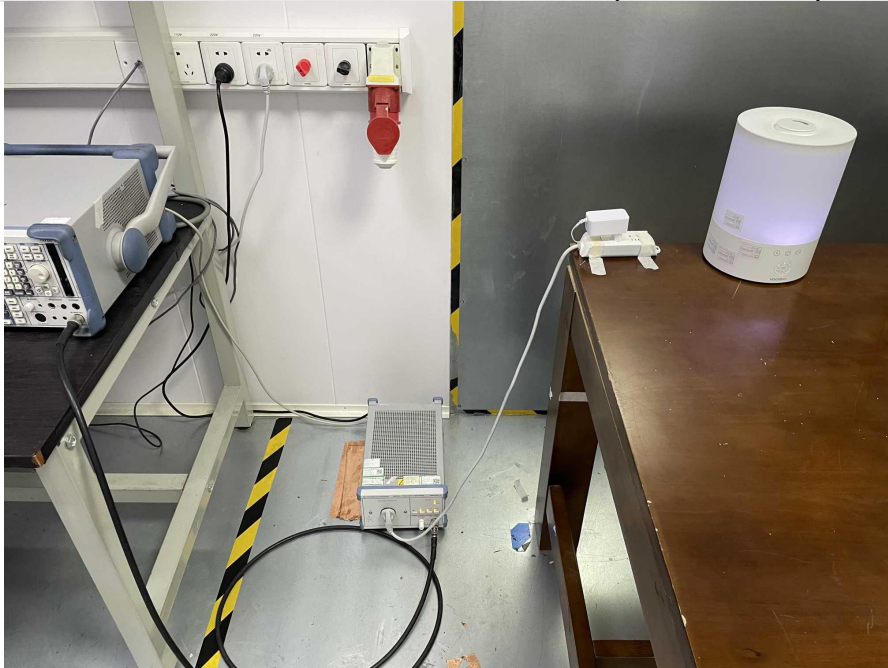
Conducted Emissions at AC Power Line (150kHz-30MHz)
