Report No.: CTA23070502801 Page 30 of 42

## 4.7 Antenna Requirement

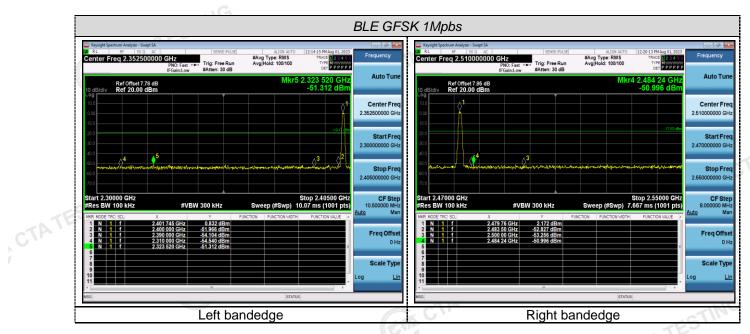
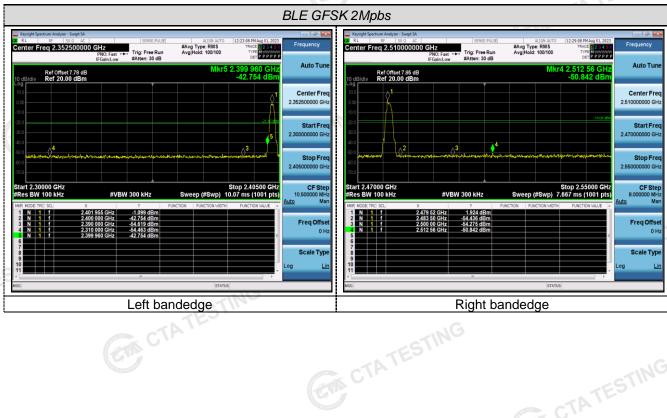
## Band-edge Measurements for RF Conducted Emissions:

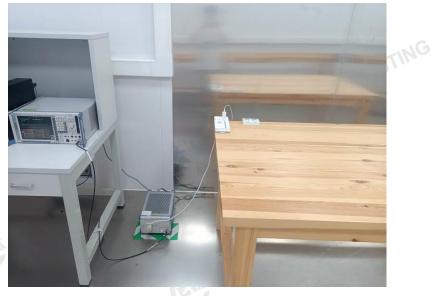
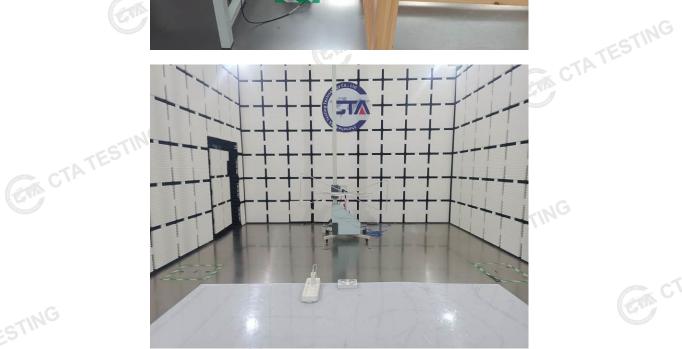
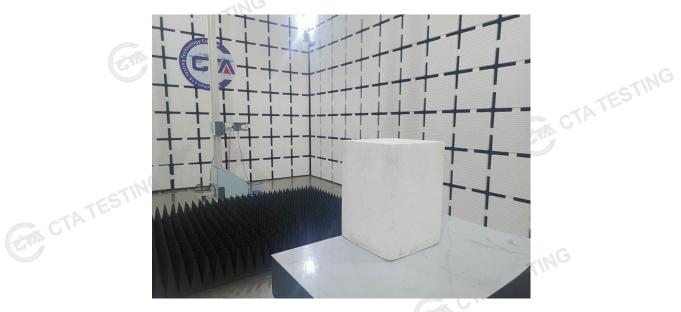
## 5 Test Setup Photos of the EUT
