9 PHOTOGRAPHS OF TEST SETUP

Test model No.: iSmartEV P01

Report No.: EED32O81173001 Page 33 of 49

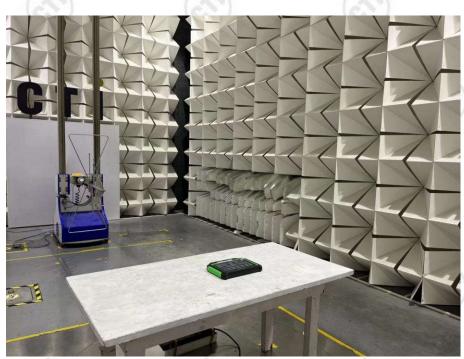
Radiated spurious emission Test Setup-1(Below 1GHz)

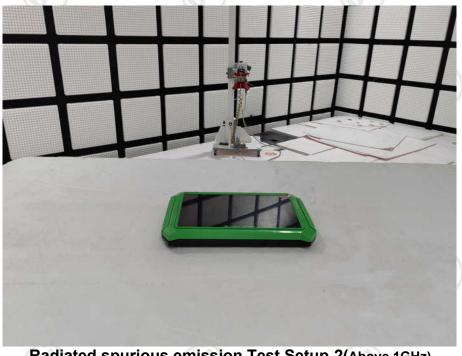
Radiated spurious emission Test Setup-2(Above 1GHz)

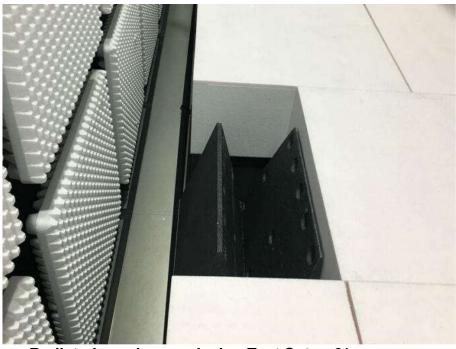
Radiated spurious emission Test Setup-3(Above 1GHz) There are absorbing materials under the ground.

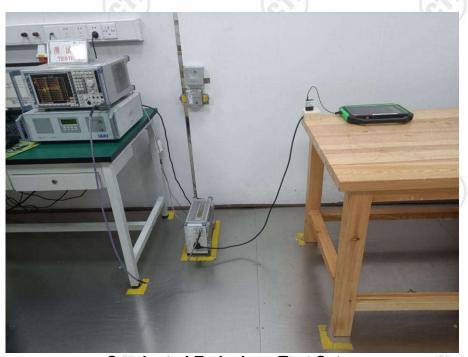
Conducted Emissions Test Setup
