Report No. : EED32P80250901

## 9 PHOTOGRAPHS OF TEST SETUP

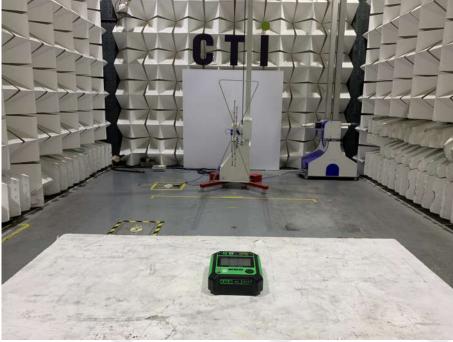
Radiated spurious emission Test Setup-1(Below 1GHz)

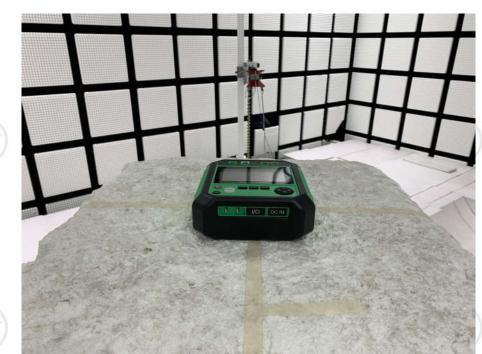
Radiated spurious emission Test Setup-2(Above 1GHz)

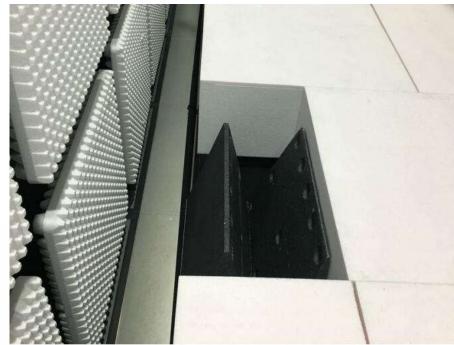
Radiated spurious emission Test Setup-3(Above 1GHz) There are absorbing materials under the ground.

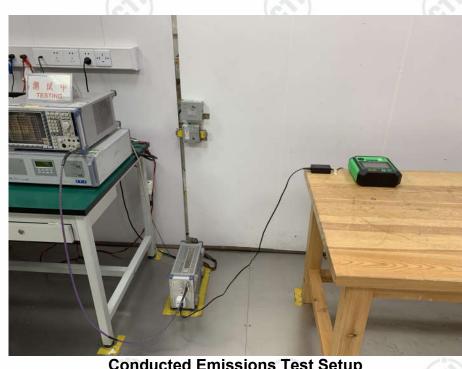
**Conducted Emissions Test Setup**
