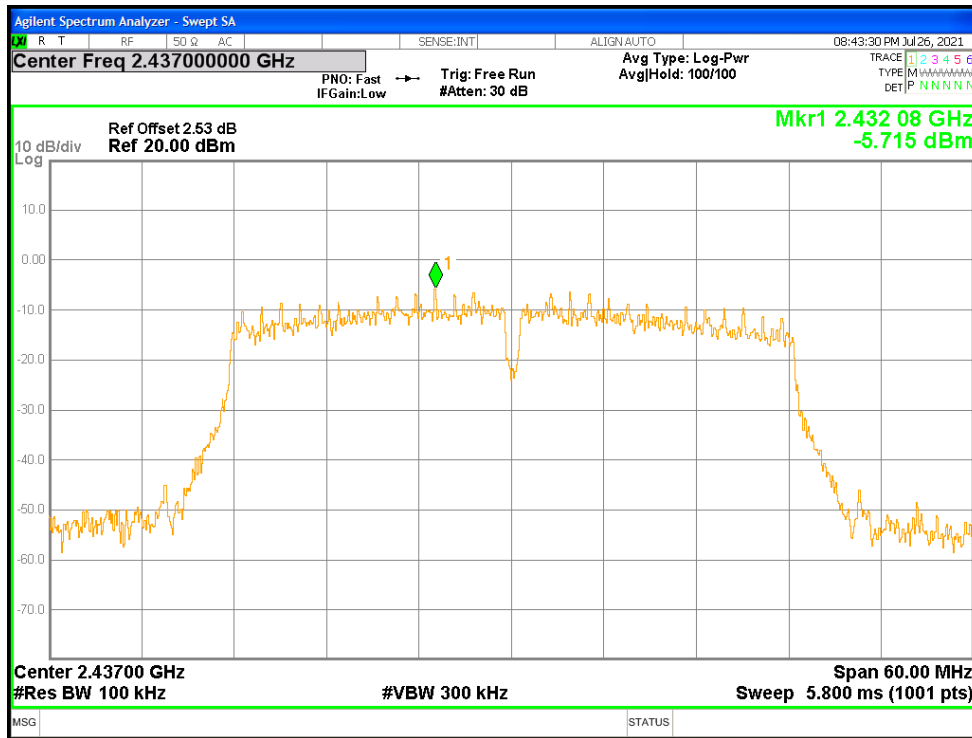
Tx. Spurious NVNT n40 2437MHz Ant1 Ref

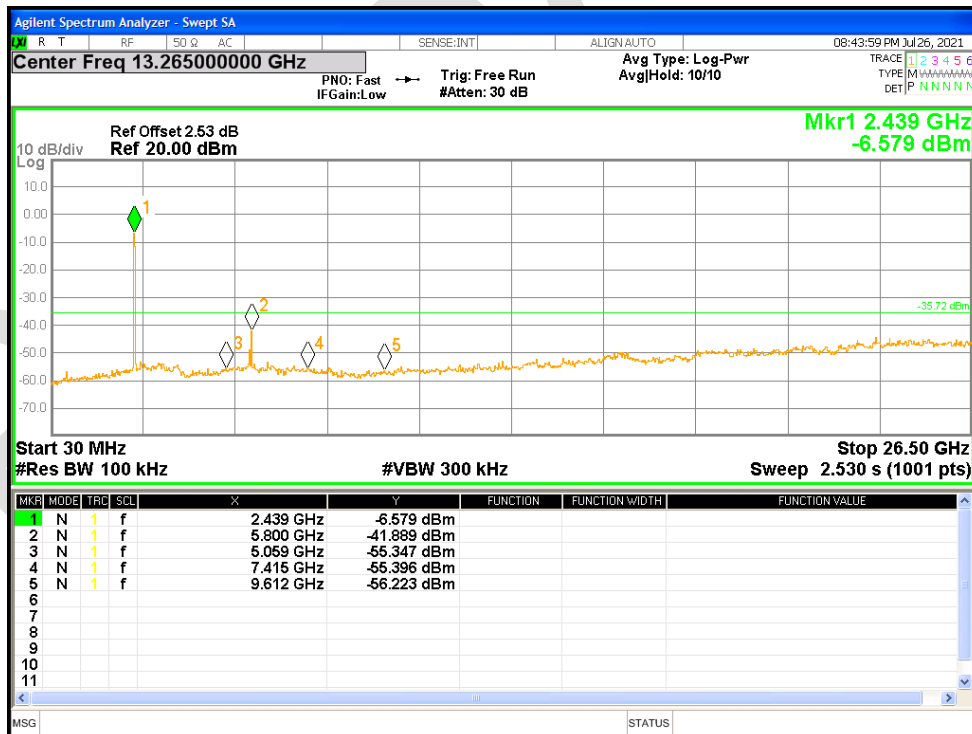
Tx. Spurious NVNT n40 2437MHz Ant1 Emission

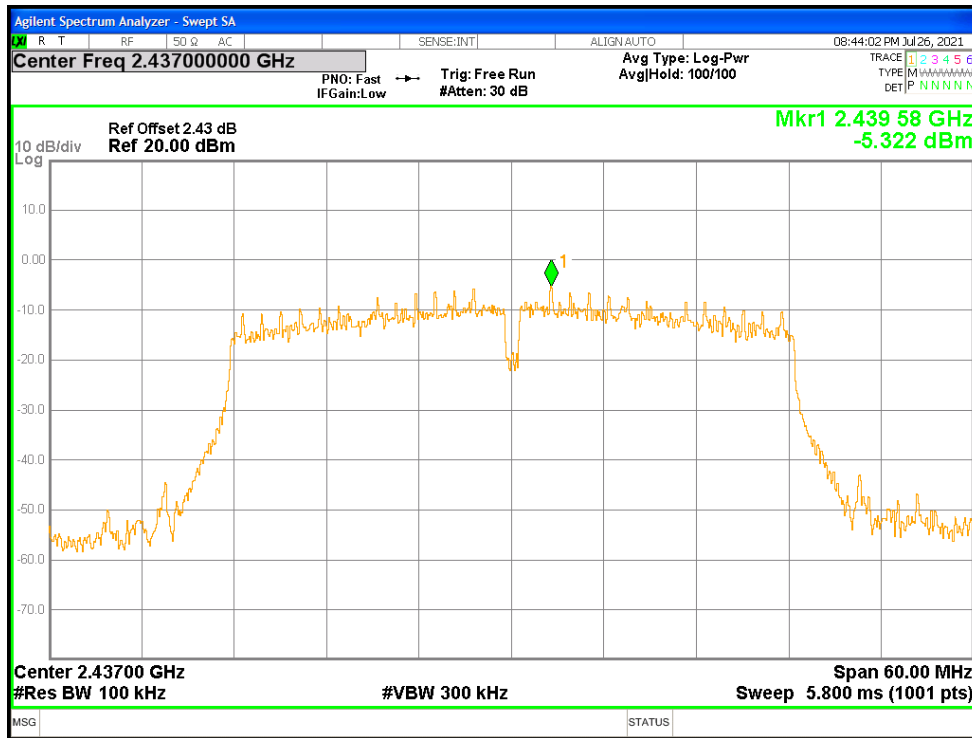
Tx. Spurious NVNT n40 2437MHz Ant2 Ref

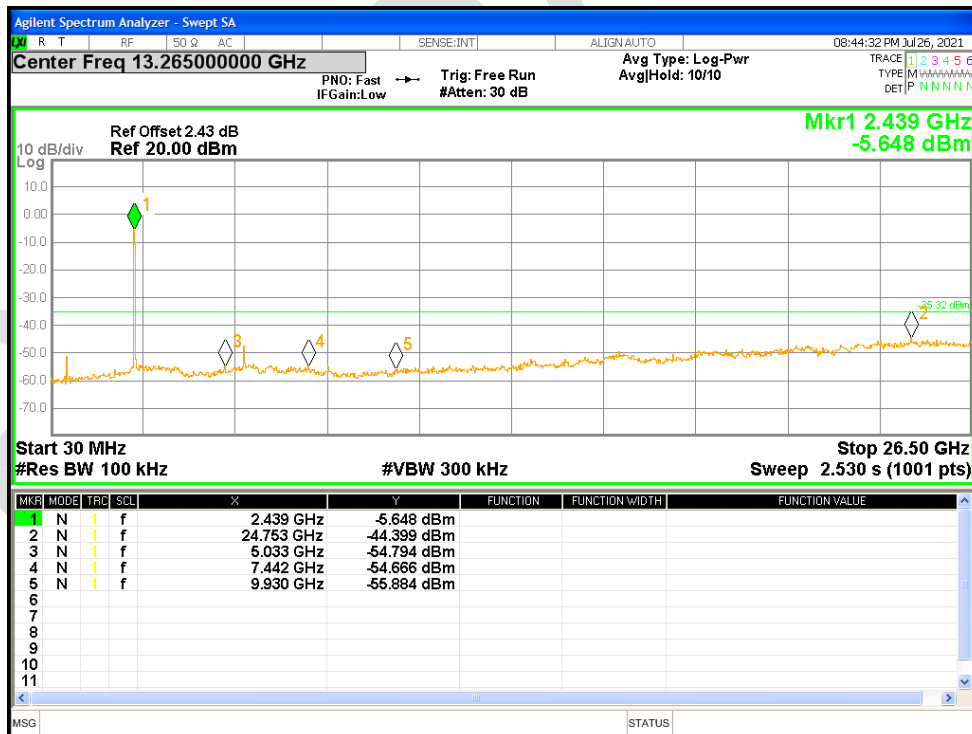
Tx. Spurious NVNT n40 2437MHz Ant2 Emission

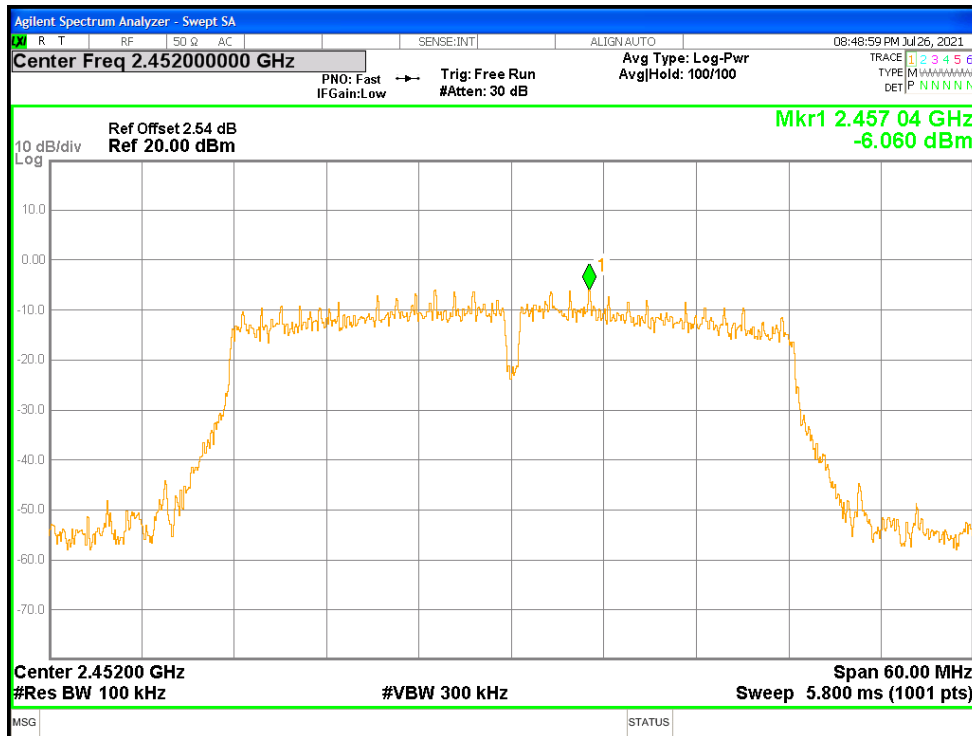
Tx. Spurious NVNT n40 2452MHz Ant1 Ref

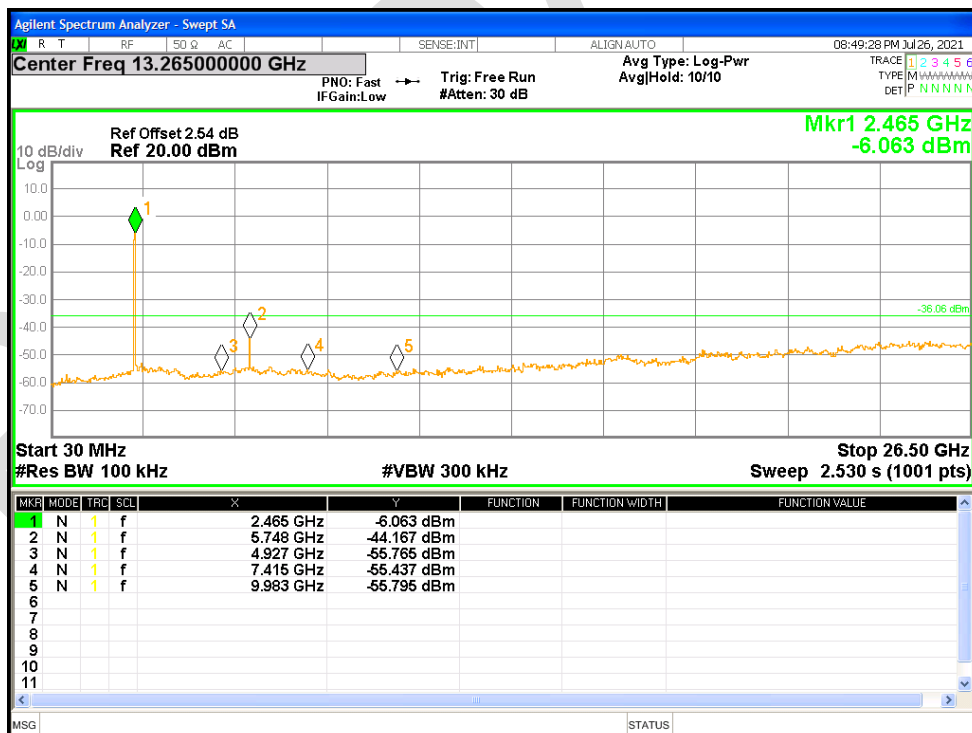
Tx. Spurious NVNT n40 2452MHz Ant1 Emission

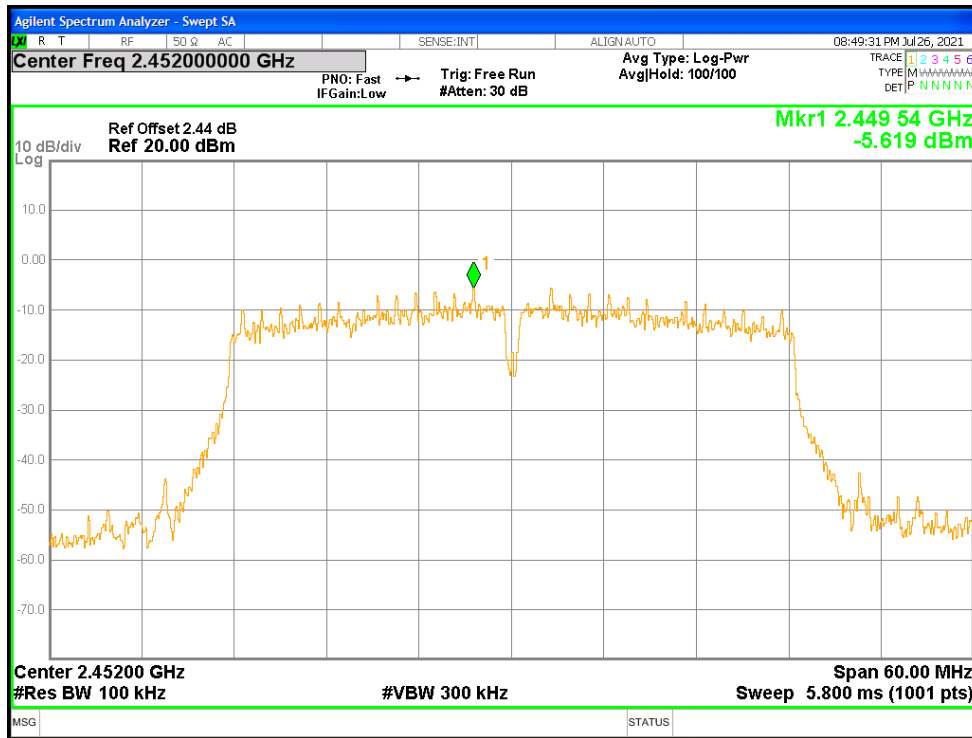
Tx. Spurious NVNT n40 2452MHz Ant2 Ref

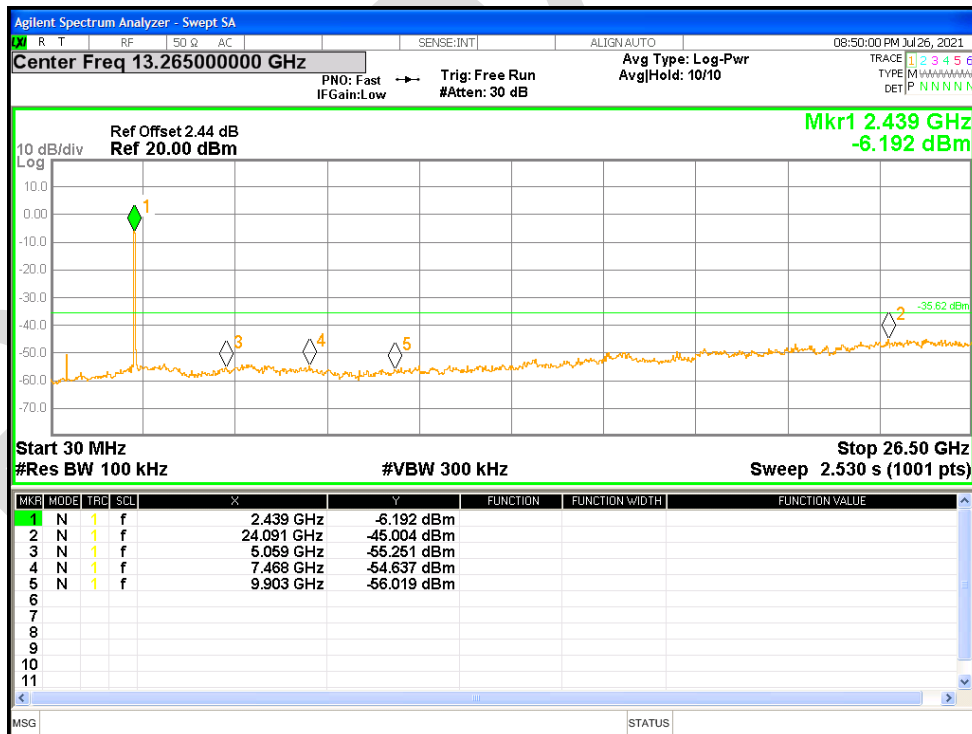
Tx. Spurious NVNT n40 2452MHz Ant2 Emission

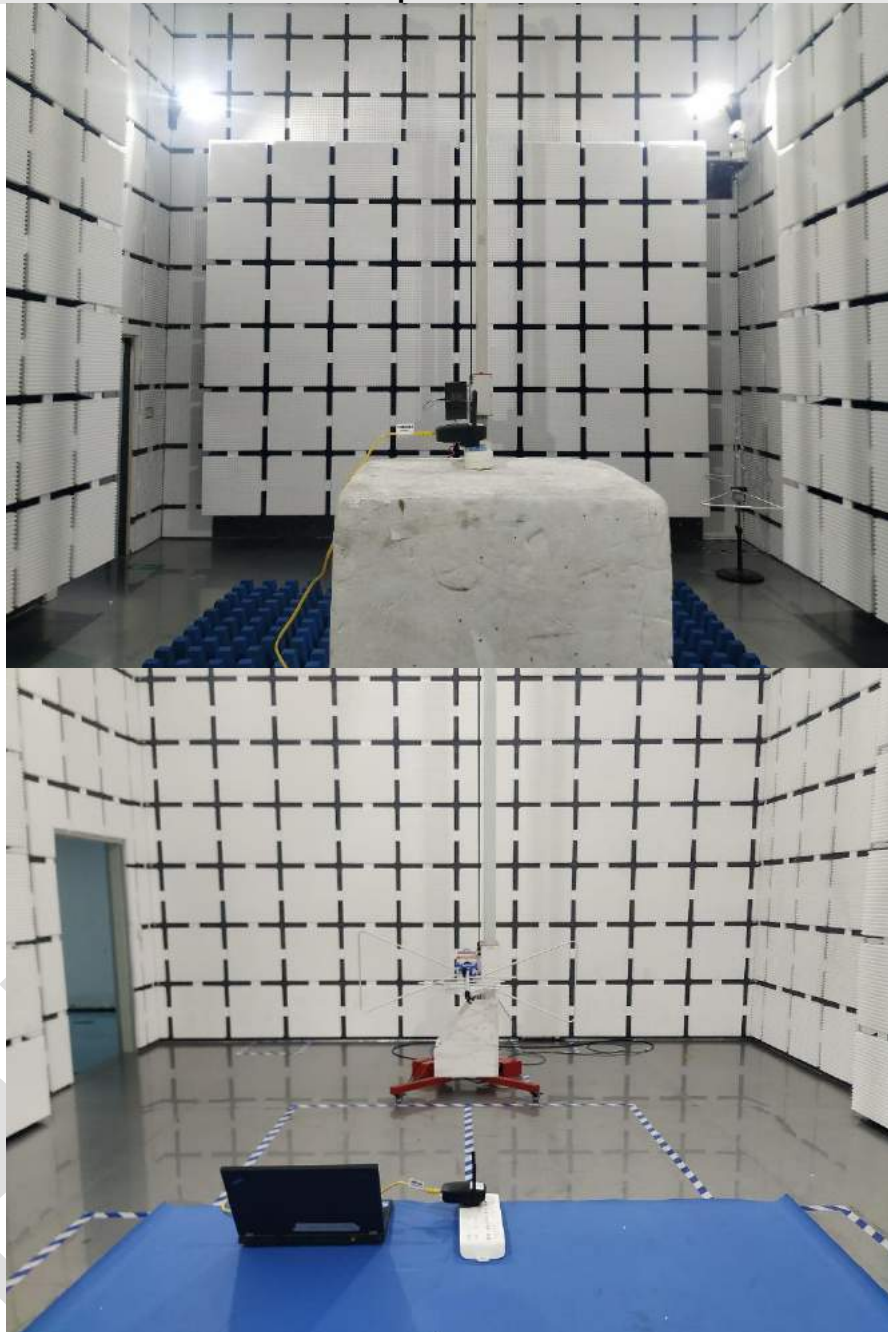
Radiated Spurious Emissions

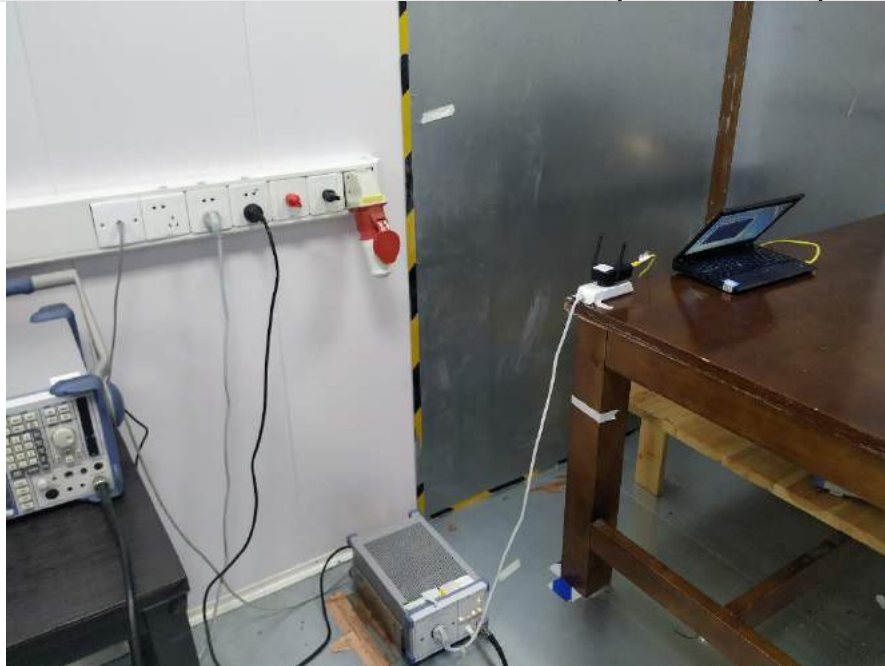
Conducted Emissions at AC Power Line (150kHz-30MHz)
