Appendix B: photographs of test setup

Reference to the test report no. BLA-EMC-202404-A6801

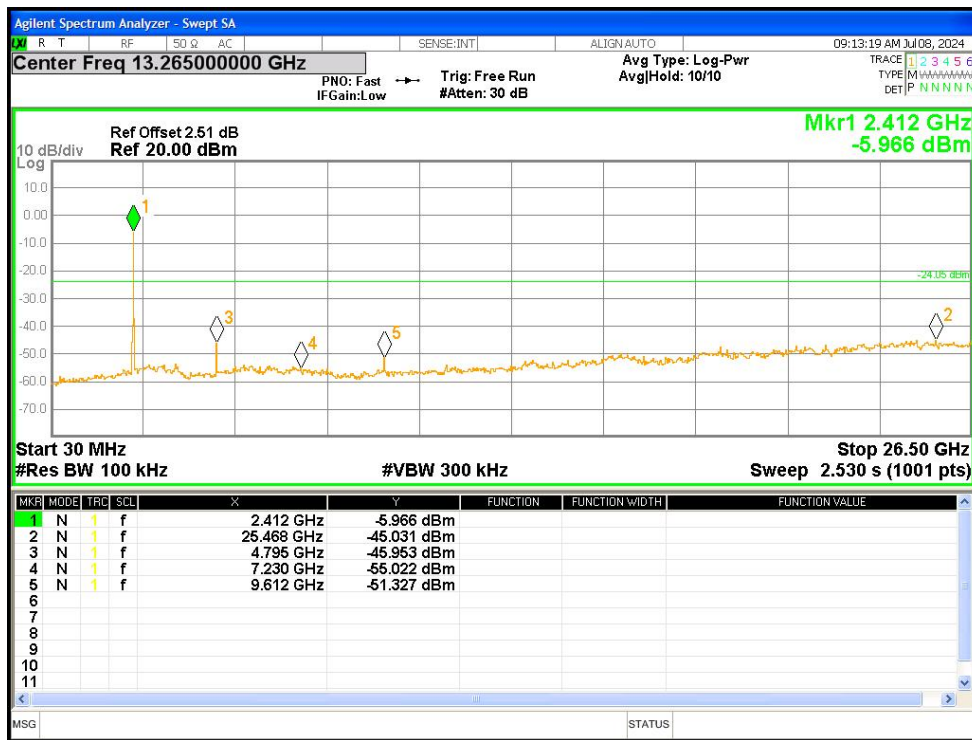
Tx. Spurious NVNT BLE 1M 2442MHz Ant1 Ref

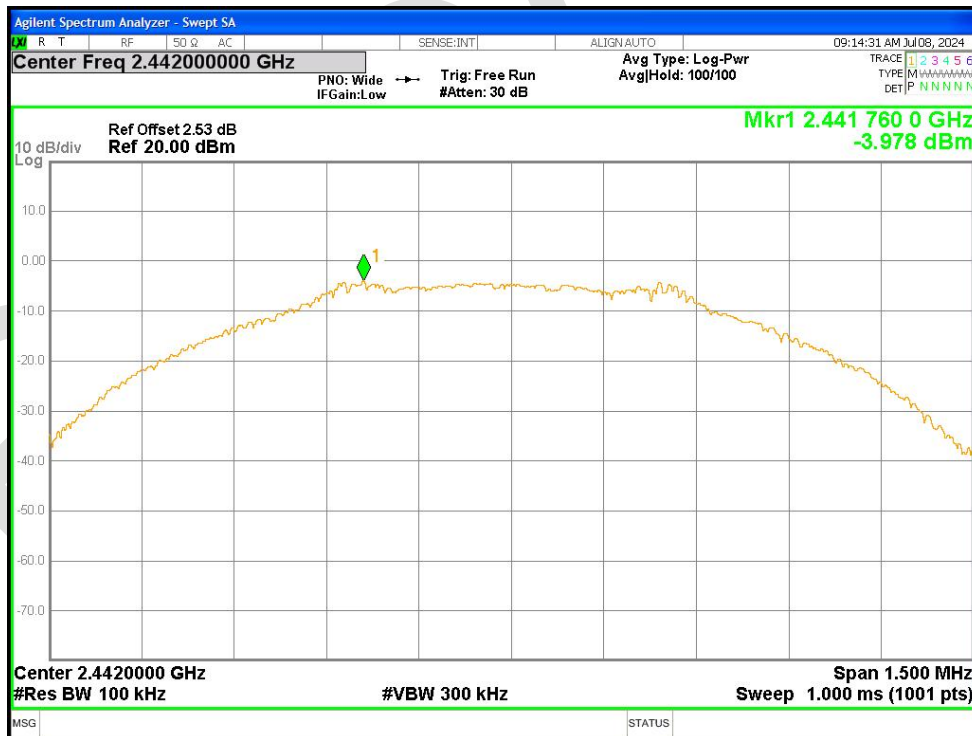
Tx. Spurious NVNT BLE 1M 2442MHz Ant1 Emission

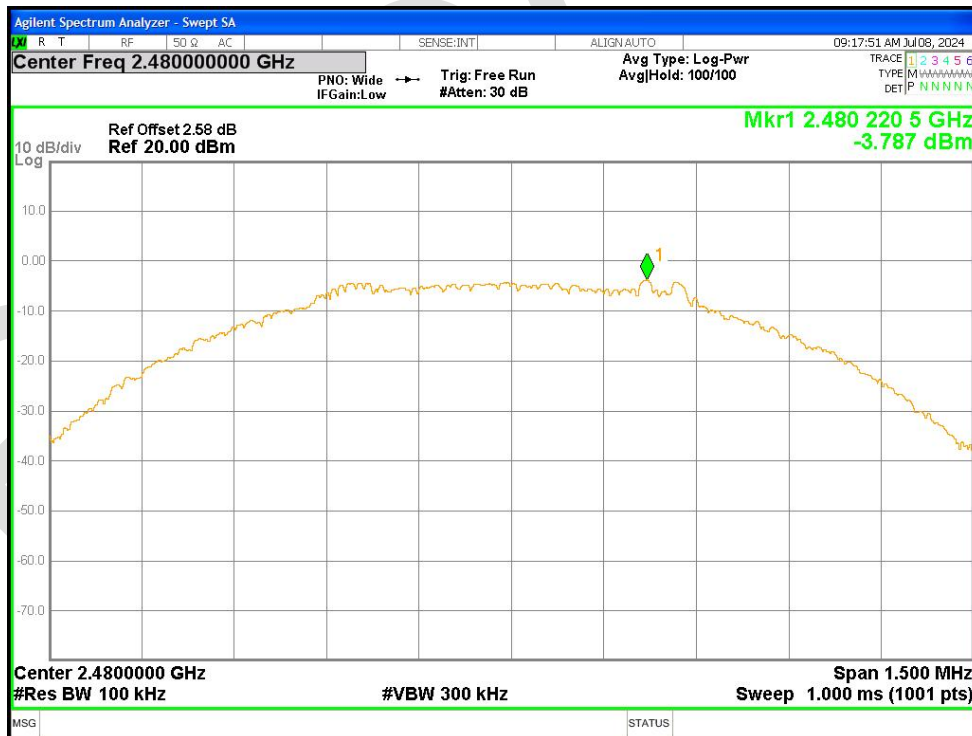
Tx. Spurious NVNT BLE 1M 2480MHz Ant1 Emission

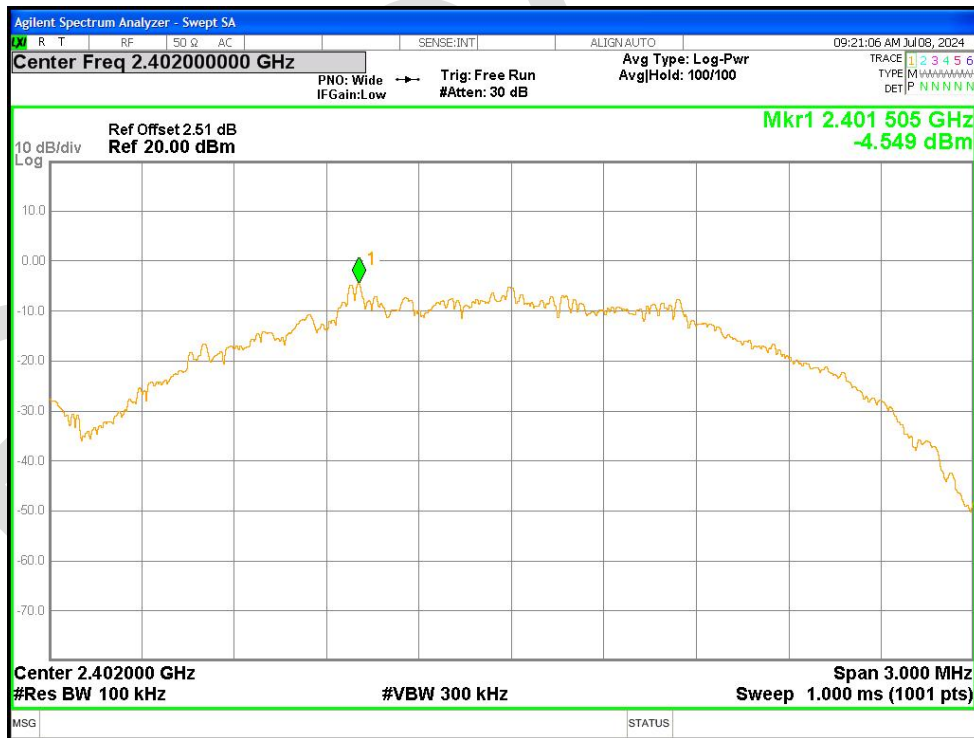
Tx. Spurious NVNT BLE 2M 2402MHz Ant1 Emission

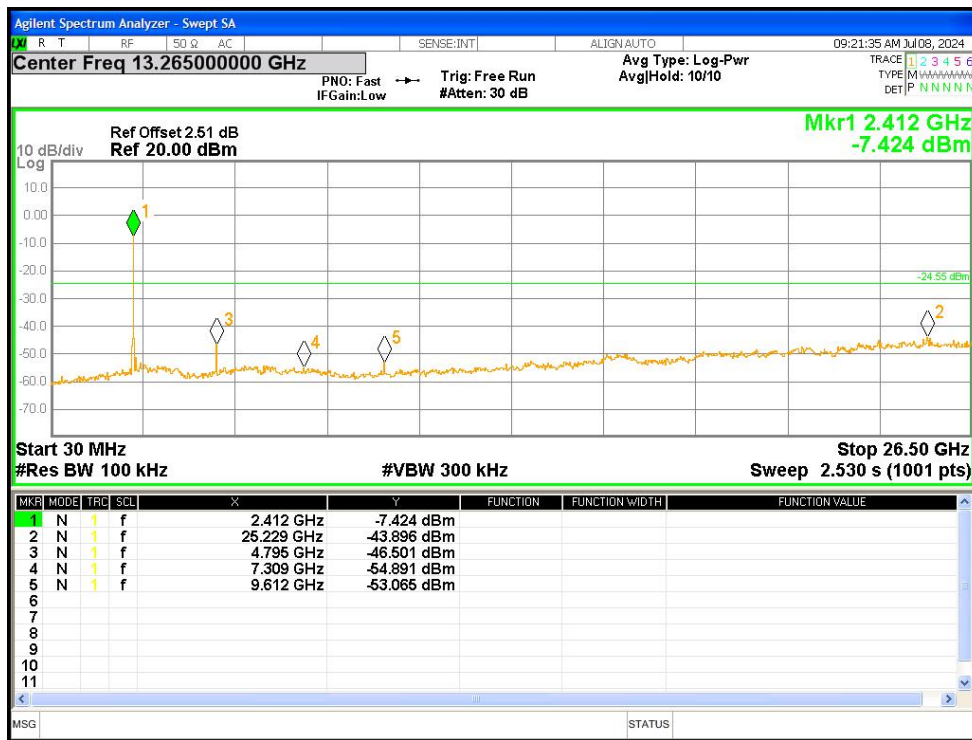
Tx. Spurious NVNT BLE 2M 2442MHz Ant1 Ref

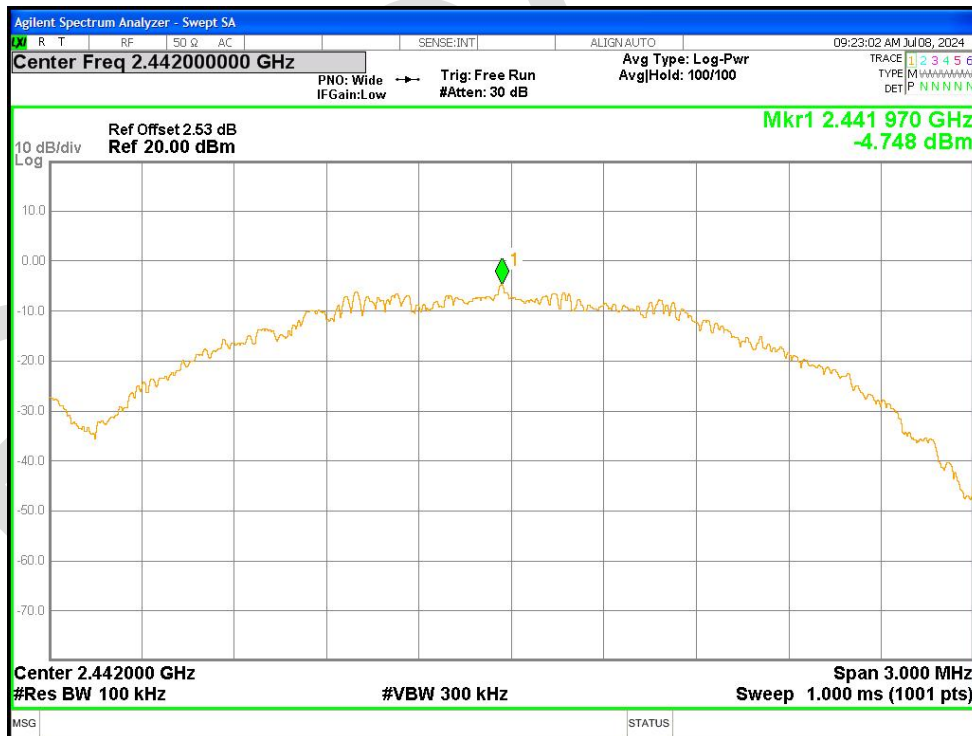
Tx. Spurious NVNT BLE 2M 2442MHz Ant1 Emission

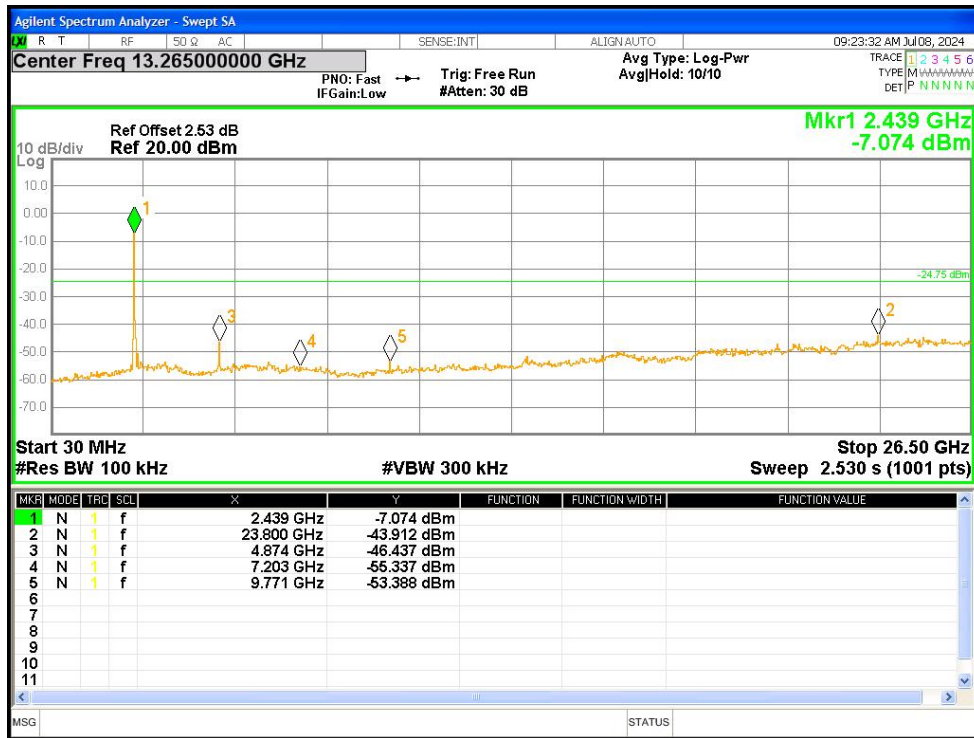
Tx. Spurious NVNT BLE 2M 2480MHz Ant1 Ref

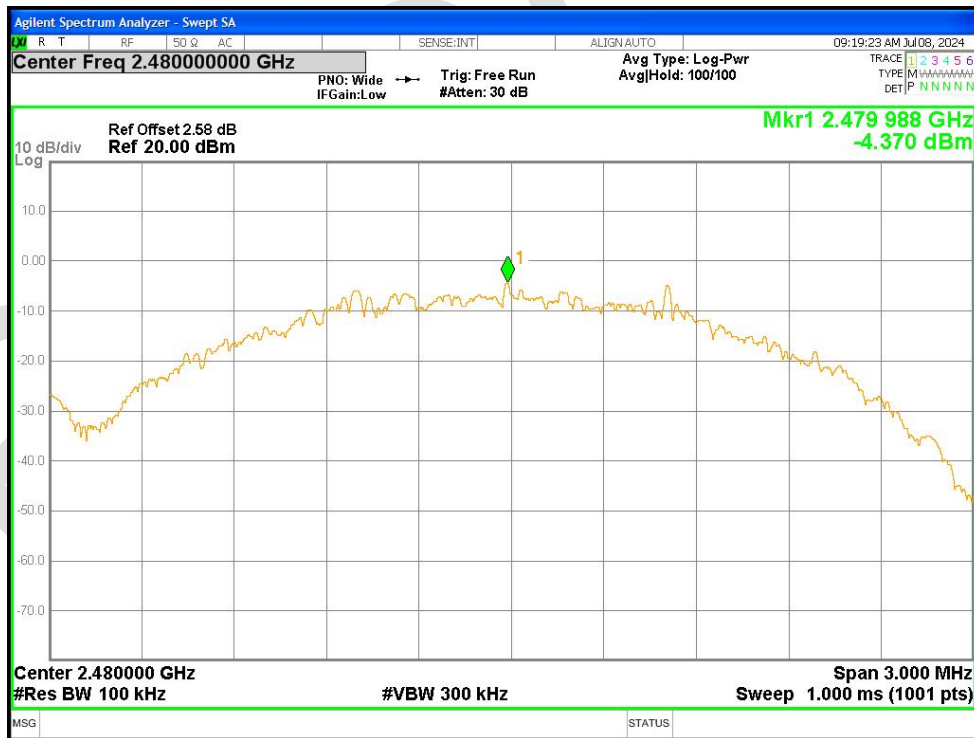
Tx. Spurious NVNT BLE 2M 2480MHz Ant1 Emission

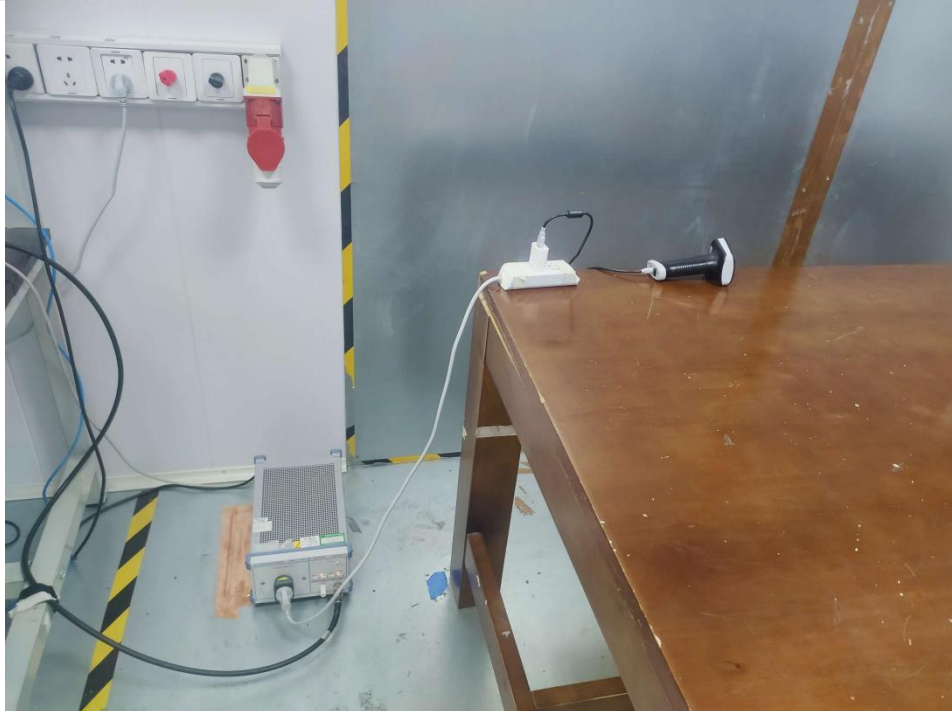
Conducted emissions at AC power line (150kHz-30MHz)

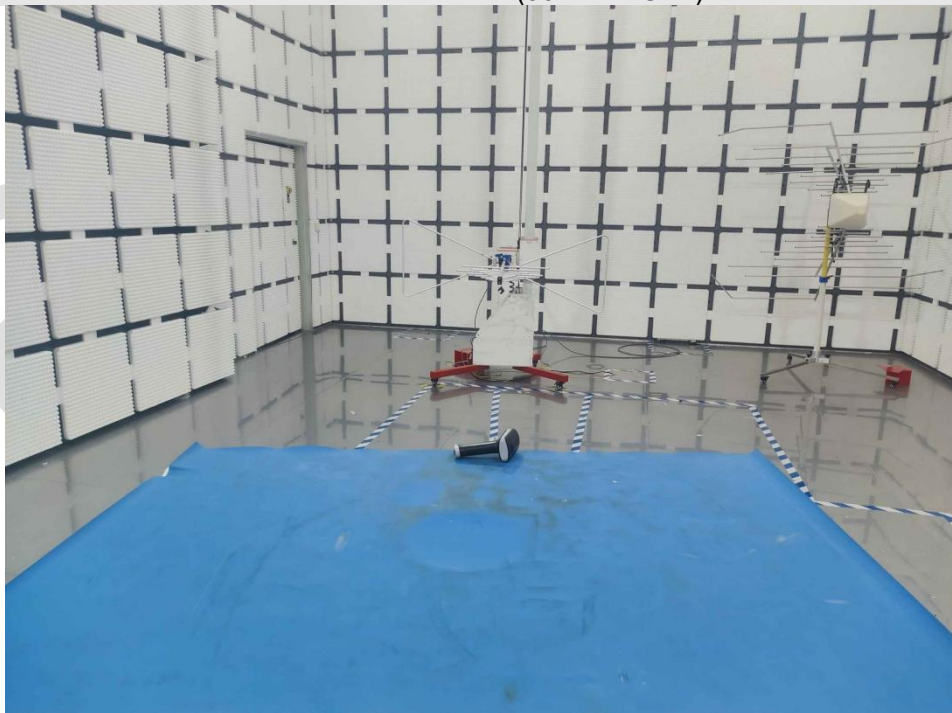
Radiated Emissions (30MHz-1GHz)

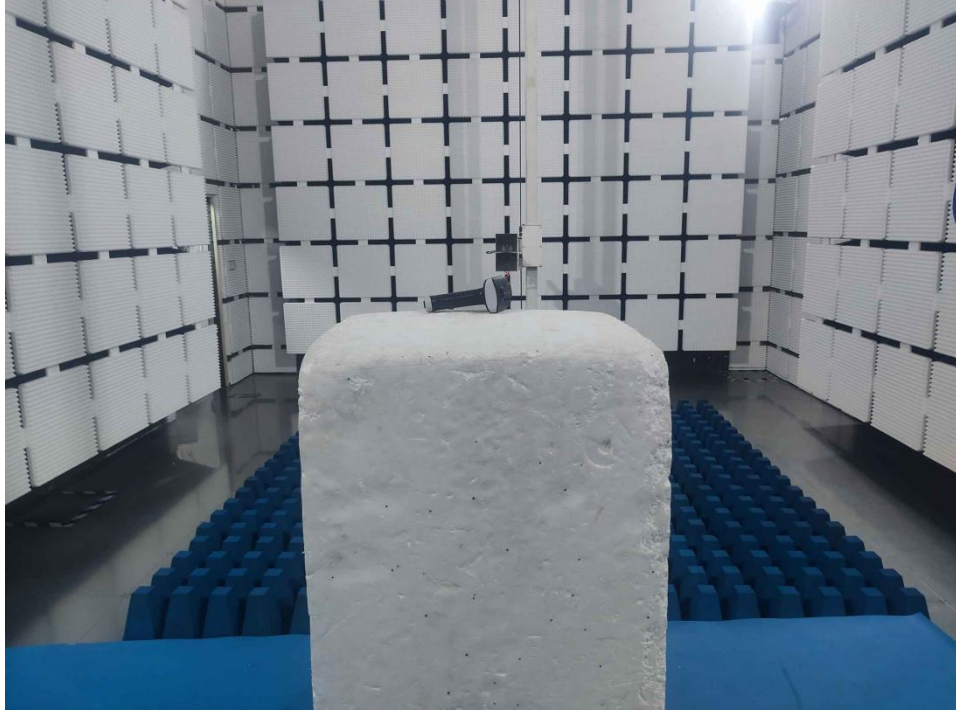
Radiated Emissions (above 1GHz)
