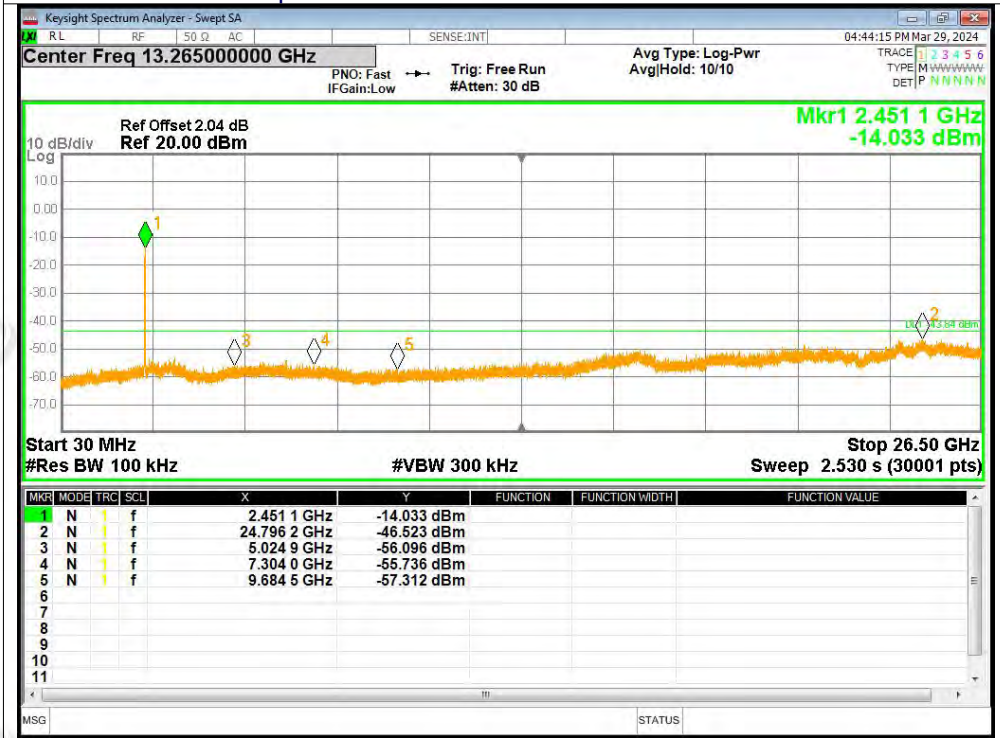
Tx. Spurious NVNT n40 2452MHz Ant1 Ref

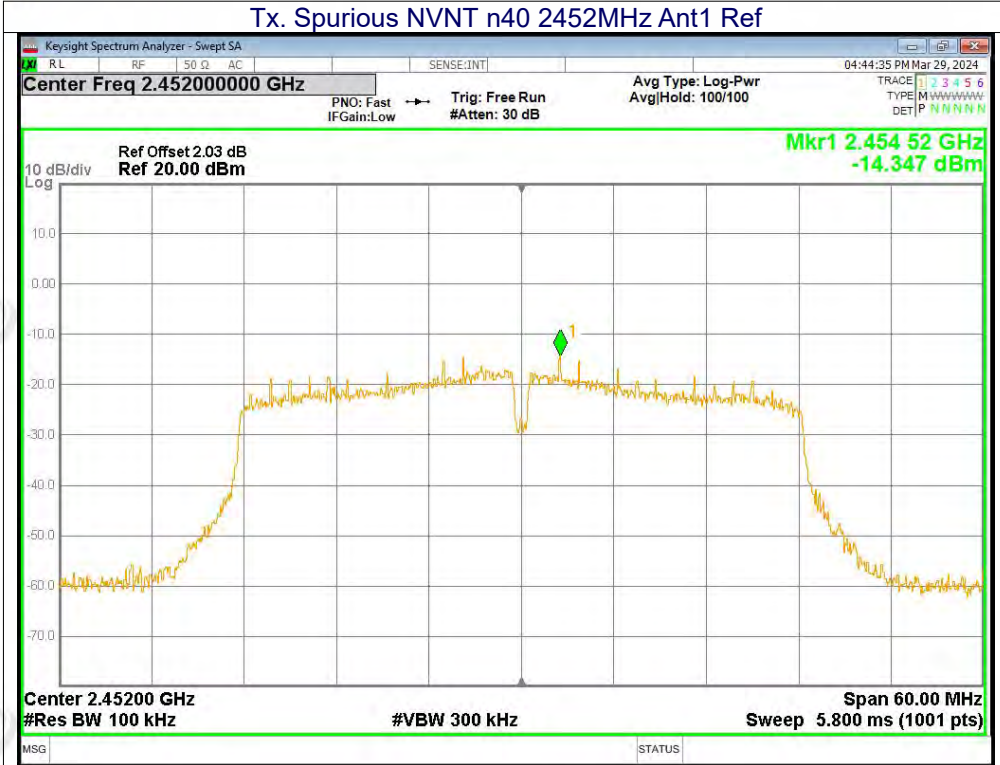
Tx. Spurious NVNT n40 2452MHz Ant1 Emission
