## Appendix B: photographs of test setup

Reference to the test report no. BLA-EMC-202407-A3801

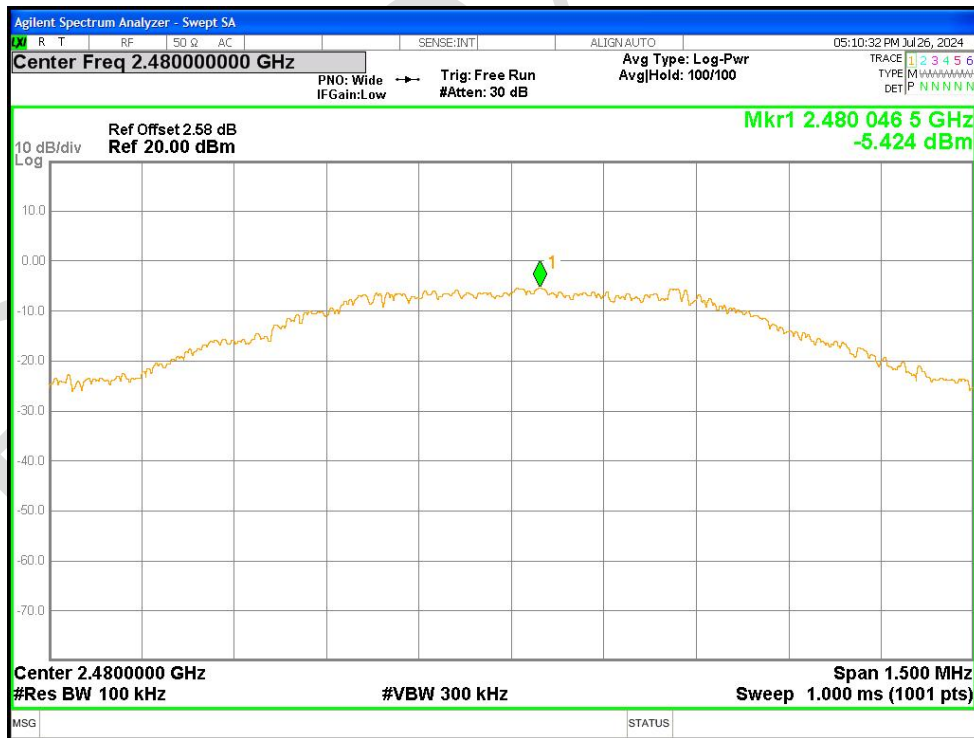
Tx. Spurious NVNT BLE 1M 2480MHz Ant1 Emission

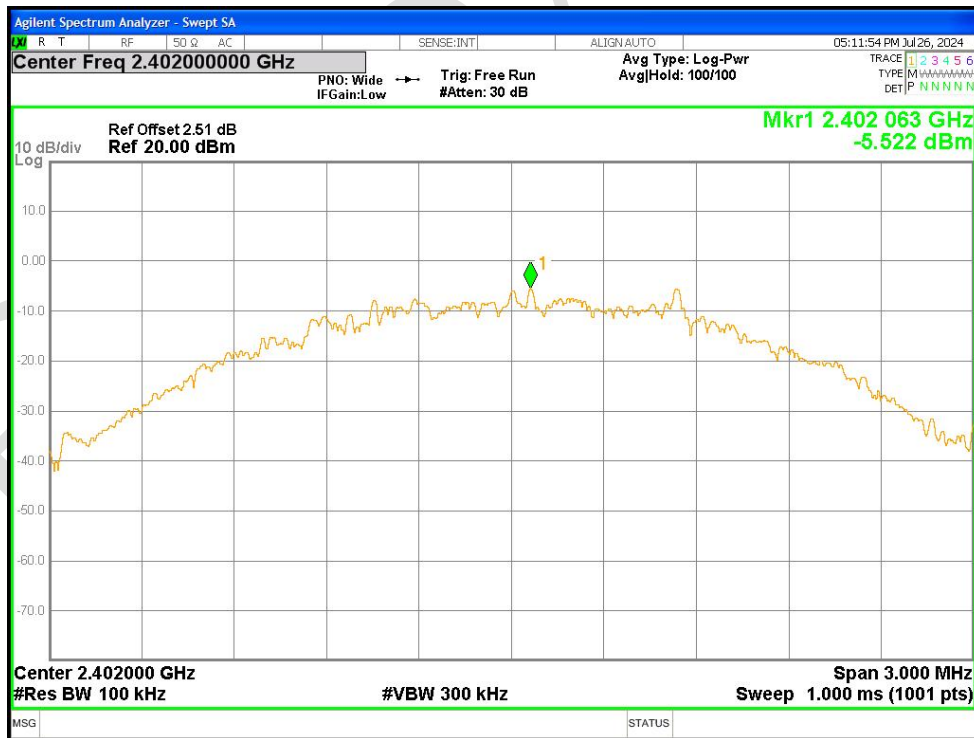
Tx. Spurious NVNT BLE 2M 2402MHz Ant1 Emission

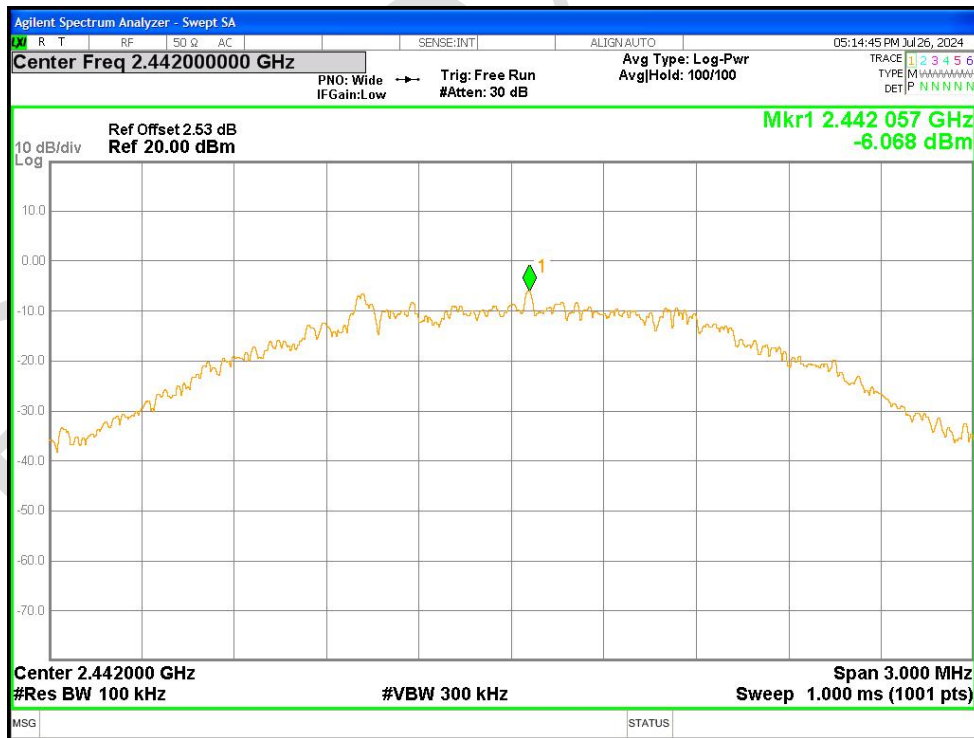
Tx. Spurious NVNT BLE 2M 2442MHz Ant1 Emission

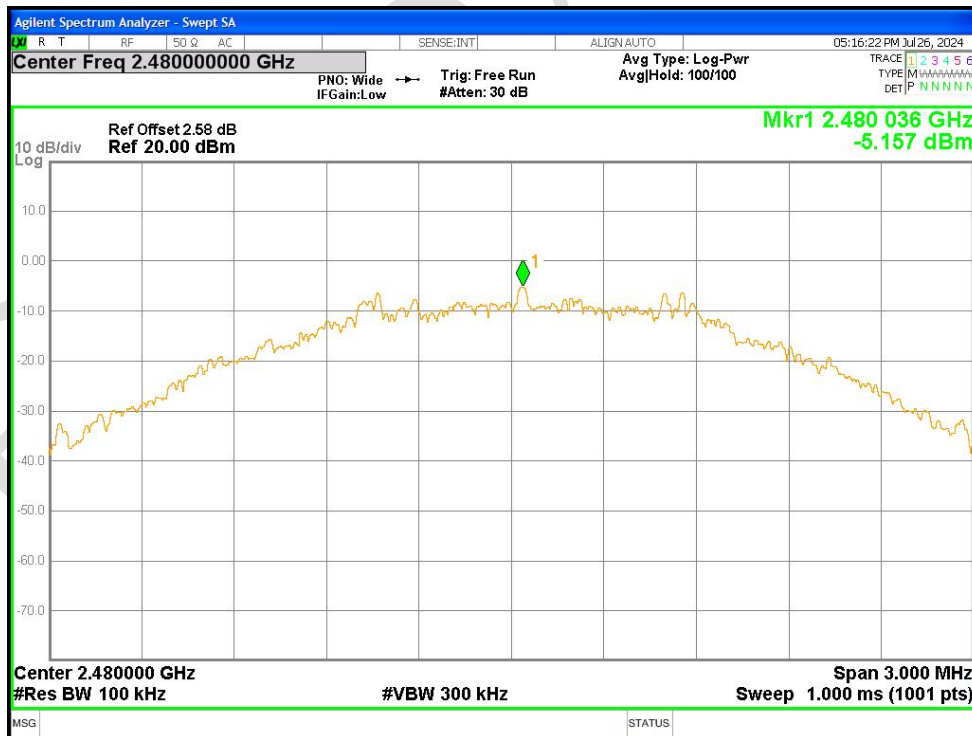
Tx. Spurious NVNT BLE 2M 2480MHz Ant1 Emission

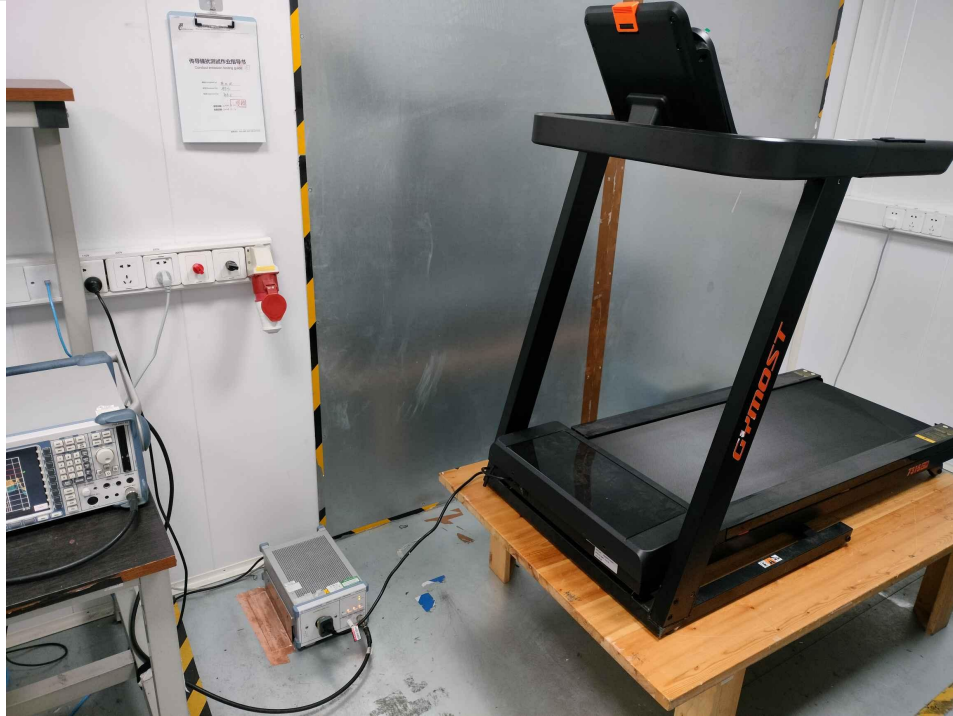
Conducted emissions at AC power line (150kHz-30MHz)

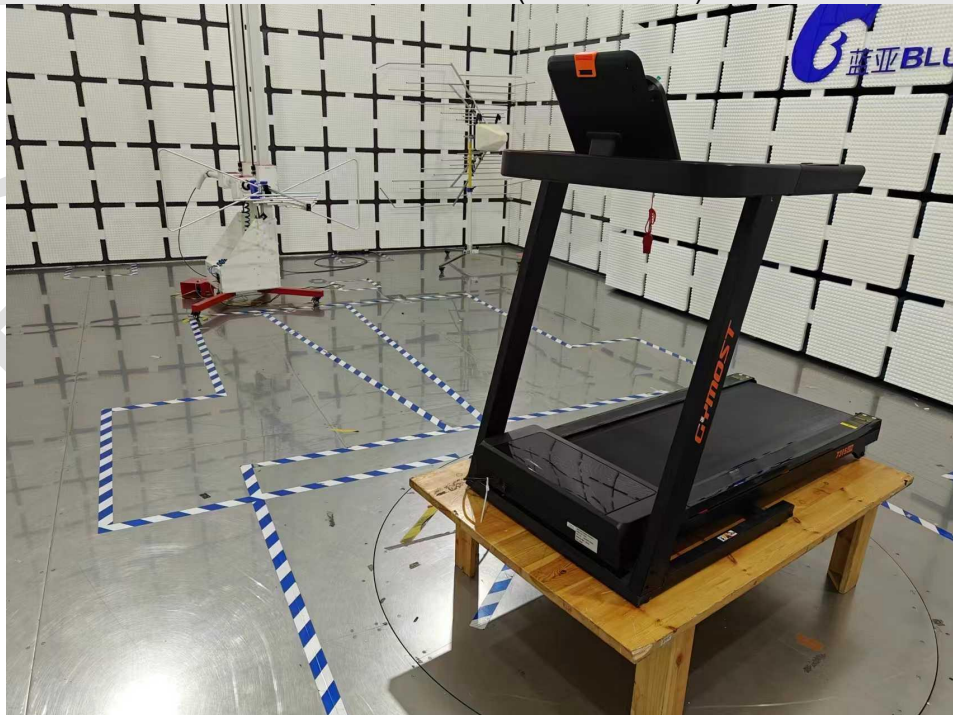
Radiated Emissions (30MHz-1GHz)

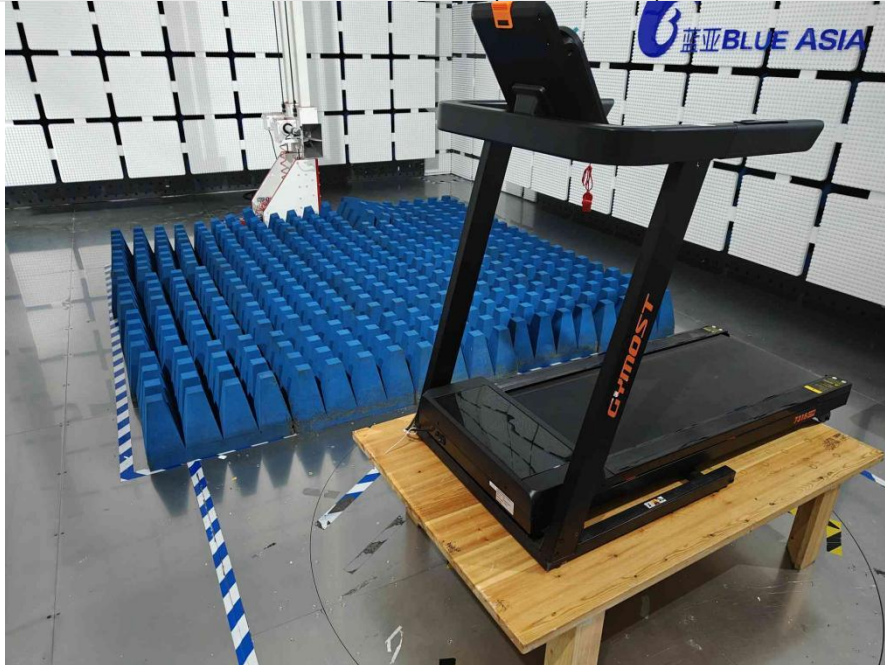
Radiated Emissions (above 1GHz)
