Report No.: SHE24080045-02CE Date: 2024-11-07 Page 59 of 81

4.2 Mains Emissions

4.2.1 Conducted Emission on AC Mains

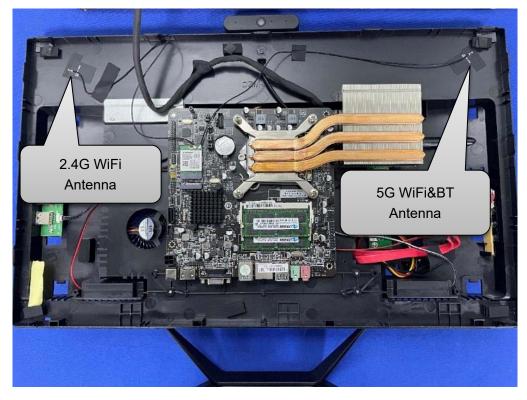
Antenna Position

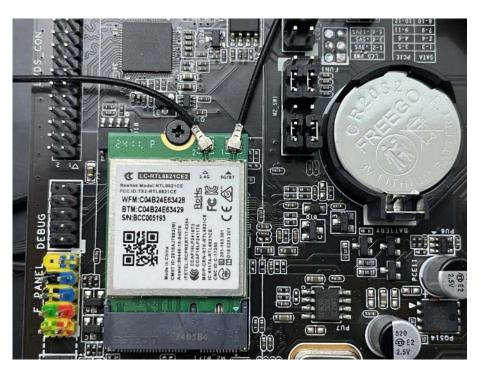
Antenna Interface

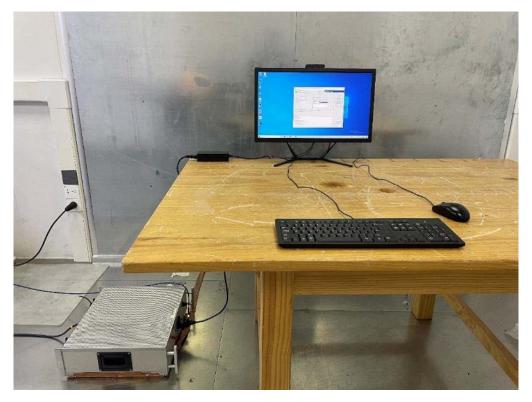
5.2 Set-up for Conducted Emission on AC Mains

Test setup

Input Voltage : which received AC 120V, 60Hz Power

Operation Mode : A.1.a

Earthing : Connected to GND

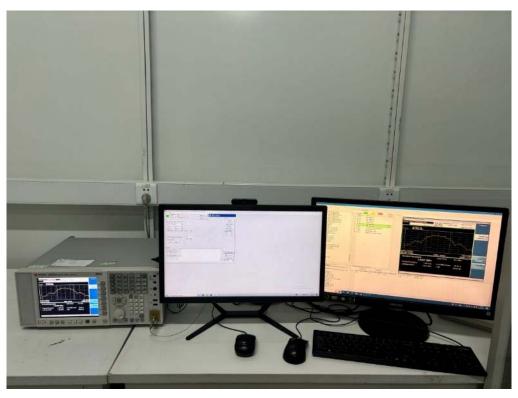
5.3 Set-up for Conducted RF test at Antenna Port

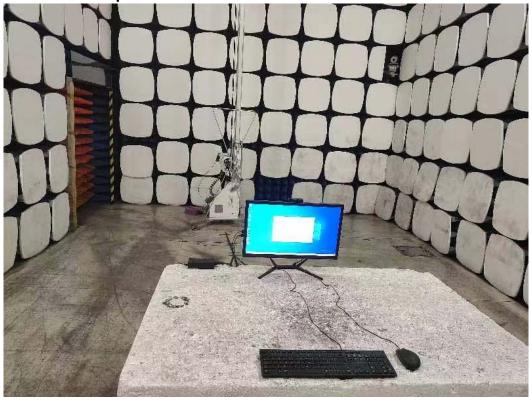
5.4 Set-up for Radiated Spurious Emissions below 1GHz
