## 6 Photographs of the Test Setup

## 7 Photographs of the EUT

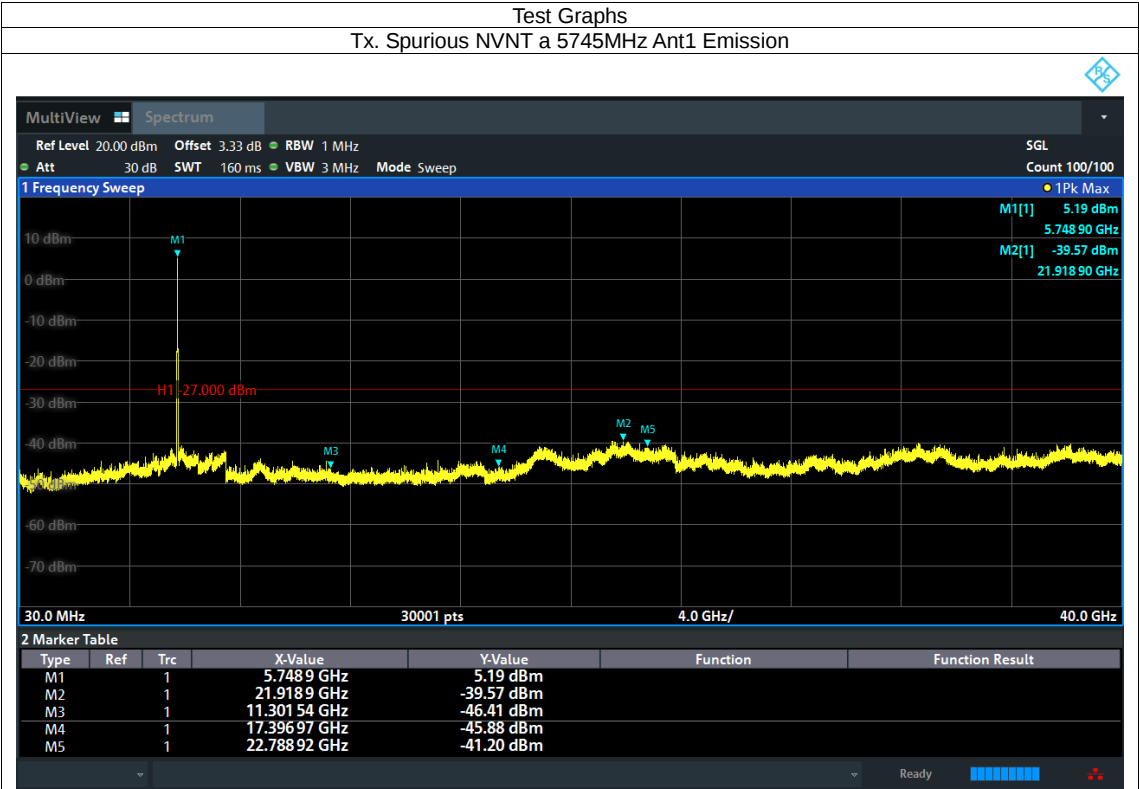
Tx. Spurious NVNT a 5785MHz Ant1 Emission

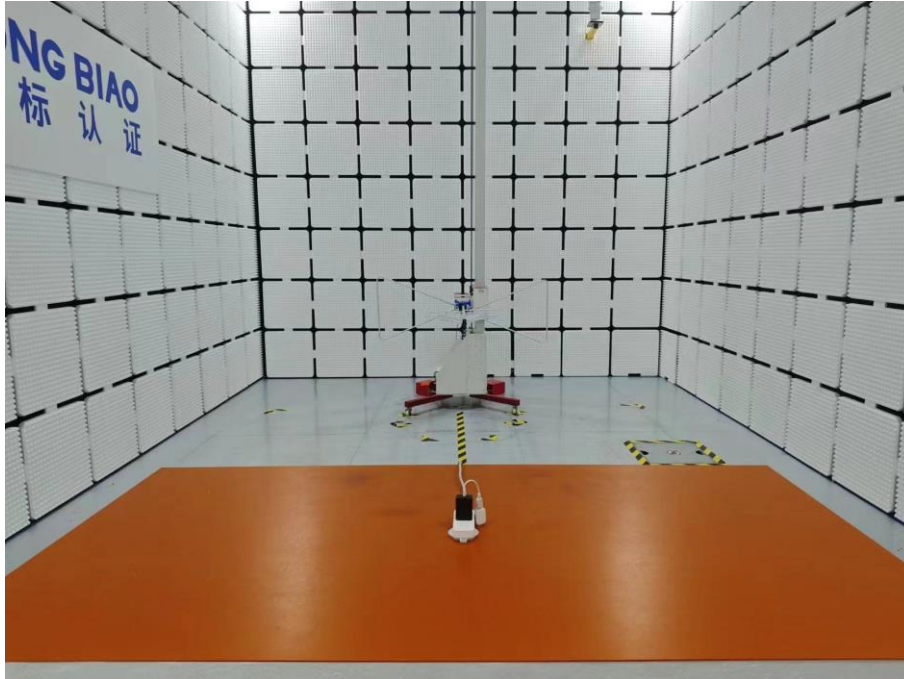
Radiated Emission Below 1GHz

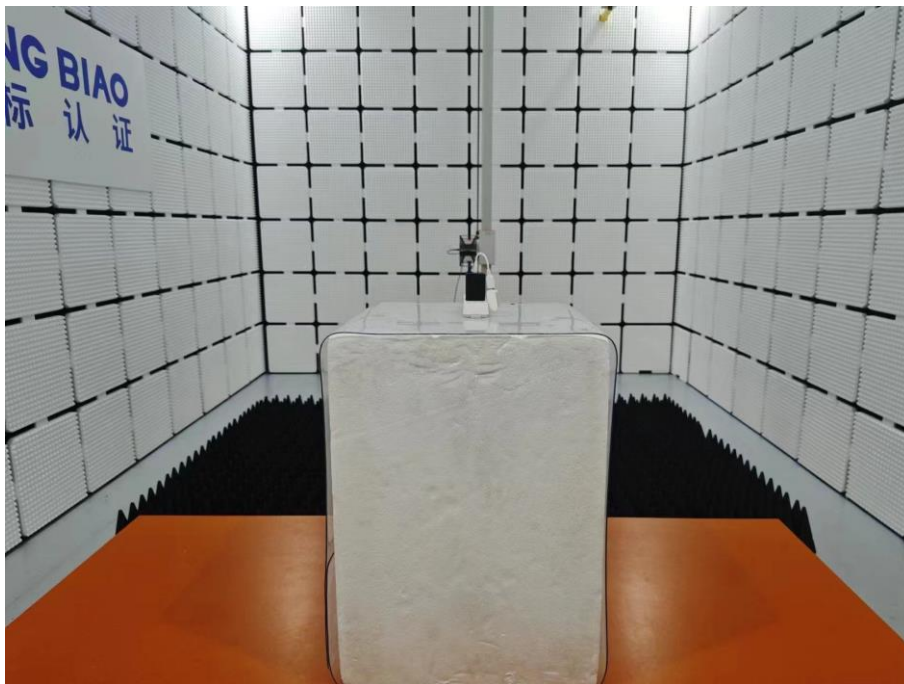
Radiated Emission Above 1GHz

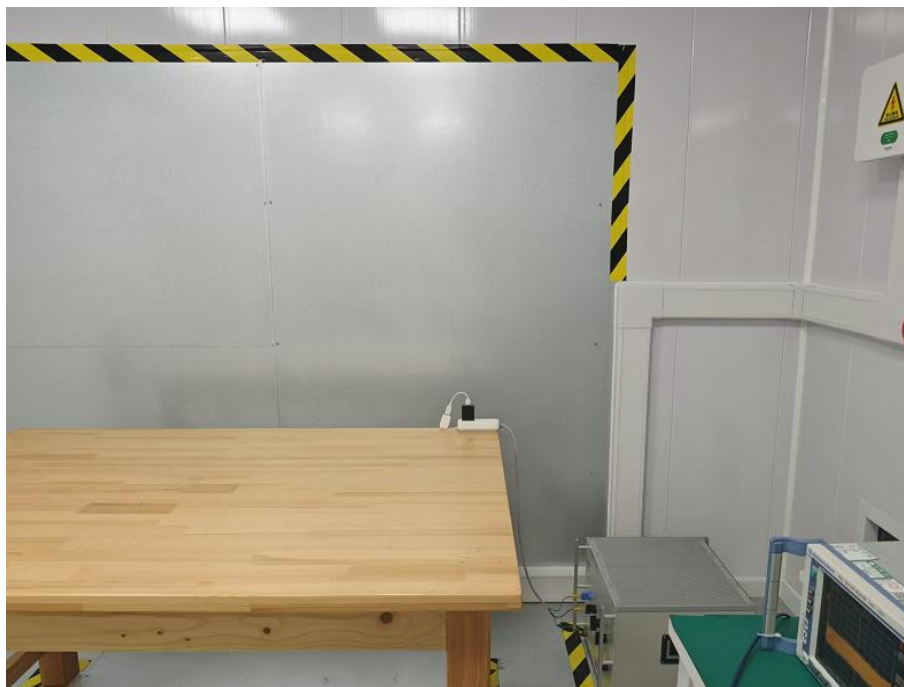
Conducted Emission
