APPENDIX B – PHOTOGRAPHS OF TEST SET-UP

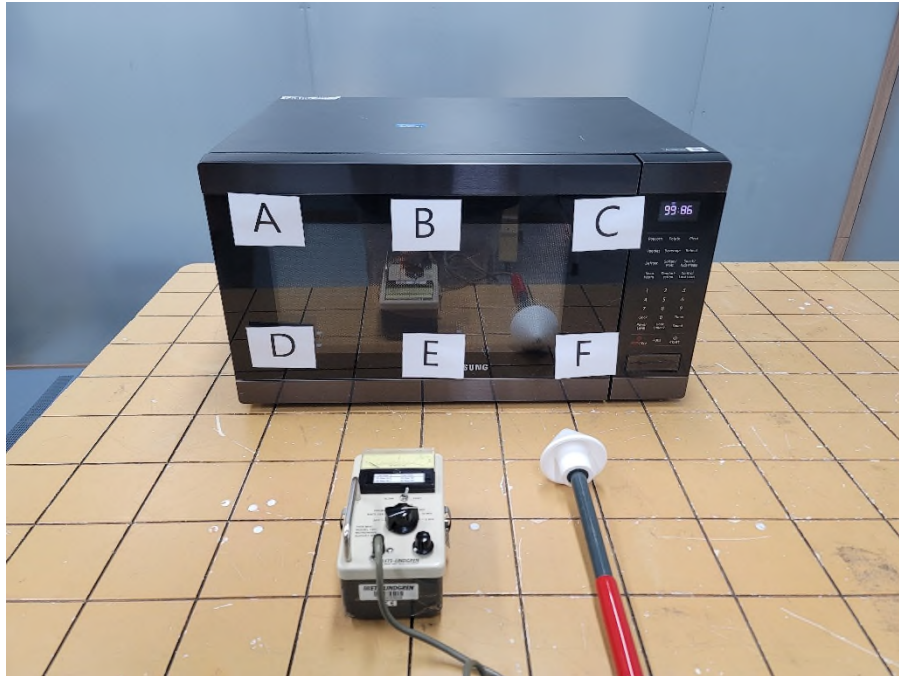
- **Radiation hazard Test Picture**

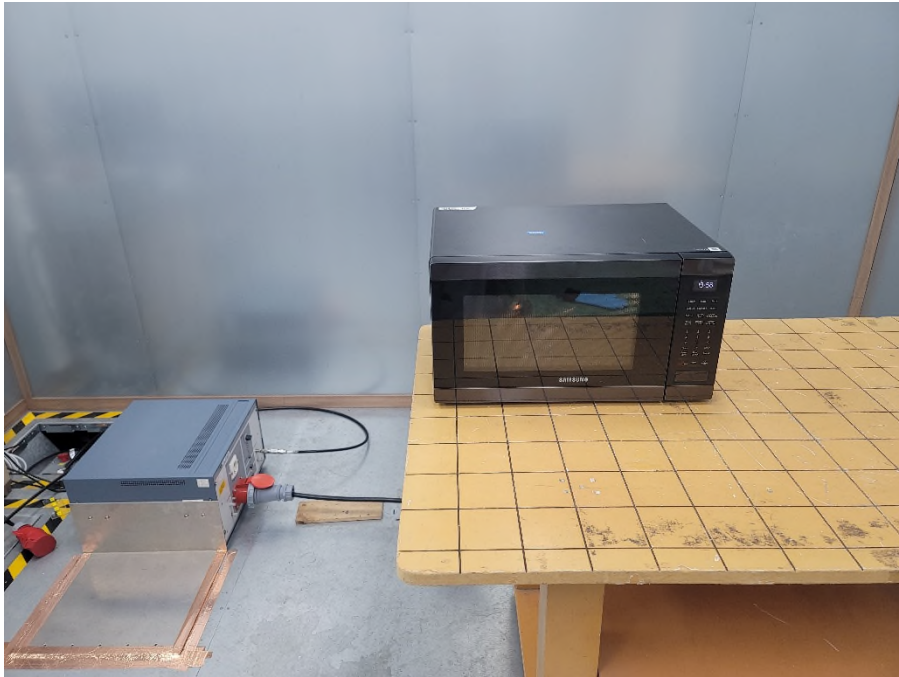
- **Conducted Test Picture (Front)**

The **Conducted Test Picture** and **Radiated Test Picture** and show the worst-case configuration and cable placement.

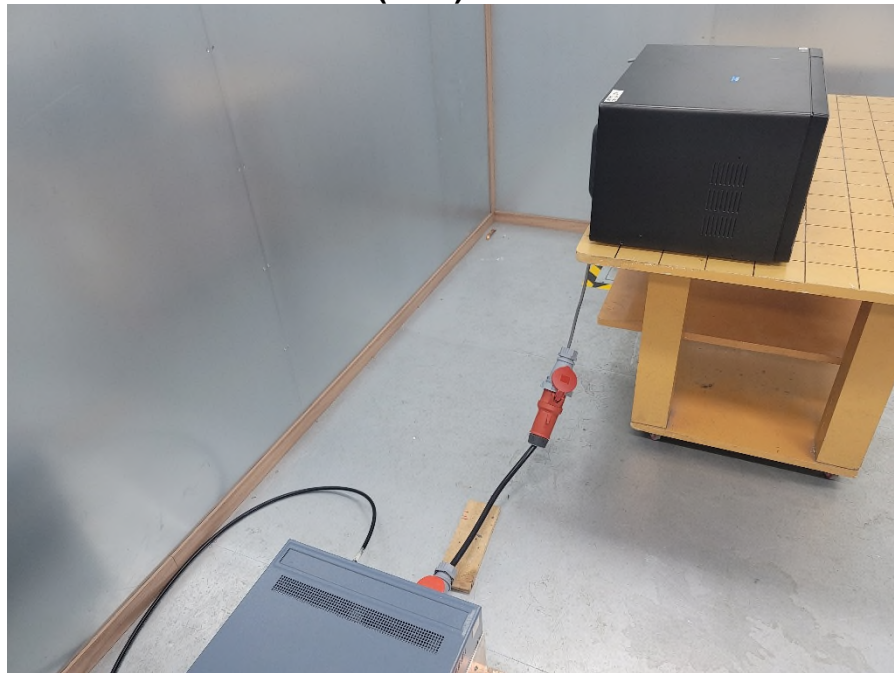
- **Conducted Test Picture (Side)**

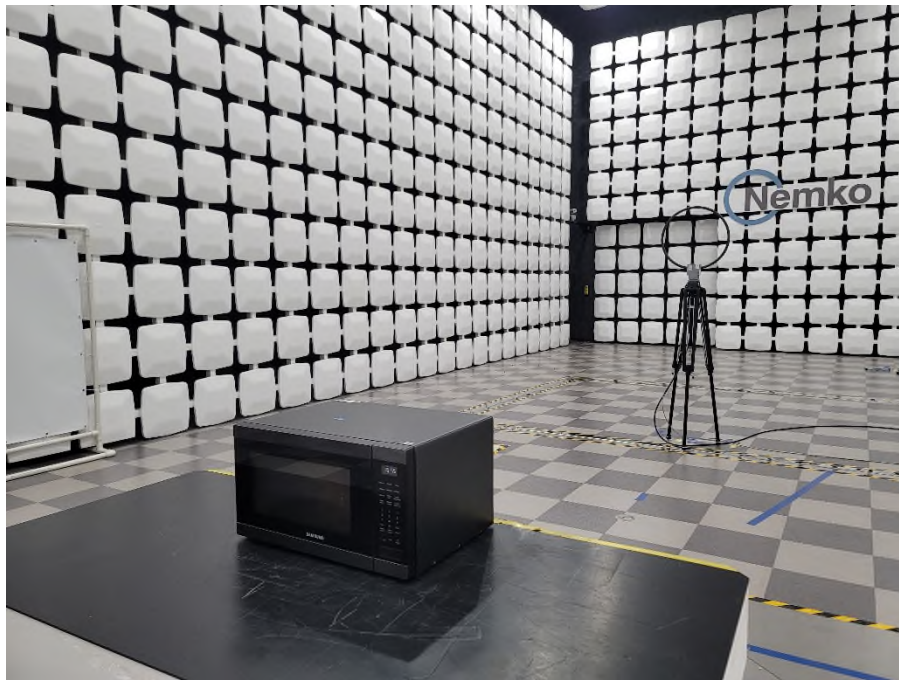
- Radiated Test Picture : 0.15 MHz ~ 30 MHz (Front)

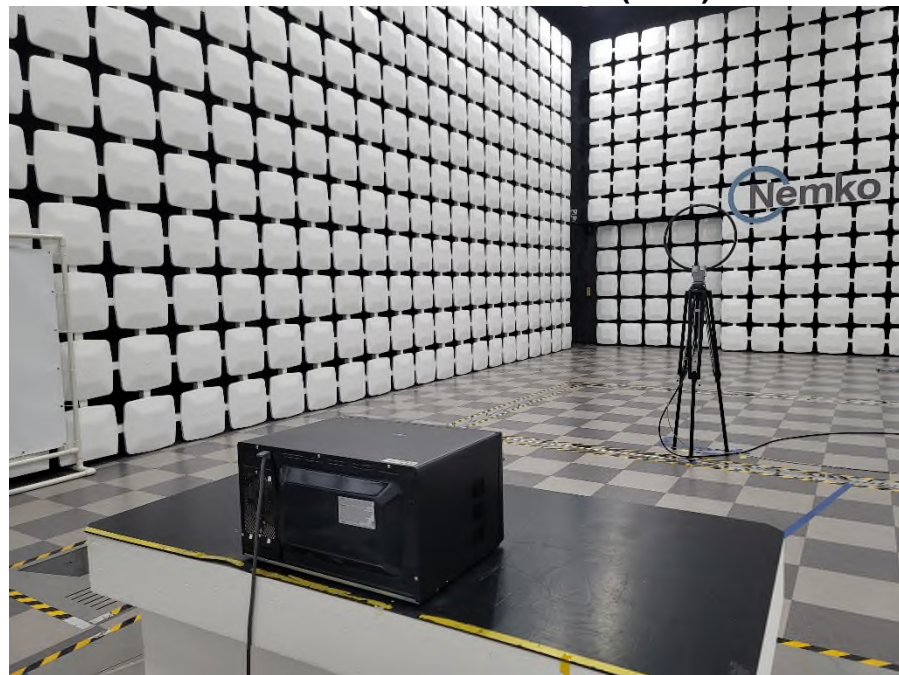
- Radiated Test Picture : 0.15 MHz ~ 30 MHz (Rear)

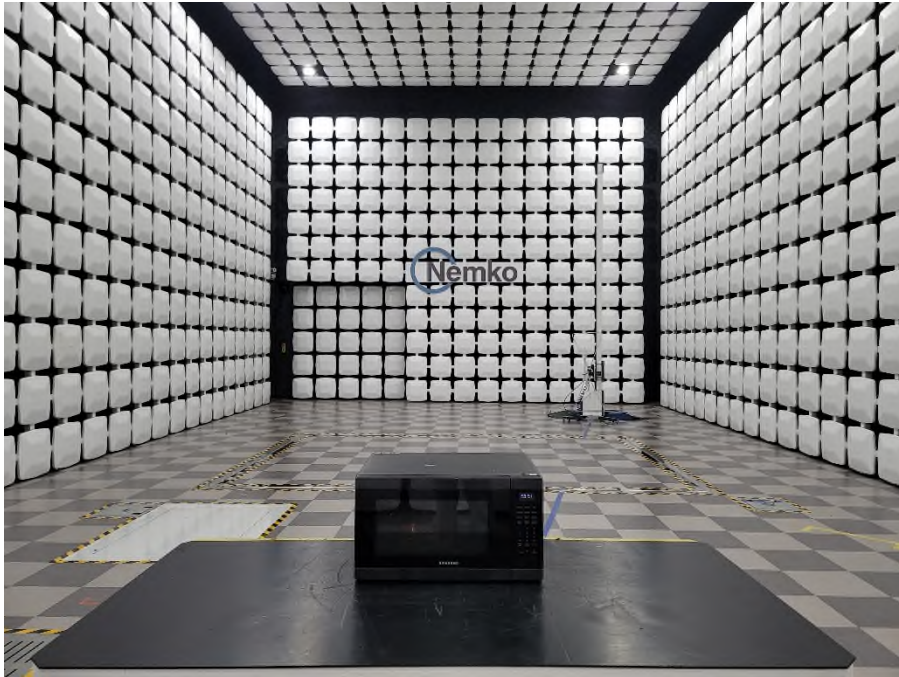
- Radiated Test Picture : 30 MHz ~ 1 GHz (Front)

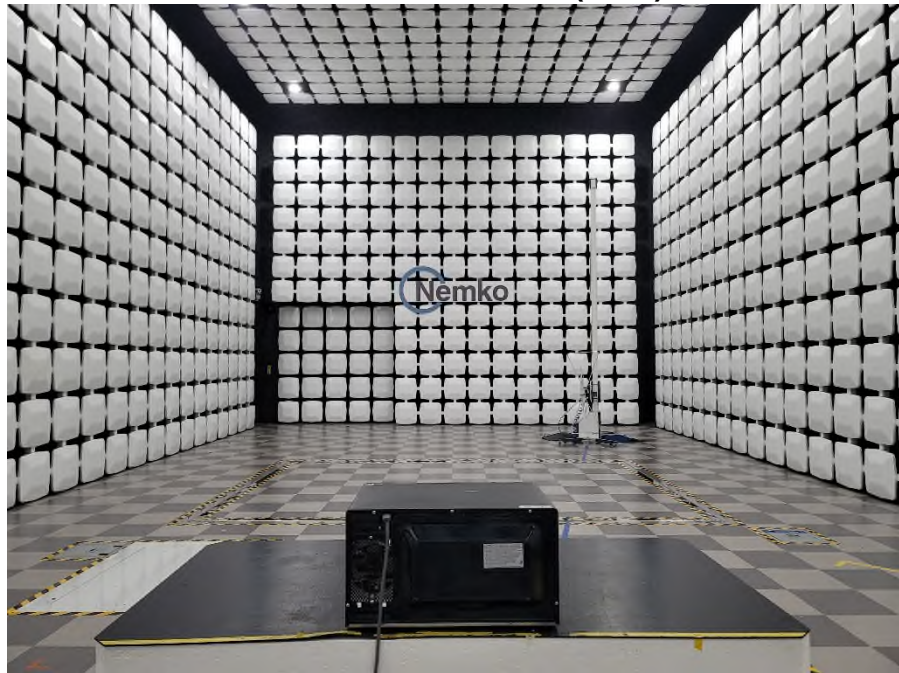
- Radiated Test Picture : 30 MHz ~ 1 GHz (Rear)

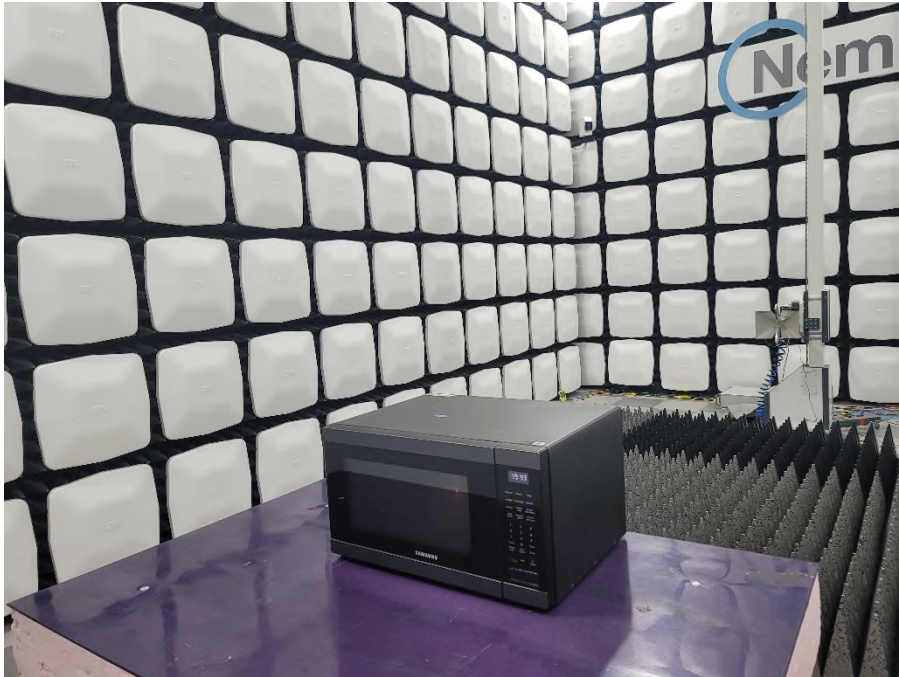
- Radiated Test Picture : 1 GHz ~ 18 GHz (Front)

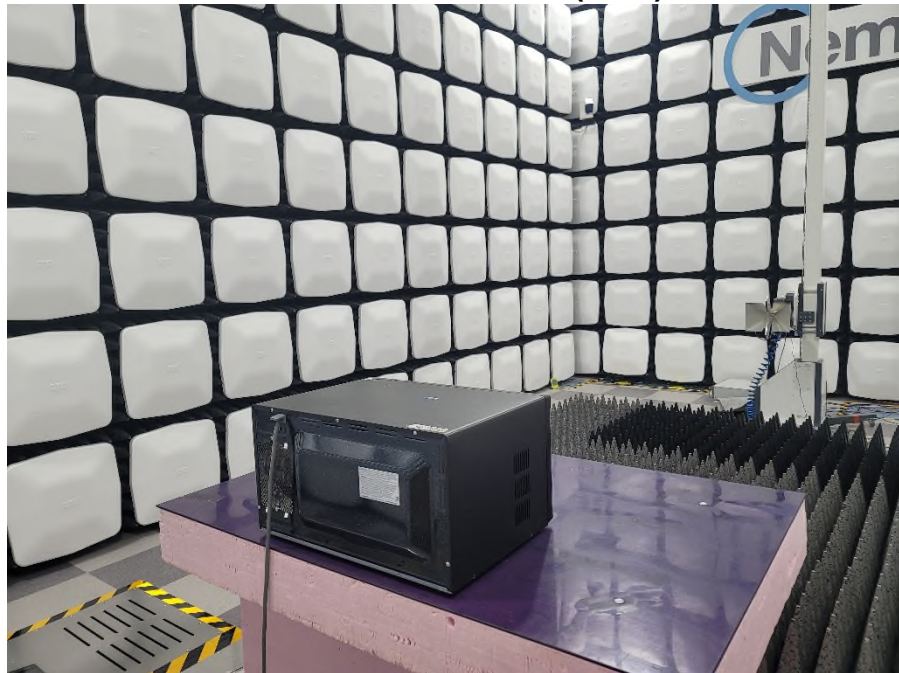
- Radiated Test Picture : 1 GHz ~ 18 GHz (Rear)
