75 – 100 GHz Result

Antenna 1 / Ant J / n261

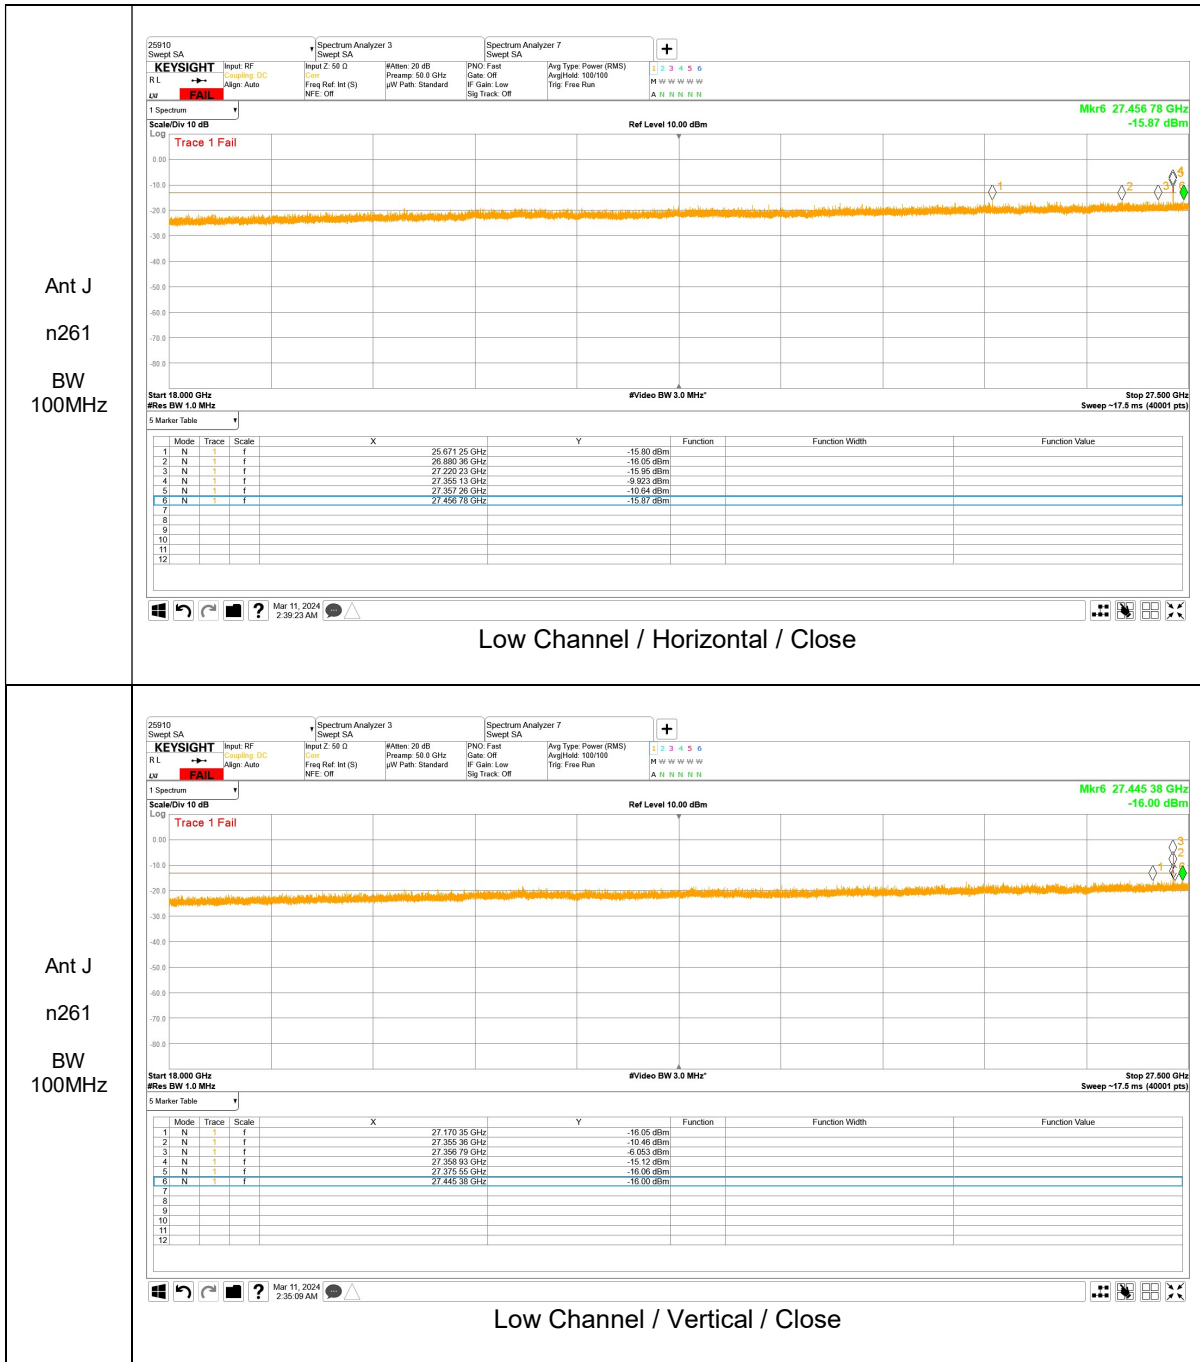
Note. After pre-scan, a zoom scan was performed on the identified spurious emissions. The final measurement result exceeds the TRP limit of the zoom scan result, and therefore a TRP measurement was performed.
