## Appendix B: photographs of test setup

## Appendix C: photographs of EUT

Reference to the test report no. BLA-EMC-202408-A3001

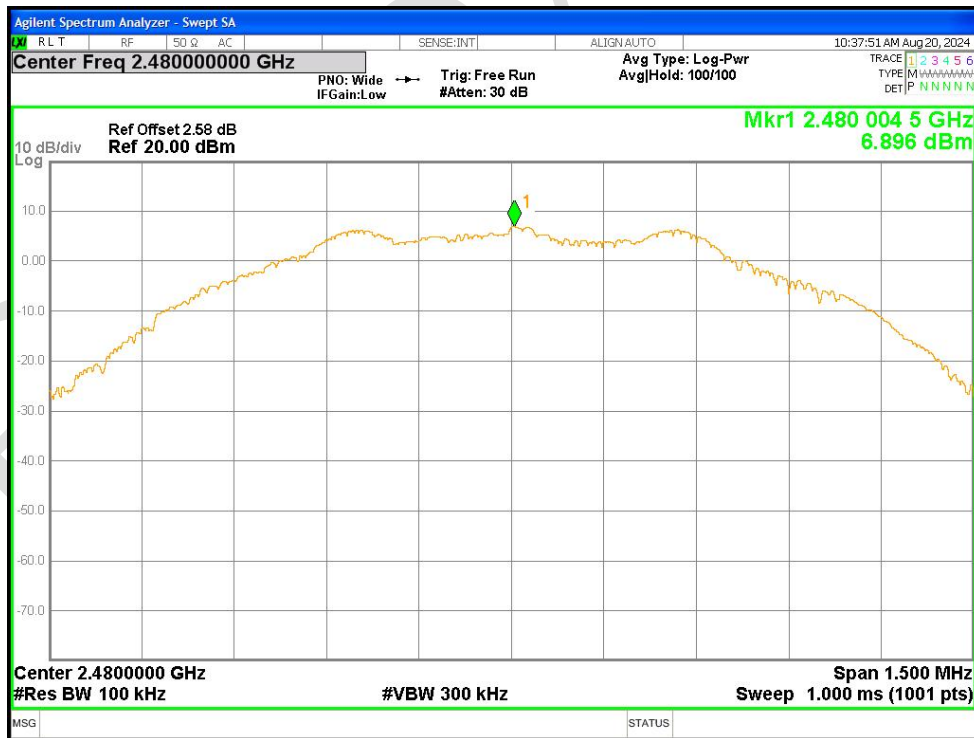
Tx. Spurious NVNT BLE 1M 2480MHz Ant1 Emission

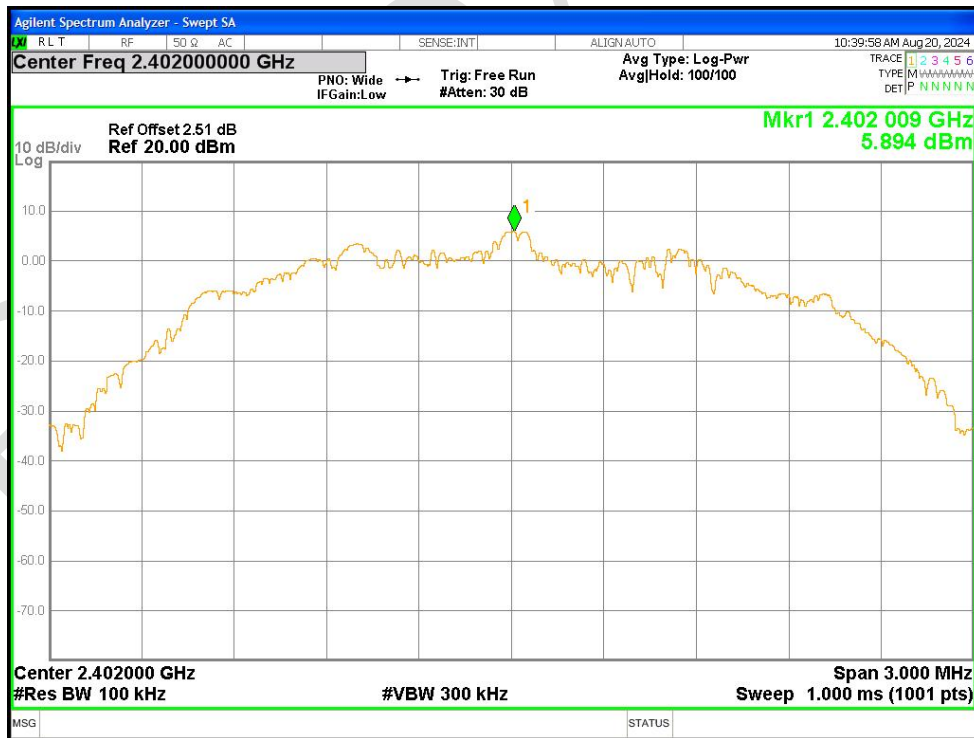
Tx. Spurious NVNT BLE 2M 2402MHz Ant1 Emission

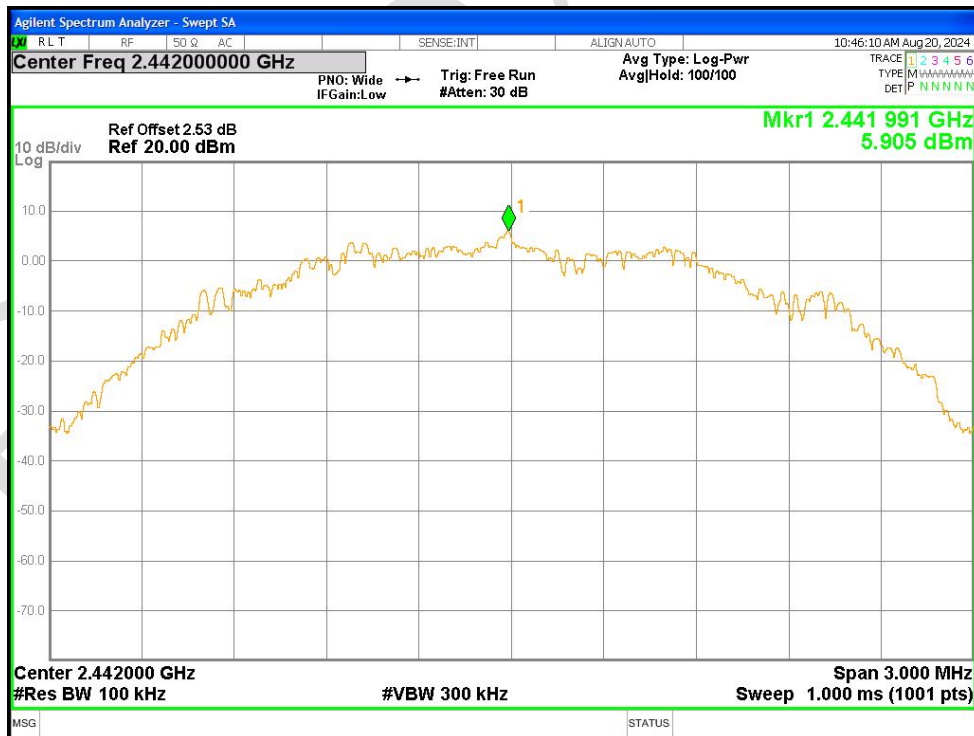
Tx. Spurious NVNT BLE 2M 2442MHz Ant1 Emission

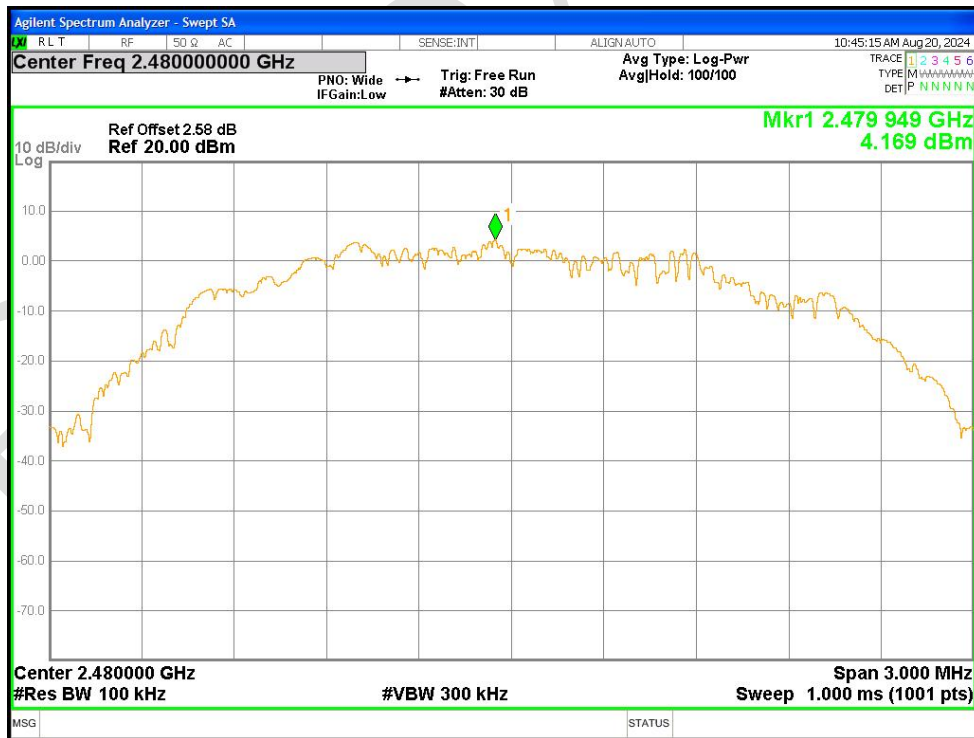
Tx. Spurious NVNT BLE 2M 2480MHz Ant1 Emission

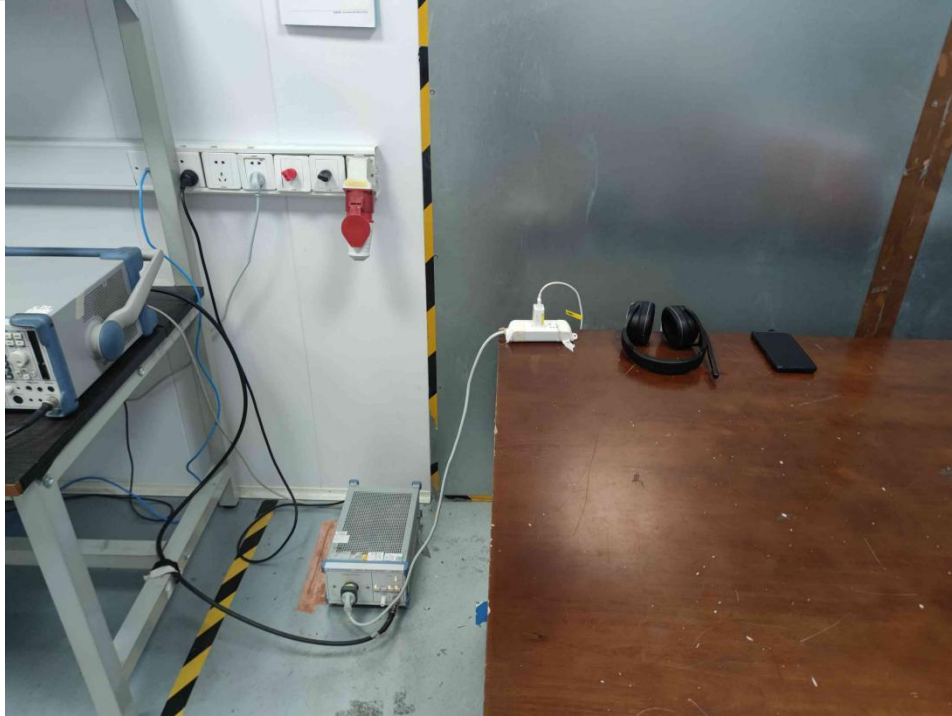
Conducted emissions at AC power line (150kHz-30MHz)

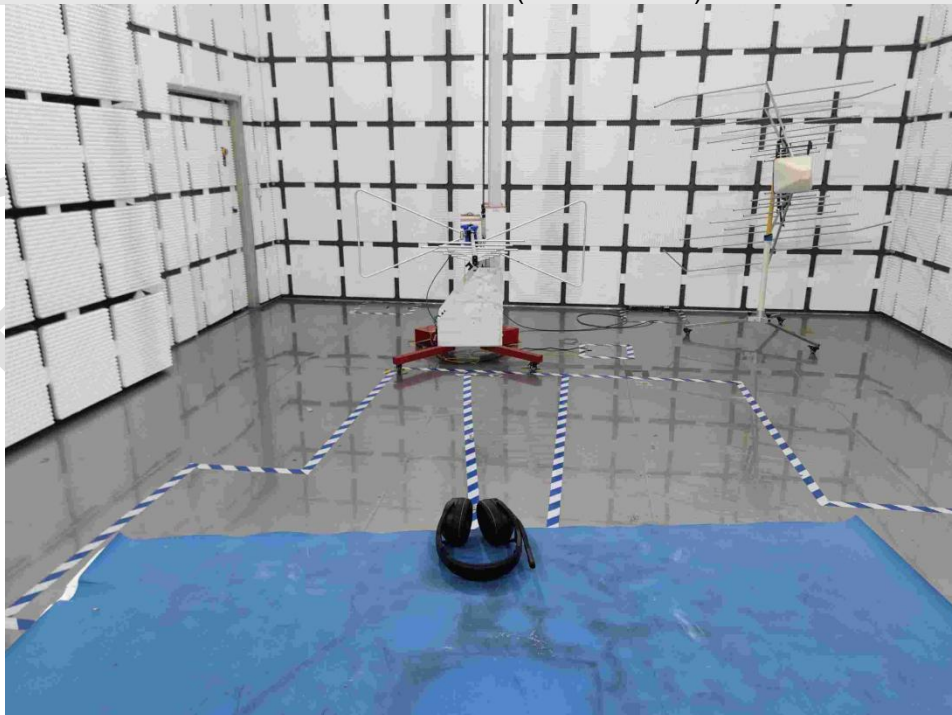
Radiated Emissions (30MHz-1GHz)

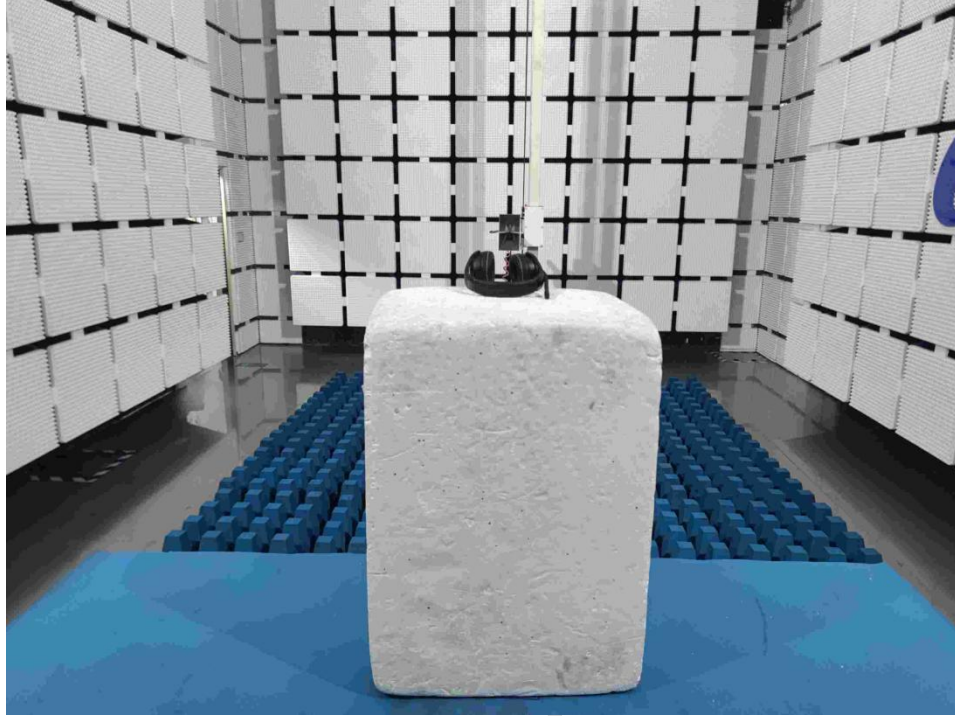
Radiated Emissions (above 1GHz)
