# AeroAntenna Technology, Inc.

## Test Setup

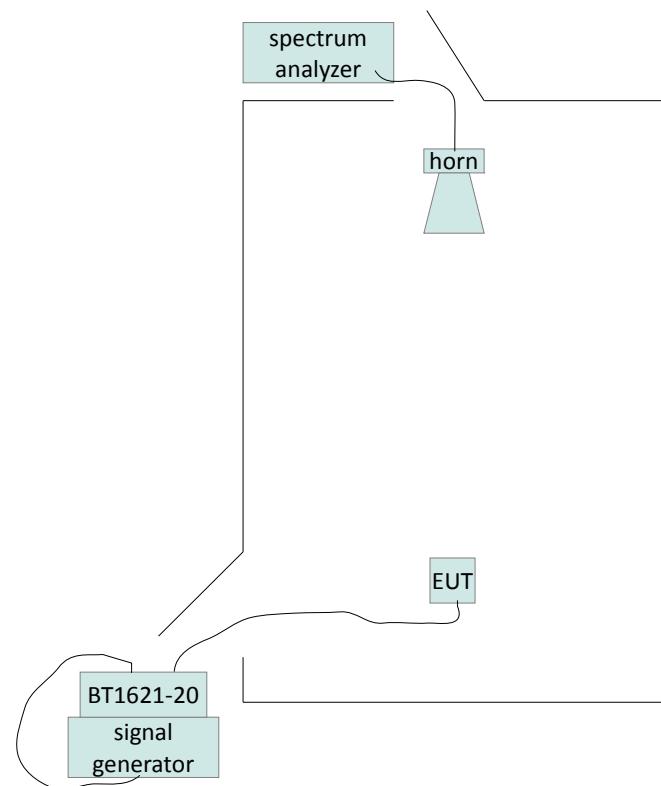
**Figure 1. Diagram of test set up in anechoic chamber. Top view of anechoic chamber. Doors are closed for measurements.**

Measurements were performed in an anechoic chamber. A diagram of the test setup is shown in Figure 1. Photographs of the side door and back door are shown in Figure 2 and Figure 3, respectively.

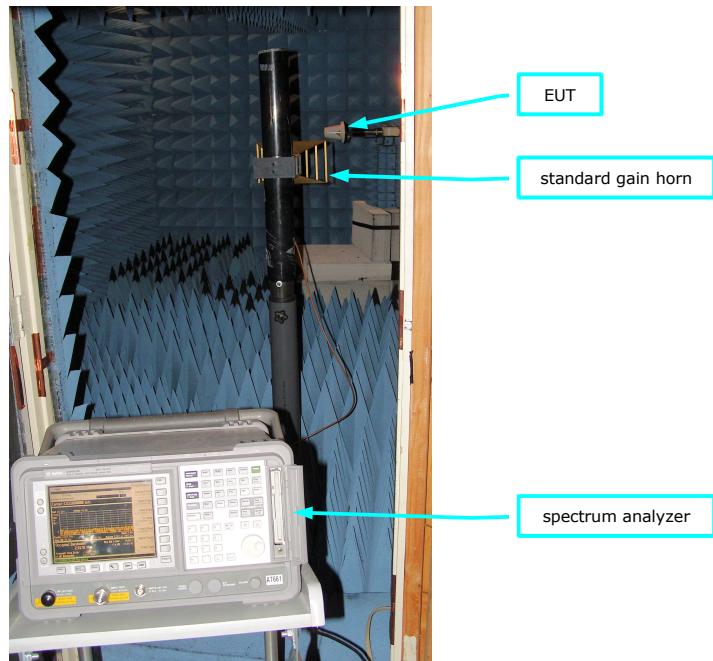
**Figure 2. Photograph of test setup. View is looking into open back door of anechoic chamber. For actual measurements, door is closed with RF cable passing through the door to the spectrum analyzer.**

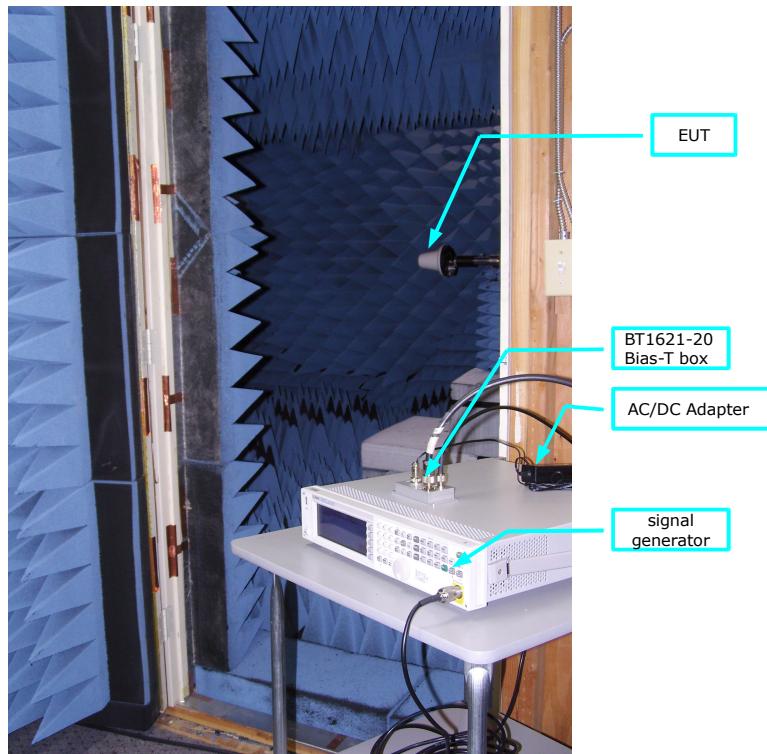
**Figure 3. Photograph of test setup. View is looking into open side door of anechoic chamber. For actual measurements, door is closed with RF cable passing through the door to the spectrum analyzer.**
