ATTACHMENT A - Description of Device

## ATTACHMENT H --- MEASUREMENT OF THE UHF NOISE FIGURES ON BULLETIN OST MP-2 AND STATISTICAL PLAN.

Product ID.Code: M4C9F  
 (Model No.: MVR4040A)  
 Brand Name: MEMOREX

Model No.: MVR4040A  
Brand: MEMOREX

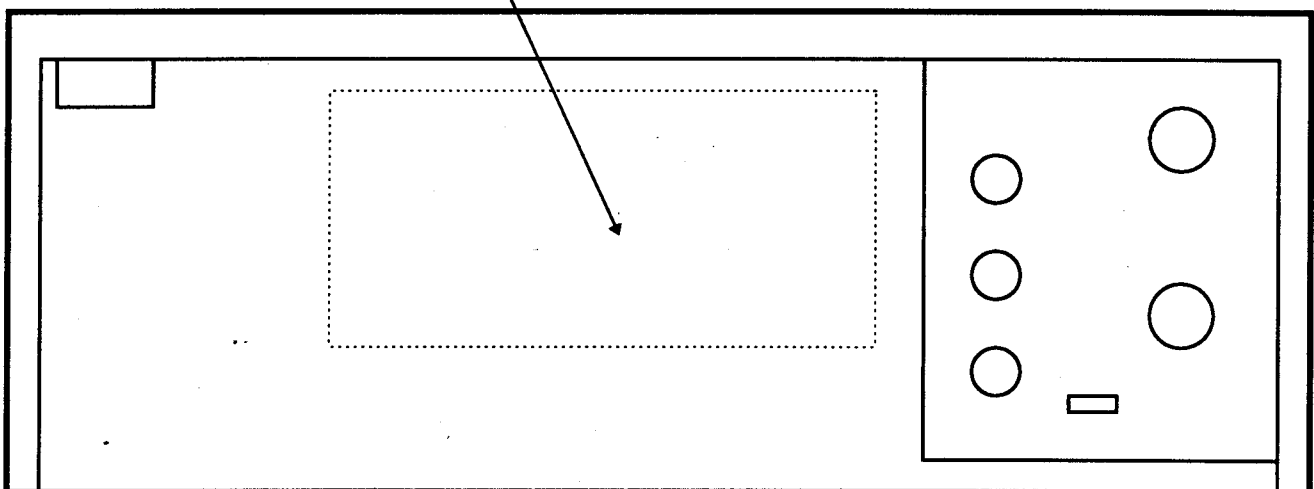
[ BACK VIEW ]

FCC IDENTIFIER (§ 2.926 ) and LABELING REQUIREMENT (§ 15.19) --- Labeling

Please see ATTACHMENT J-1 and Photographs for detail of indication place.
