## 15 Appendix D - Troubleshooting Pictures

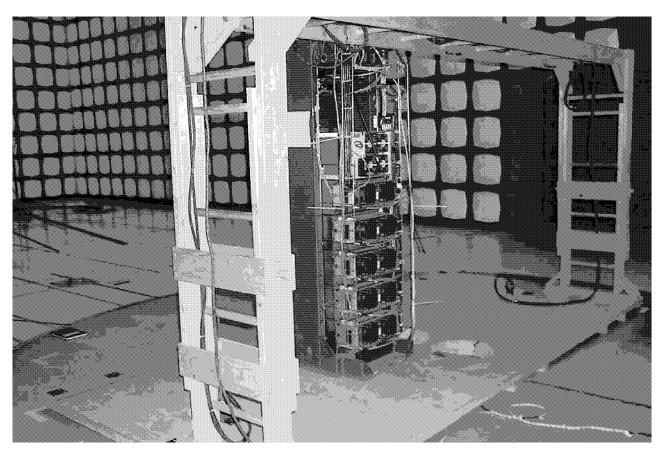
Figure C4 - EUT Rear-Right View
