APPENDIX 3: Photographs of test setup

Radiated Spurious Emission

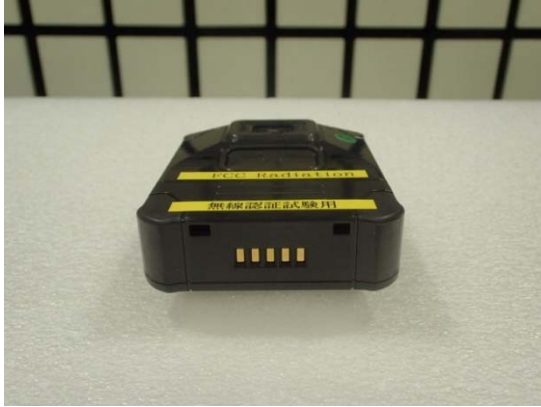
X-axis

Worst Case Position

Below 1GHz (Horizontal: X-axis/ Vertical: Y-axis)
Above 1GHz (Horizontal: Y-axis/ Vertical: Z-axis)
