APPENDIX 3: Photographs of test setup

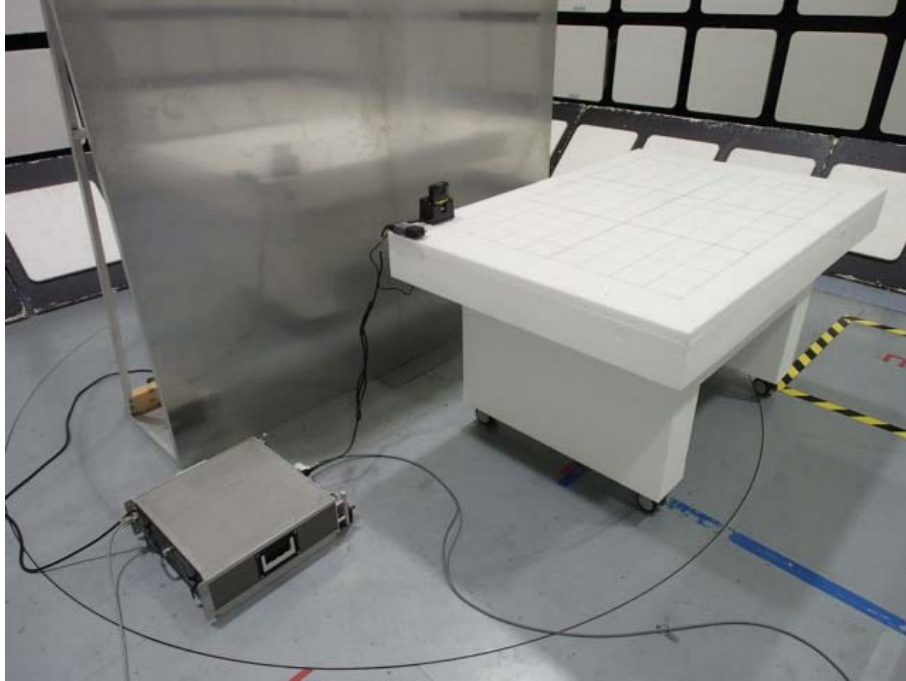
Photo 1

Conducted Emission

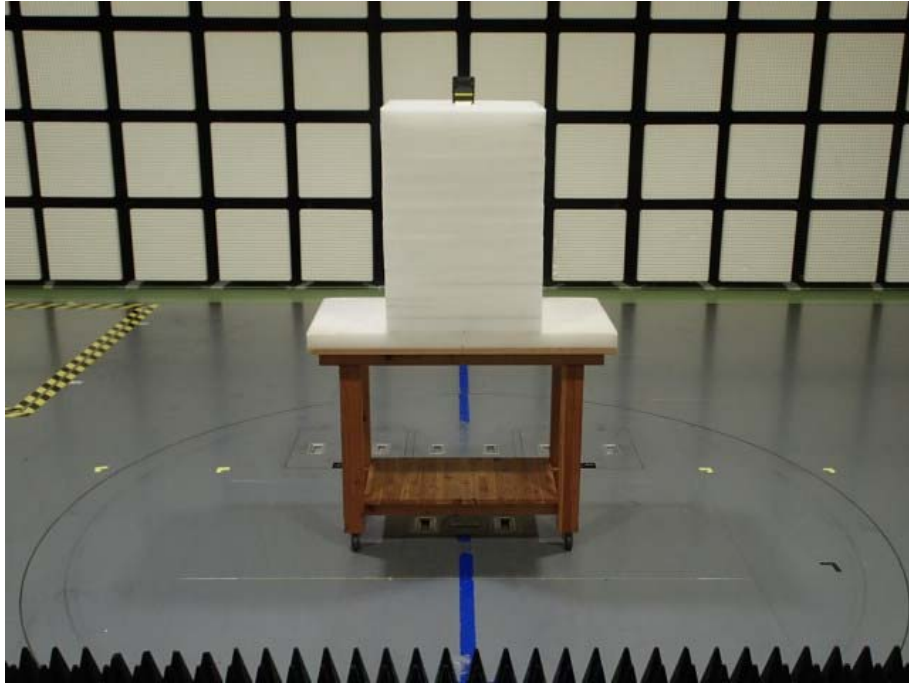
Photo 1

Radiated Spurious Emission

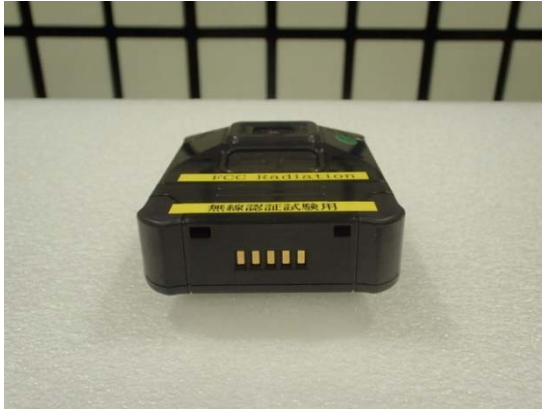
X-axis

Worst Case Position

Below 1 GHz (Horizontal: X-axis/ Vertical: Y-axis)

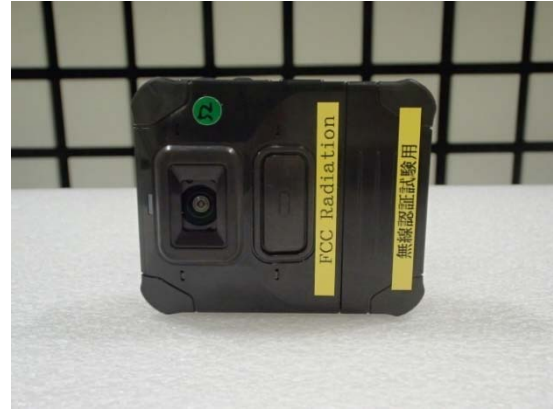
Z-axis

Above 1 GHz (Horizontal: Z-axis/ Vertical: Y-axis)
