APPENDIX 3: Photographs of test setup

Conducted Emission

Radiated Spurious Emission

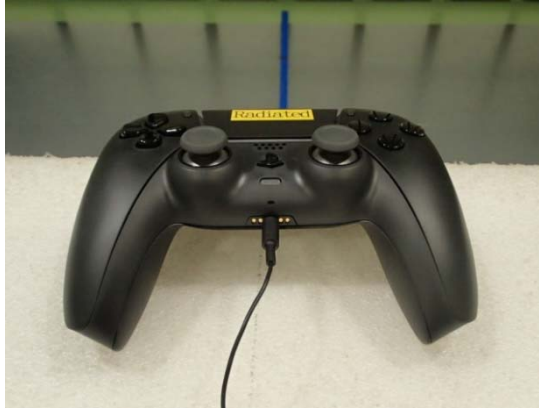
X-axis

Worst Case Position
Below 1GHz (Horizontal: X-axis/ Vertical: X-axis)
Above 1GHz (Horizontal: Y-axis/ Vertical: Z-axis)
