**APPENDIX 3: Photographs of test setup**

**Radiated Spurious Emission**

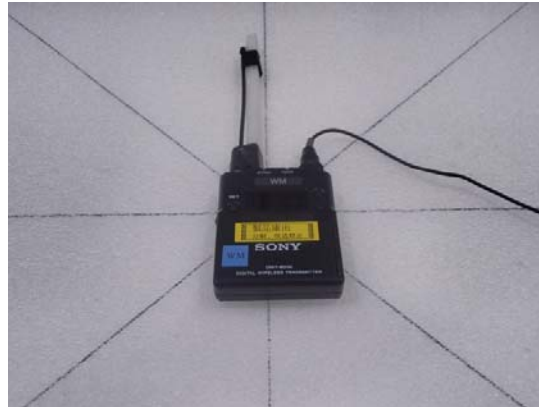
**X-axis**

**Worst Case Position**

**Below 1 GHz (Horizontal: X-axis/ Vertical: Y-axis)**

**Above 1 GHz (Horizontal: Z-axis/ Vertical: X-axis)**
