6. Photographs of test setup

The following photographs show the arrangement of the worst case.

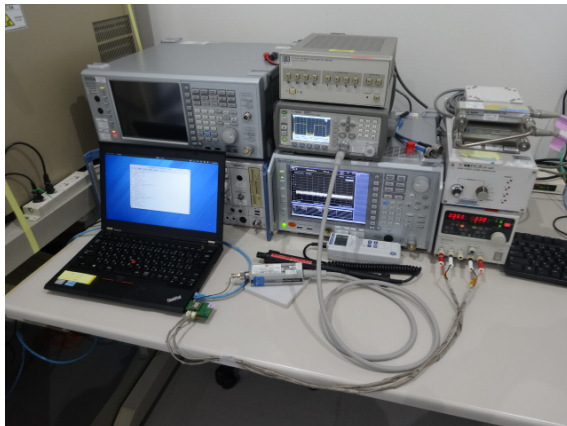
6.2. Antenna-port Conducted Measurements Photo(s)

Maximum Peak Conducted Output Power

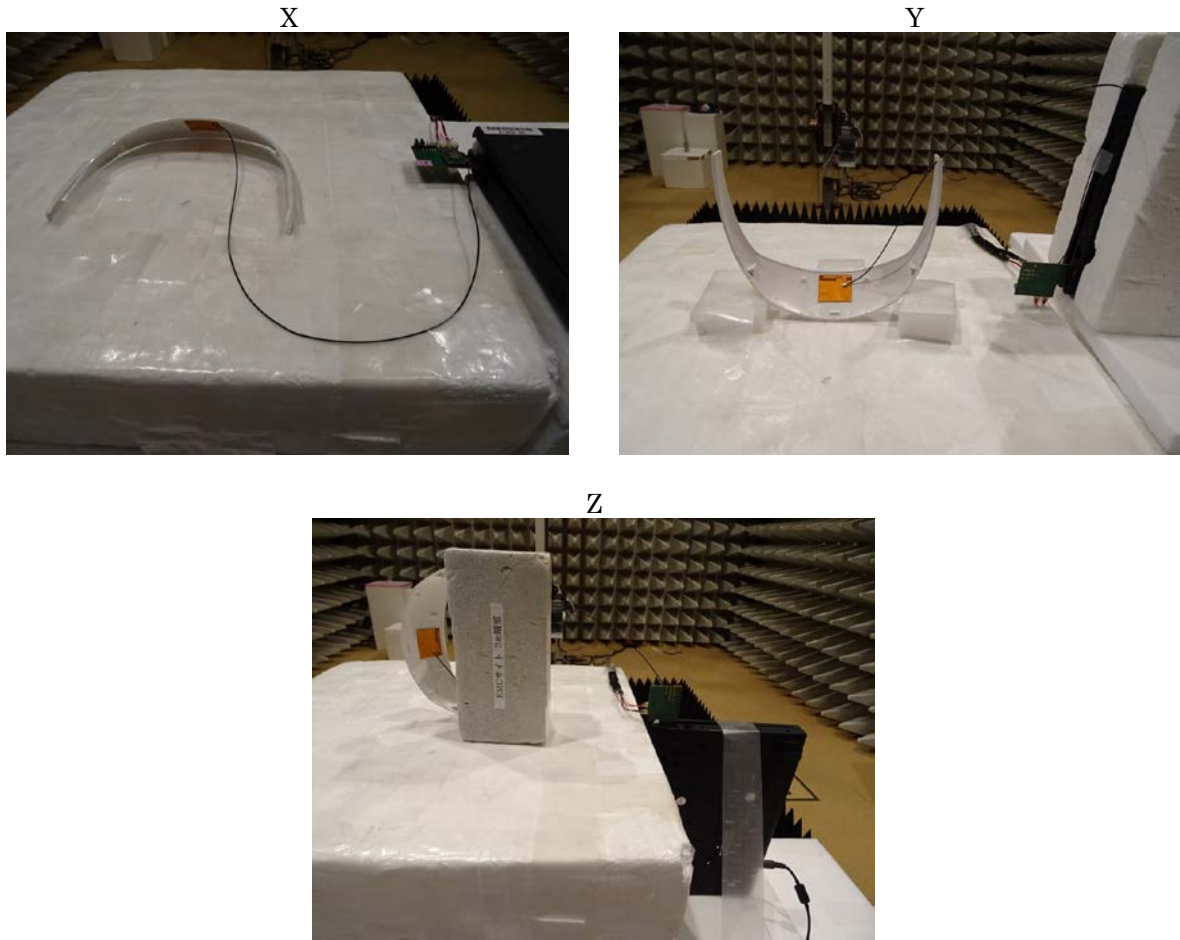
<EUT Axis>

The antenna was tested with attached to supporting jig that does not affect EMC characteristic in order to place for each axis.
