8. Photographs of the Test Setup

Prüfbericht - Nr.: 12605643 003
Test Report No.:

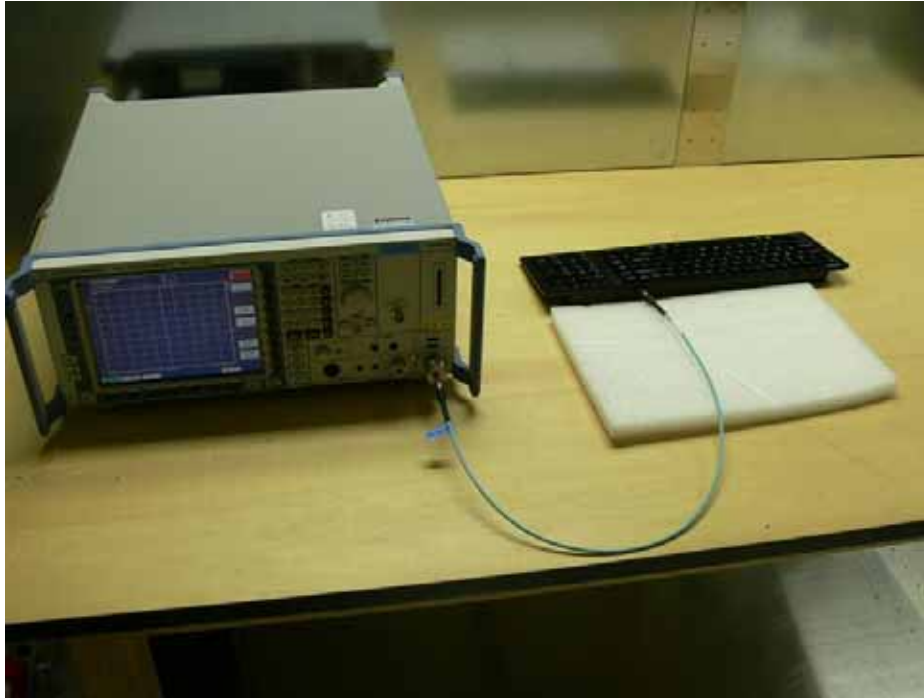
Photograph 1: Set-up for Conducted Emissions at Antenna Port

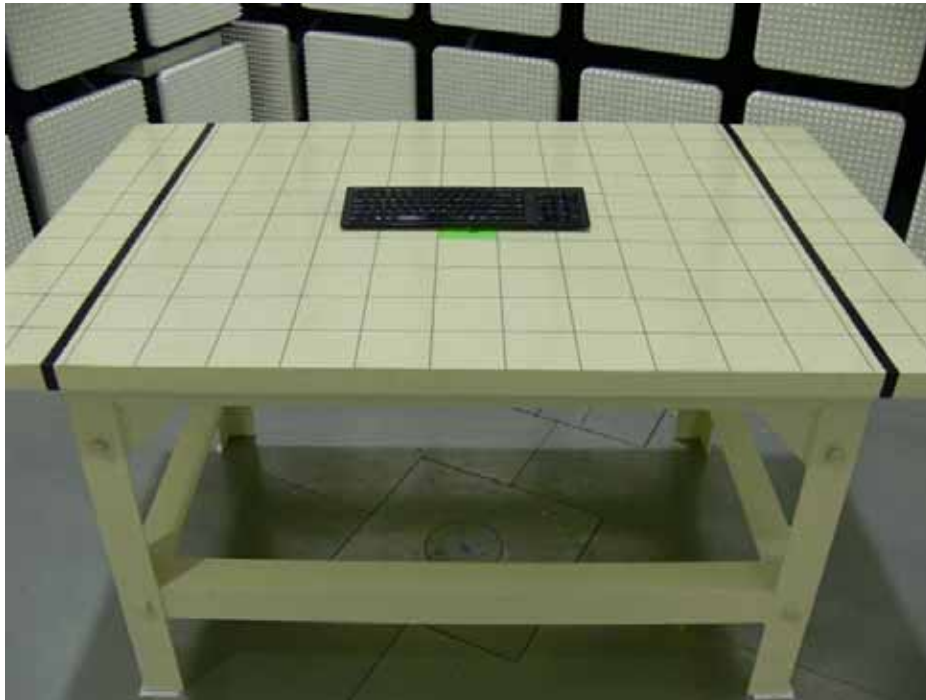
Photograph 2: Set-up for Radiated Emission of Transmitter, Front View

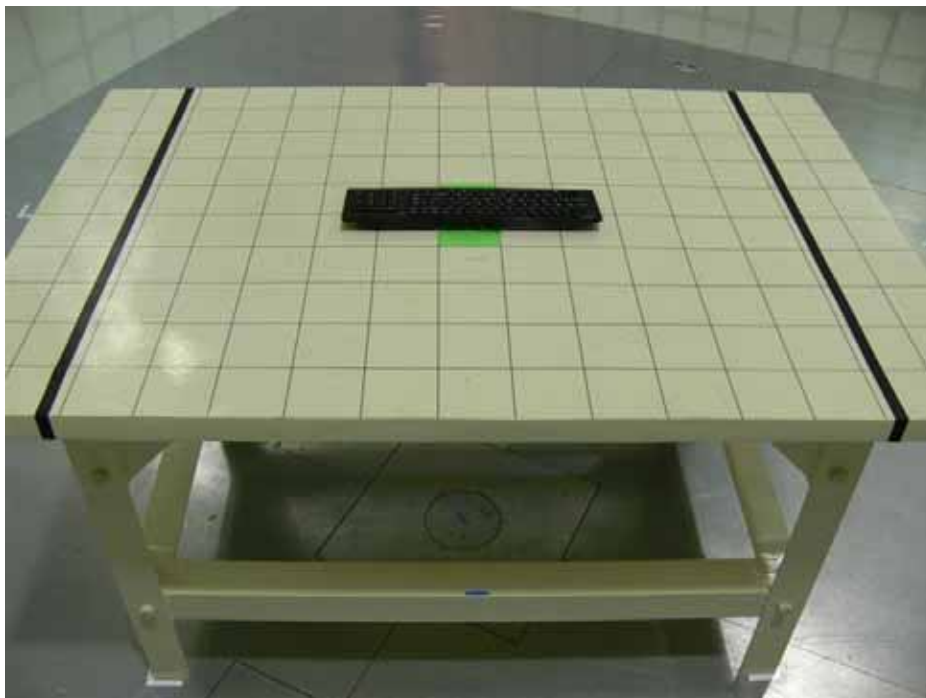
Photograph 3: Set-up for Radiated Emission of Transmitter, Rear View

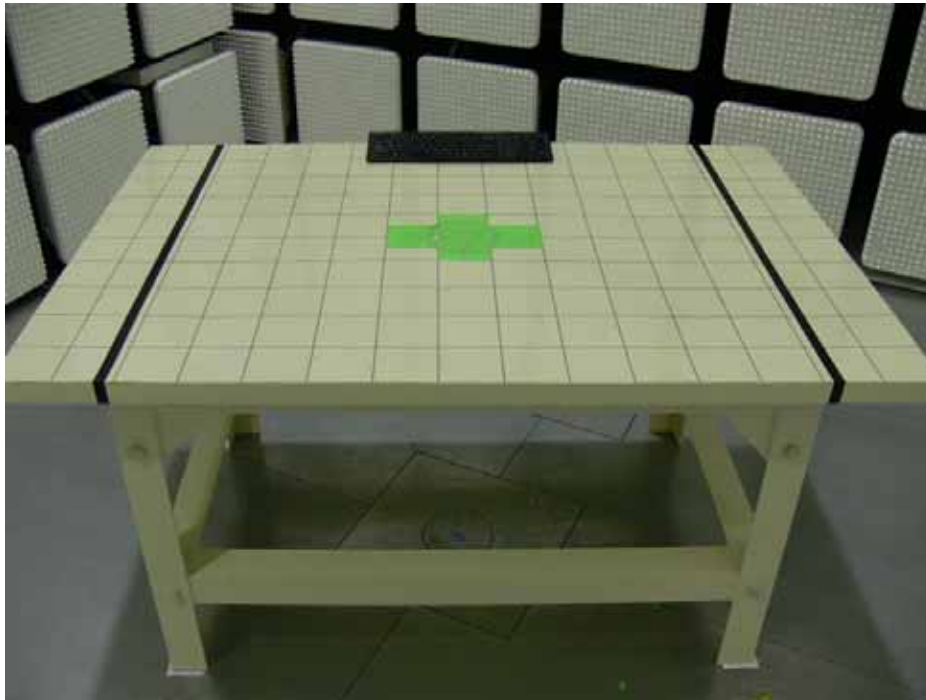
Photograph 4: Set-up for Radiated Emission of Receiver, Front View

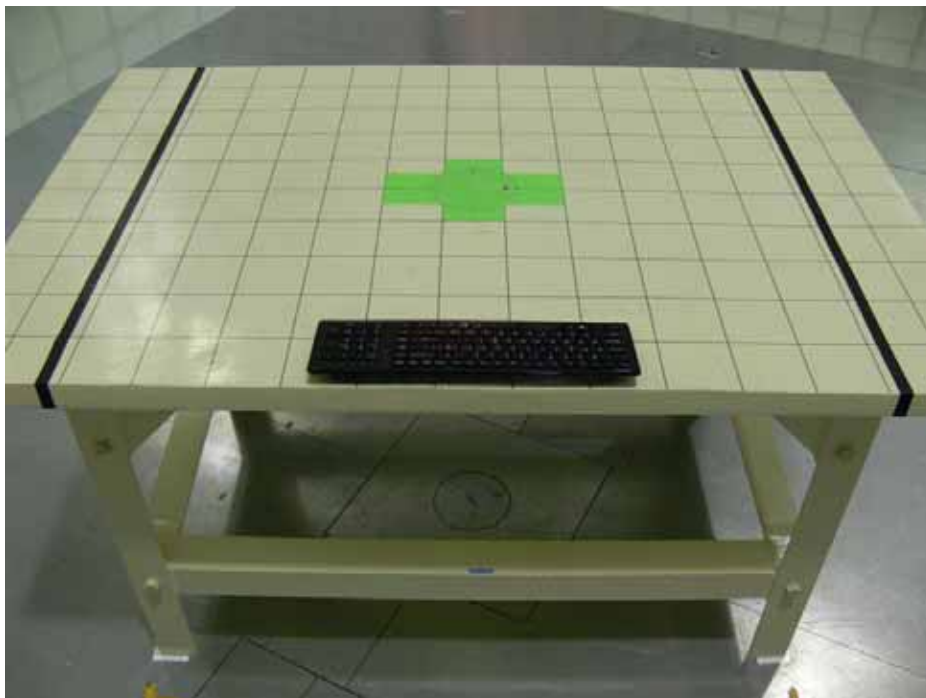
Photograph 5: Set-up for Radiated Emission of Receiver, Rear View
