APPENDIX 3: Photographs of test setup

Radiated Spurious Emission

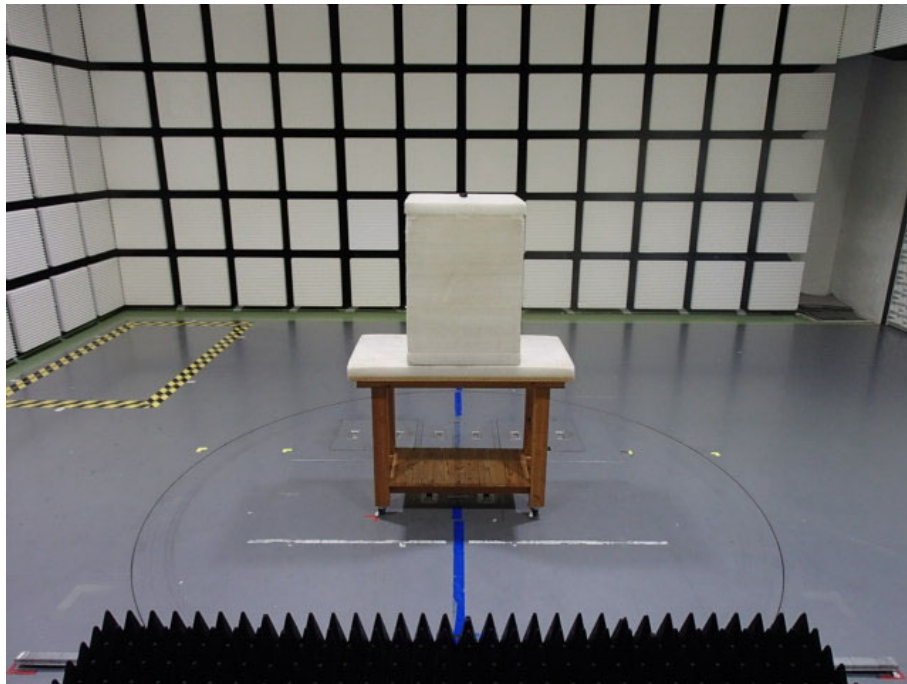
Photo 1

Radiated Spurious Emission

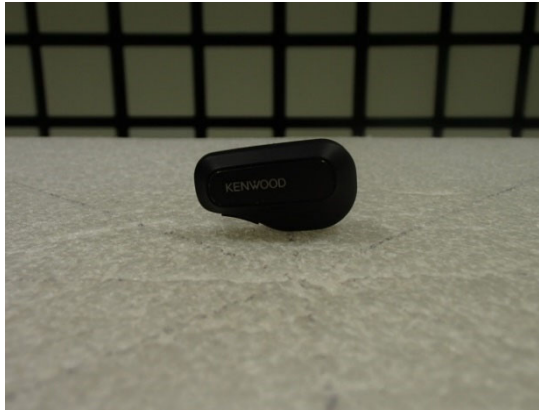
X-axis

Worst Case Position

Below 1GHz (Horizontal: X-axis/ Vertical:X-axis)
Above 1GHz(Horizontal: Z-axis/ Vertical:X-axis)
