Certificate of Environmental Testing

Serial Number: 6239

Test Specimen: 1 off Marine Transmitter, EPIRB
Model RLB30, Sample No.5
CEEL Stores No.01834

Test Specification: Testing was carried out in general accordance with ETS 300.152, sections 3.8 and 3.8.1 and 4.9.2 and the relevant subclauses of CEPT Recommendation T/R 34.01 Annex V1 as follows:-

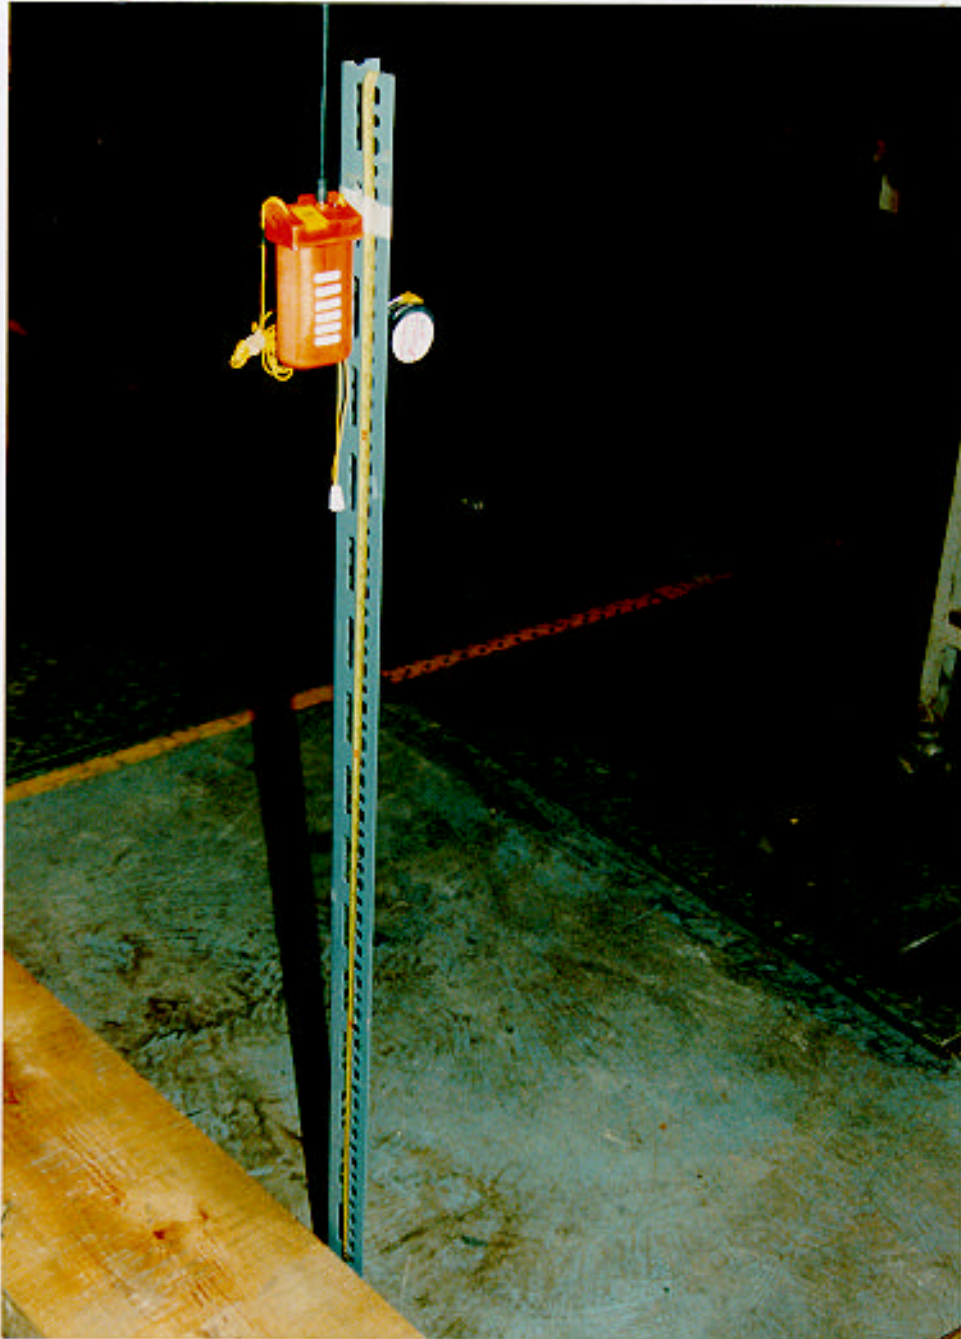
Photograph No. CBE/1023/19

Specimen configuration for drop testing.

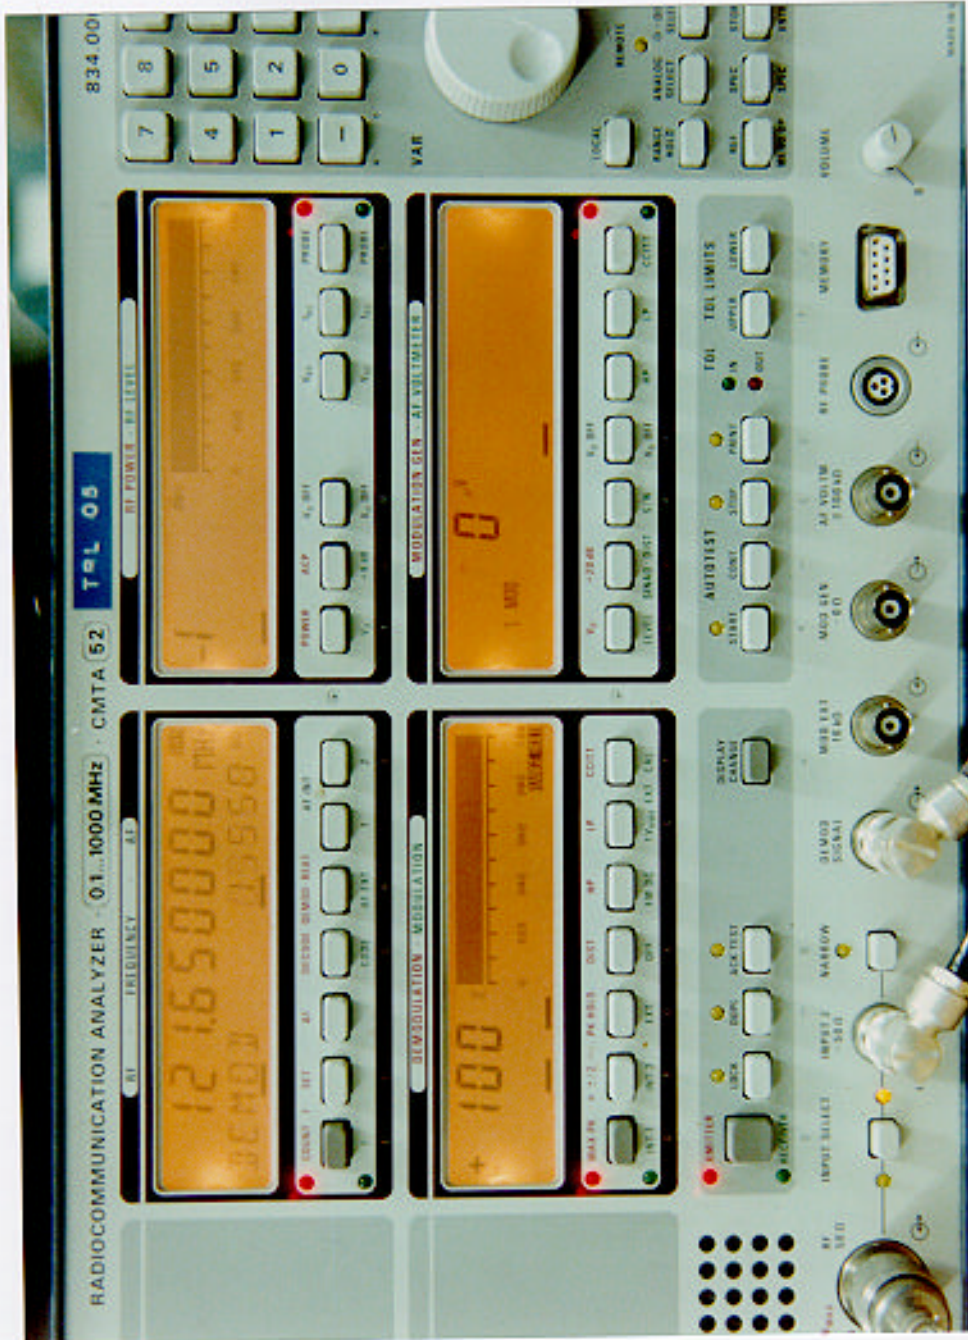
Photograph No. CEE/1022/24

Performance check readings.
