APPENDIX 3: Photographs of test setup

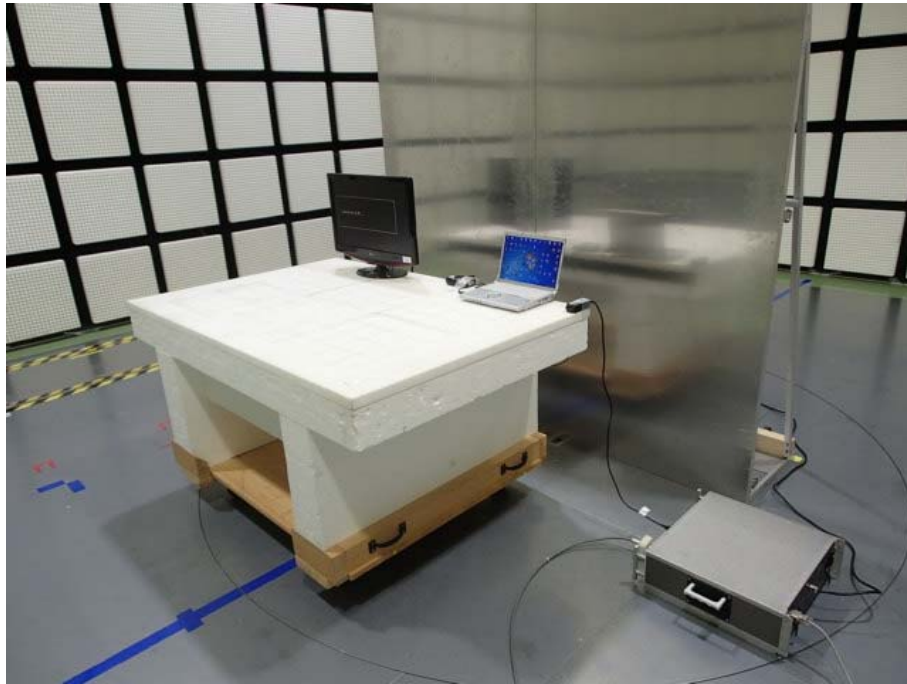
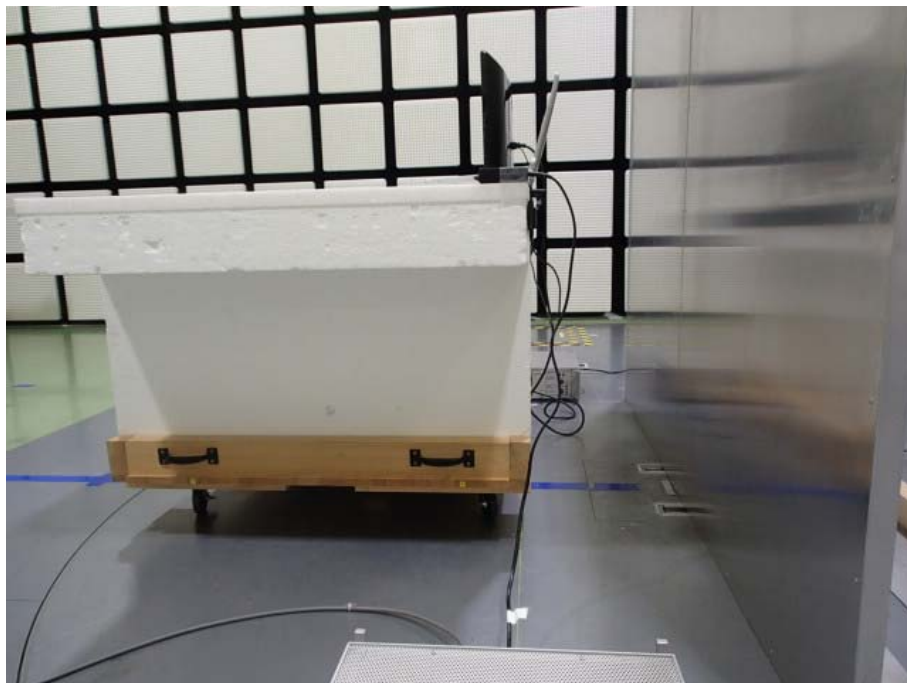
Conducted Emission

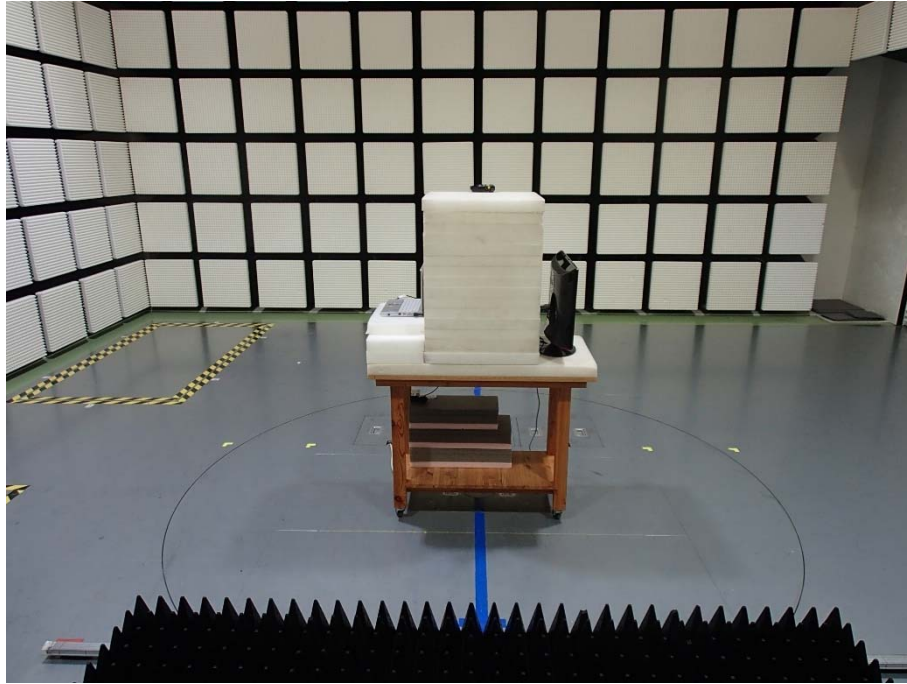
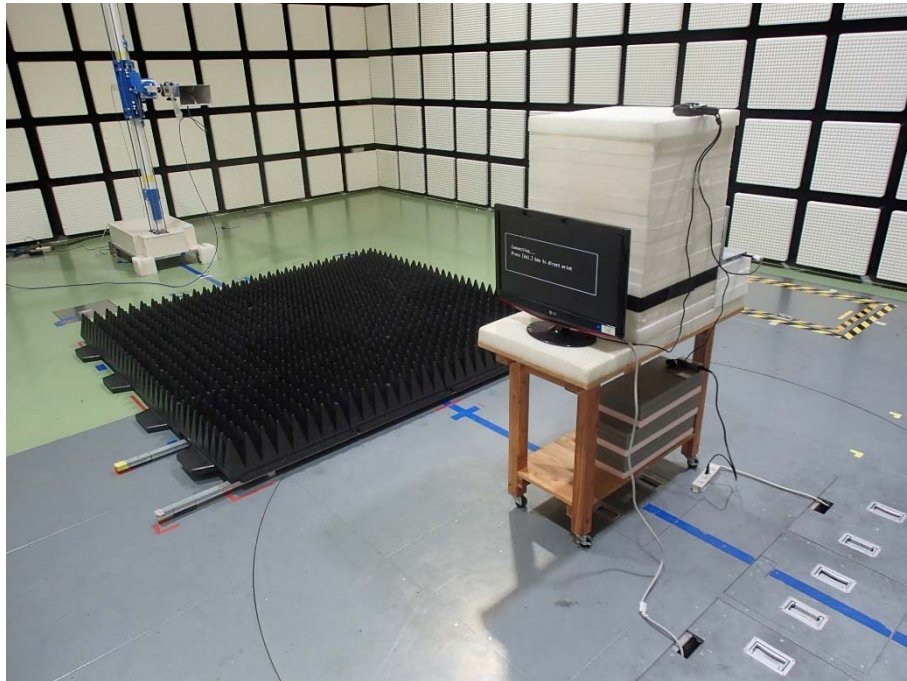
Radiated Spurious Emission

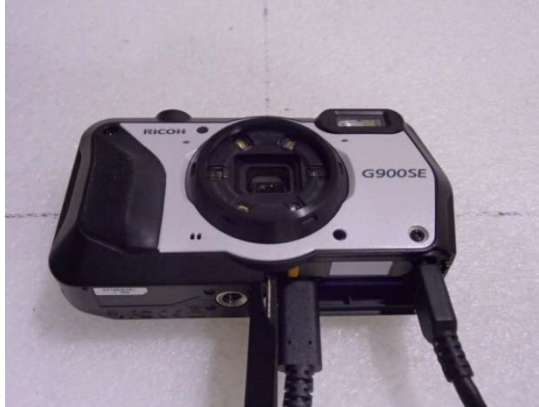
X-axis

Worst Case Position

Below 1GHz : (Horizontal: Z-axis/ Vertical: Y-axis)

Above 1GHz : (Horizontal: Z-axis/ Vertical: X-axis)
