APPENDIX 3: Photographs of test setup

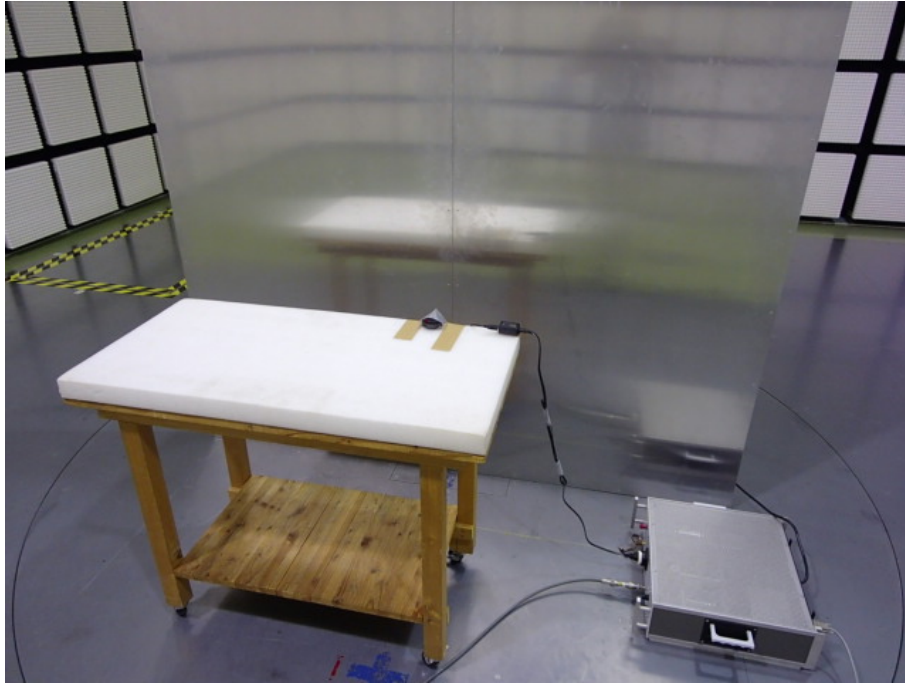
Photo 1

Conducted Emission

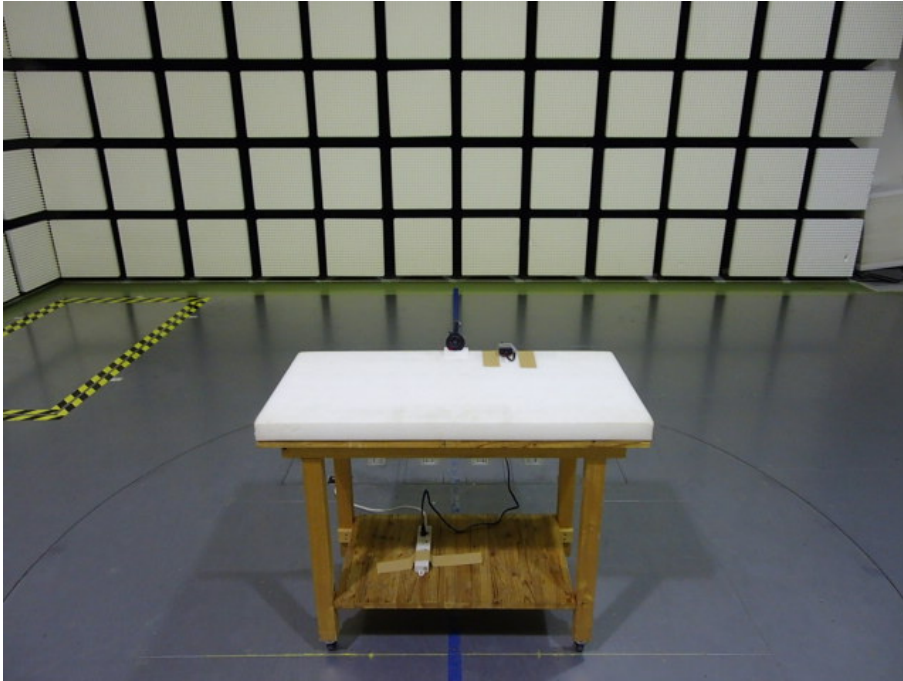
Photo 1

Radiated Spurious Emission

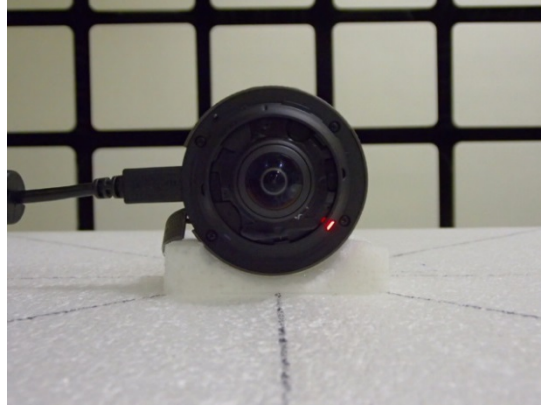
X-axis

Worst Case Position

WLAN (Horizontal: Z-axis/ Vertical: X-axis)
BT LE below 1 GHz (Horizontal: Y-axis/ Vertical: Y-axis)
BT LE above 1 GHz (Horizontal: Y-axis/ Vertical: X-axis)
