APPENDIX 3: Photographs of test setup

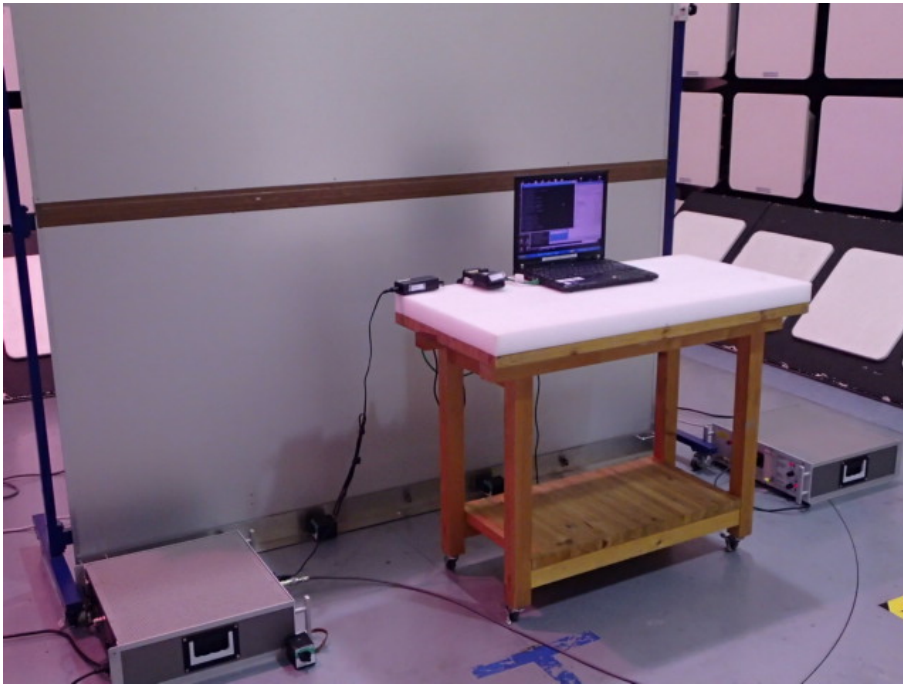
Photo 1

Conducted Emission

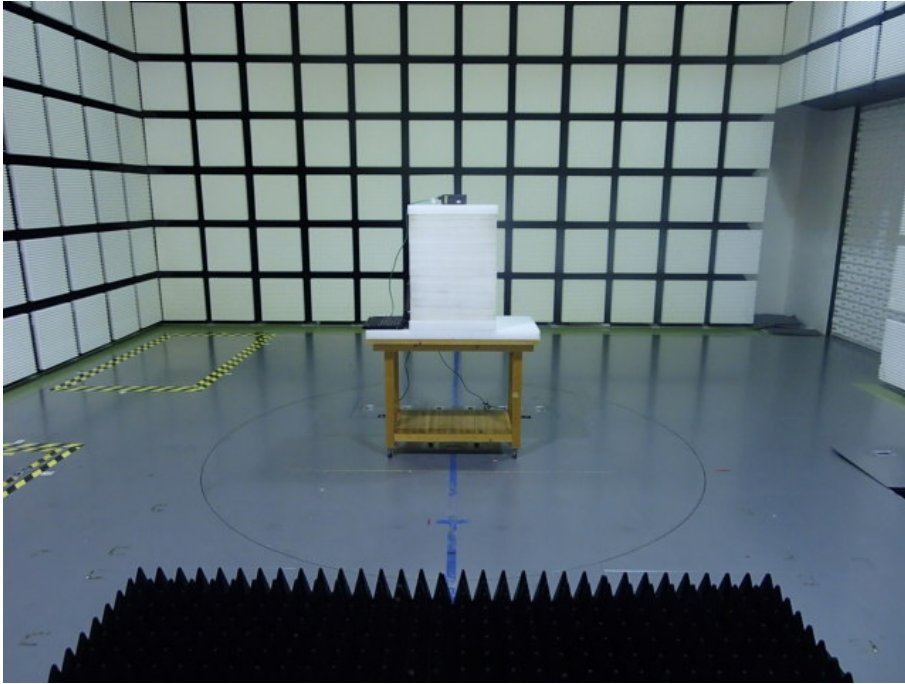
Photo 1

Radiated Spurious Emission

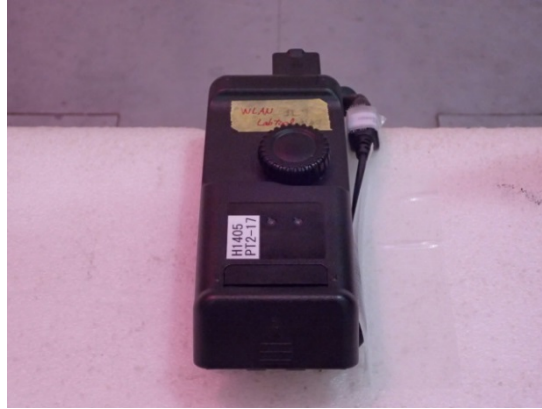
X-axis

Worst Case Position
(Horizontal: Z-axis / Vertical: Y-axis)
