**APPENDIX 3: Photographs of test setup**

**Radiated emission**  
Below 1GHz

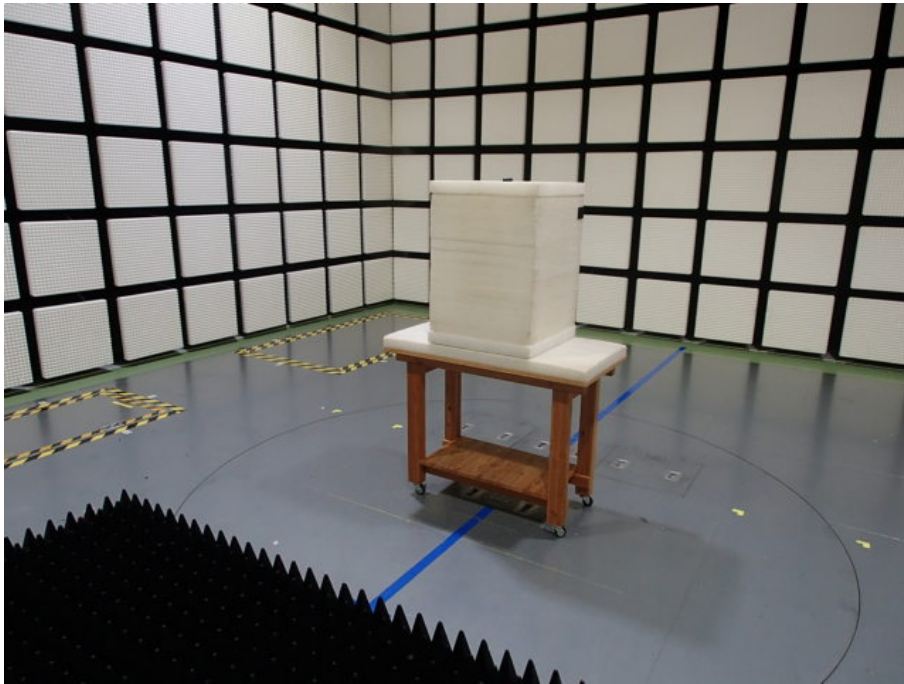
**Photo 1**

**Radiated emission**  
Above 1GHz

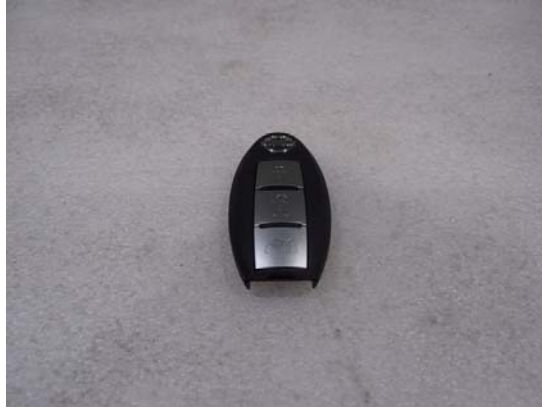
**X-axis**

**Worst case position**

(Below 1GHz Horizontal: X-axis / Vertical: Y-axis)  
(Above 1GHz Horizontal: Y-axis / Vertical: Z-axis)

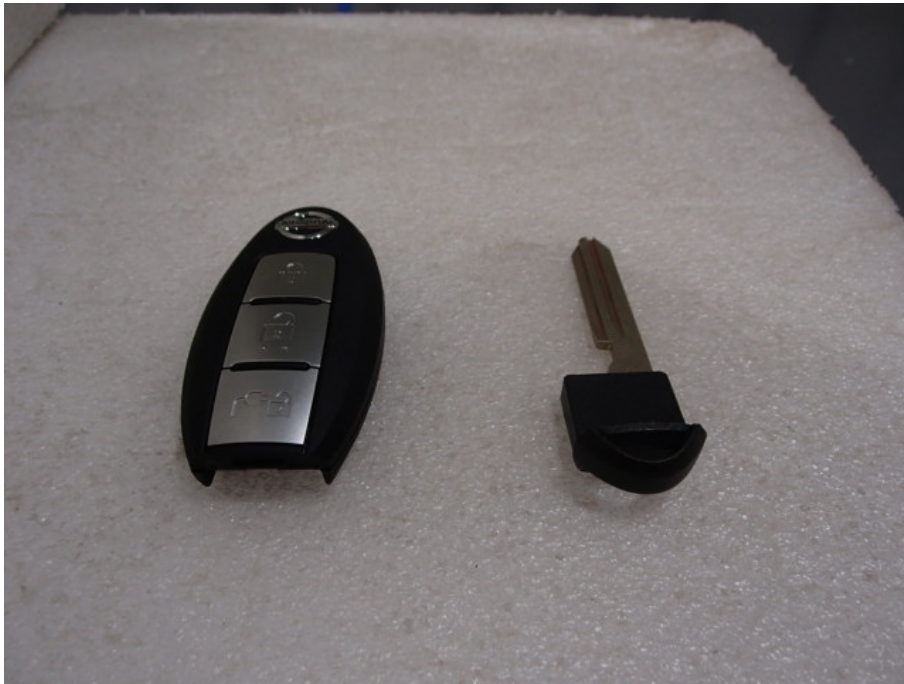
**Worst case position**

**Mechanical Key (Not Inserted) Worst**

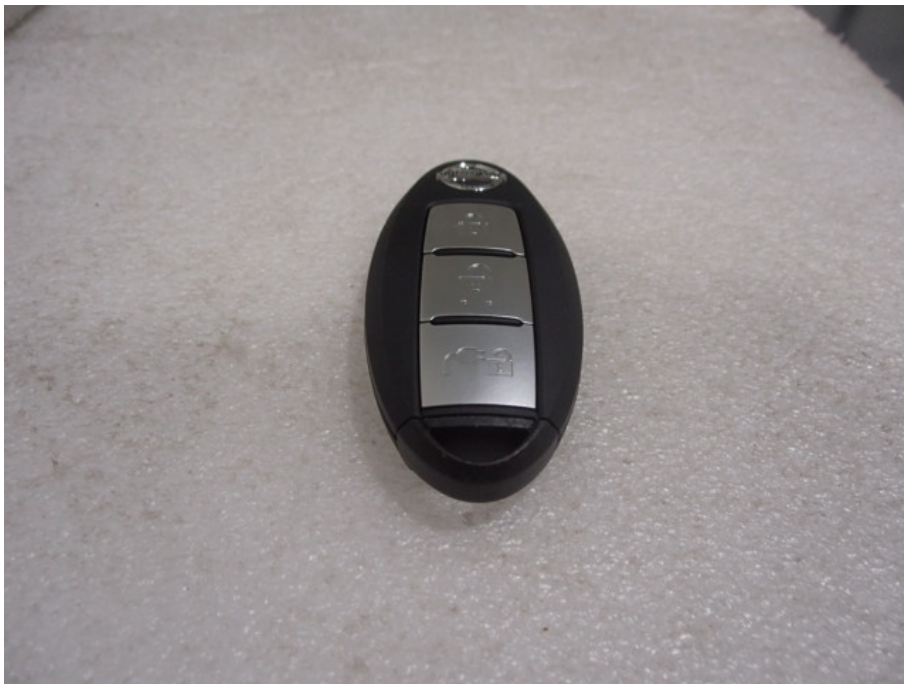
**Mechanical Key (Inserted)**
