APPENDIX 3: Photographs of test setup

Radiated Spurious Emission

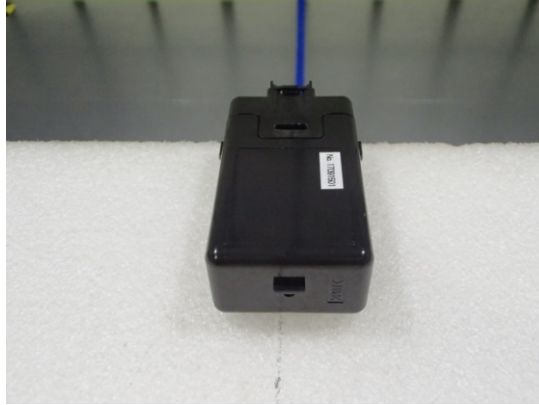
X-axis

Worst Case Position

Above 1GHz : (Horizontal: X-axis/ Vertical:Z-axis)

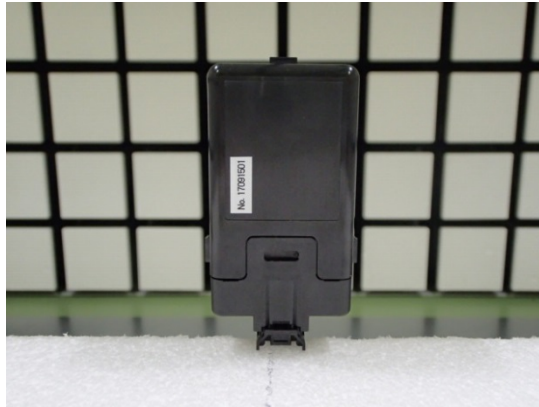
Y-axis

Below 1GHz : (Horizontal: Y-axis/ Vertical:Y-axis)
