APPENDIX 3: Photographs of test setup

Conducted emission

Radiated emission

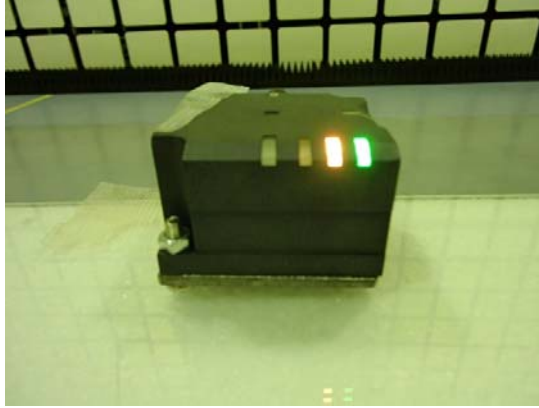
Worst Case Position

Below 30MHz Z-axis
Above 30MHz Horizontal:Z-axis / Vertical:Z-axis

X-axis

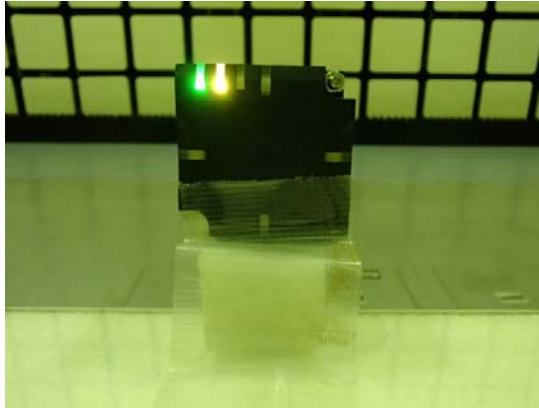
Y-axis

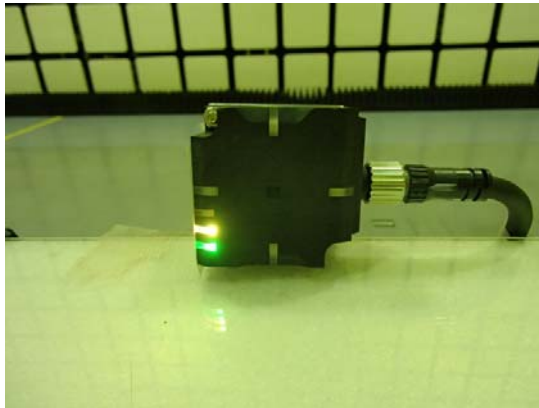
Z-axis

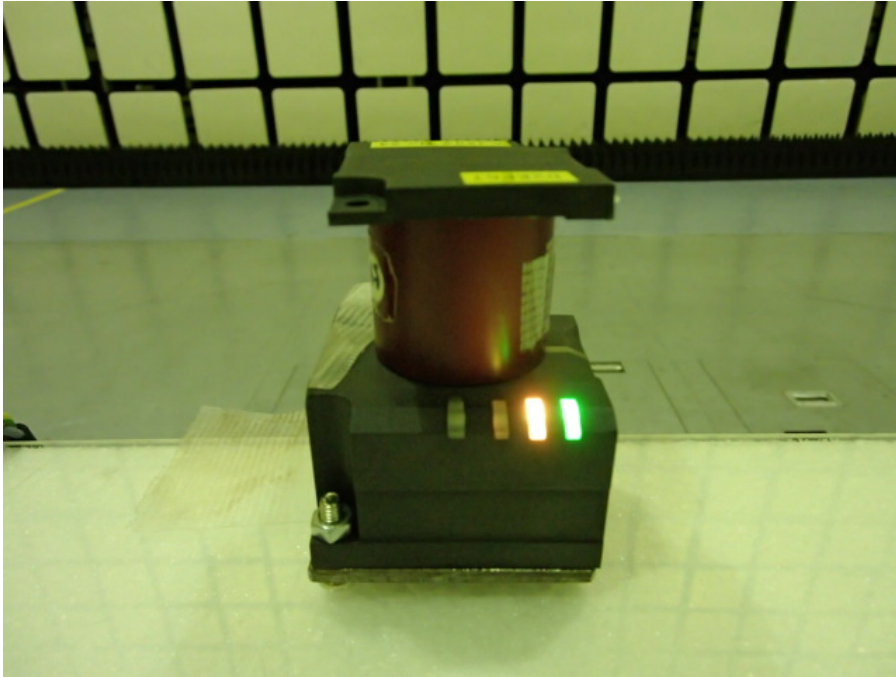
With/Without Tag

With Tag

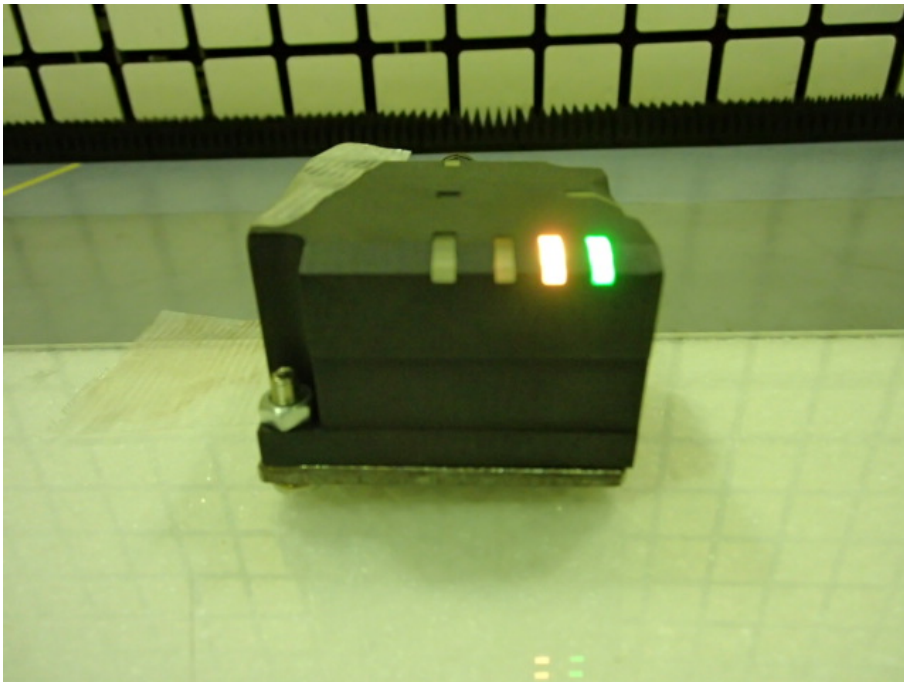
Without Tag (Worst)
