APPENDIX 3: Photographs of test setup

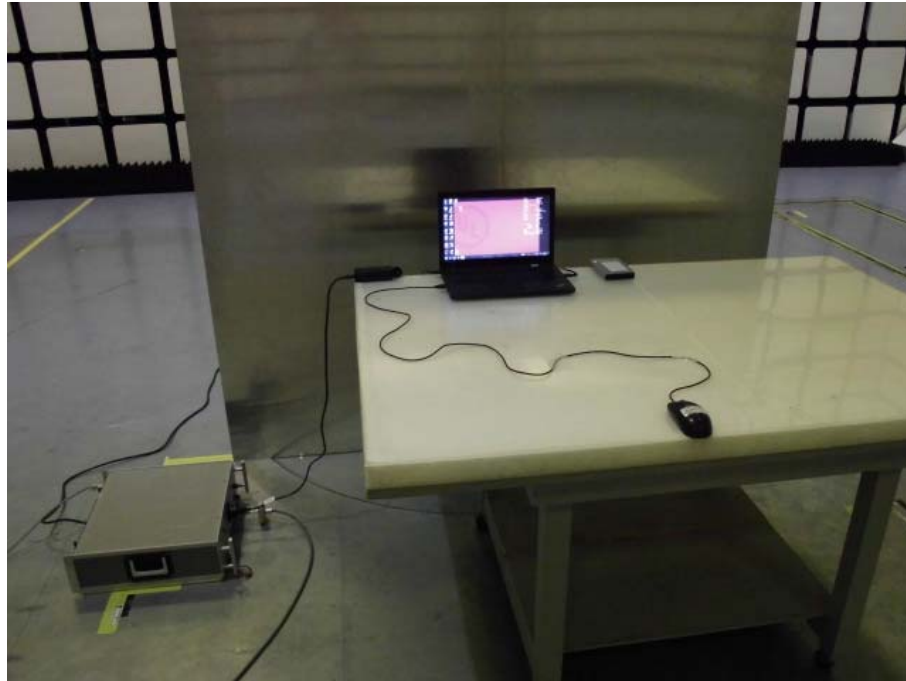
Photo 1

Conducted emission

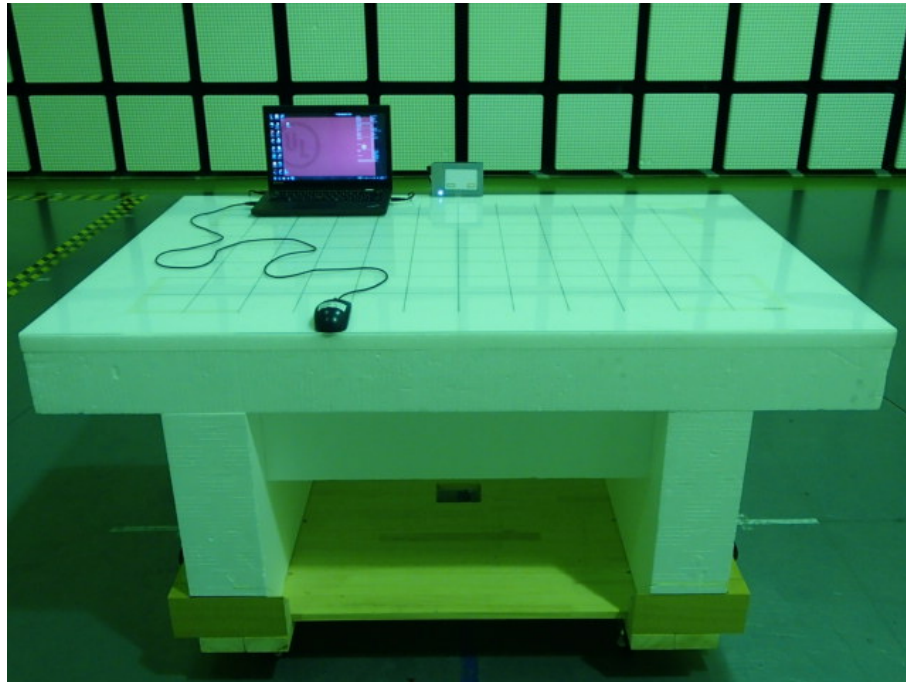
Photo 1

Radiated emission

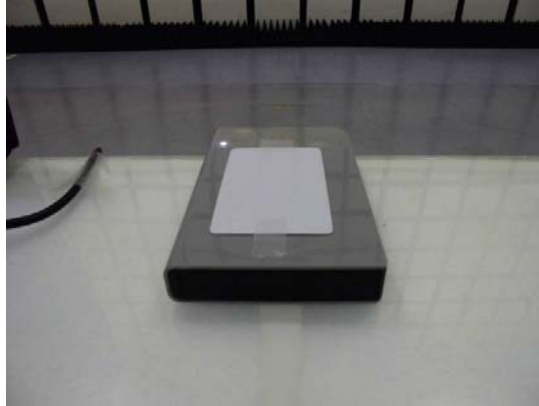
X-axis

Worst Case Position

Below 30MHz: Z-axis
Above 30MHz: Horizontal:Z-axis / Vertical:Z-axis

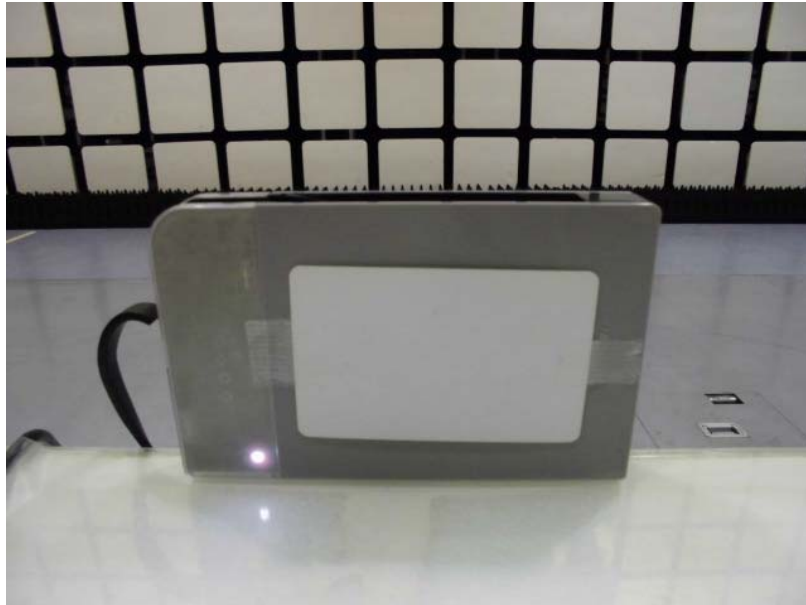
With/Without Tag

With Tag (Worst)

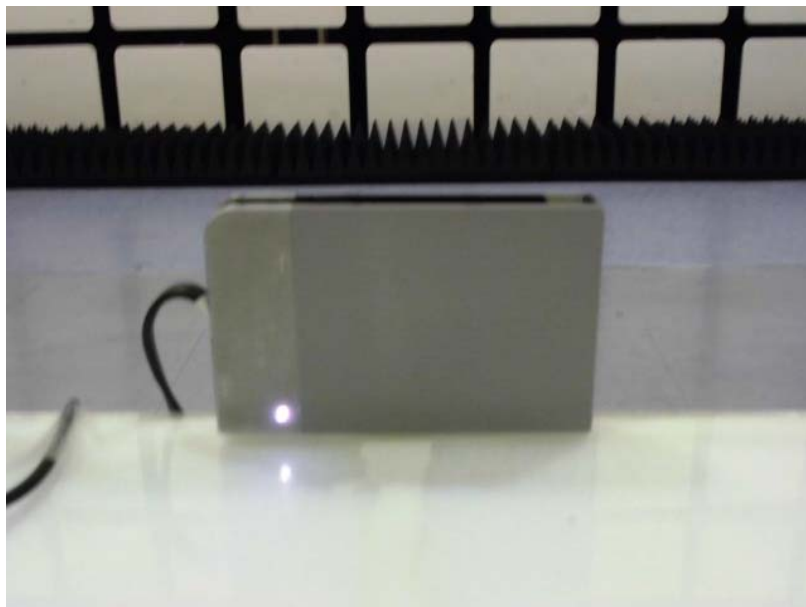
Without Tag
