15 Annex A

15.1 Pictures taken during testing

Cherry GmbH

RS6600-C3R / GT 9998

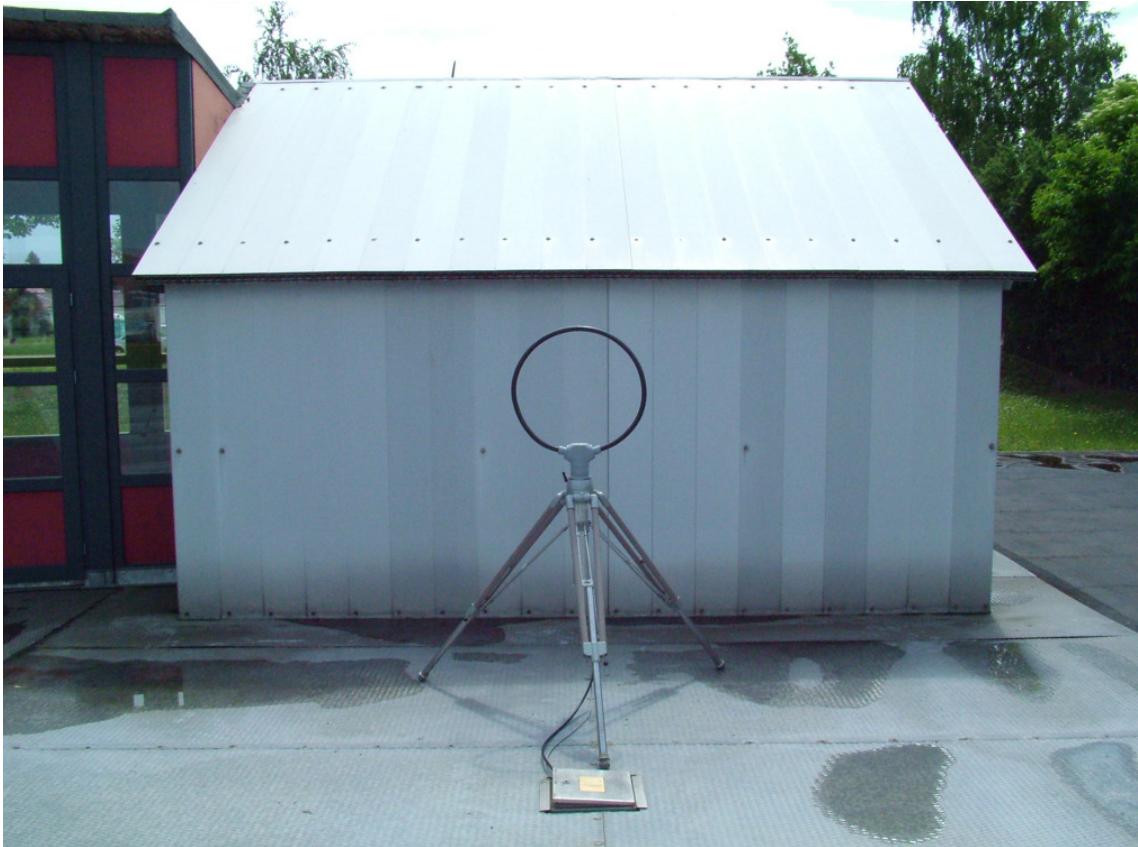
Picture 15-1: Loop antenna on open site 3m for spectrum mask and radiated emission test

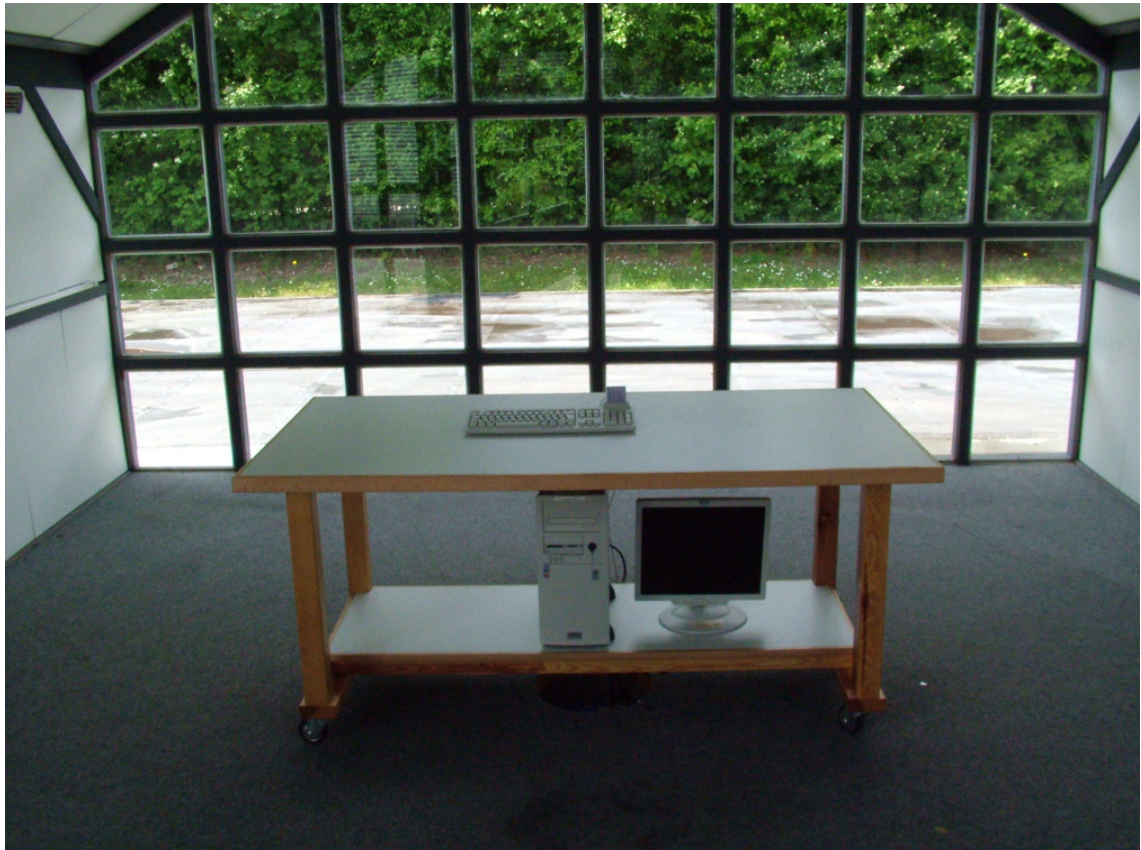
Picture 15-2: EUT test setup open site for spectrum mask and radiated emission test

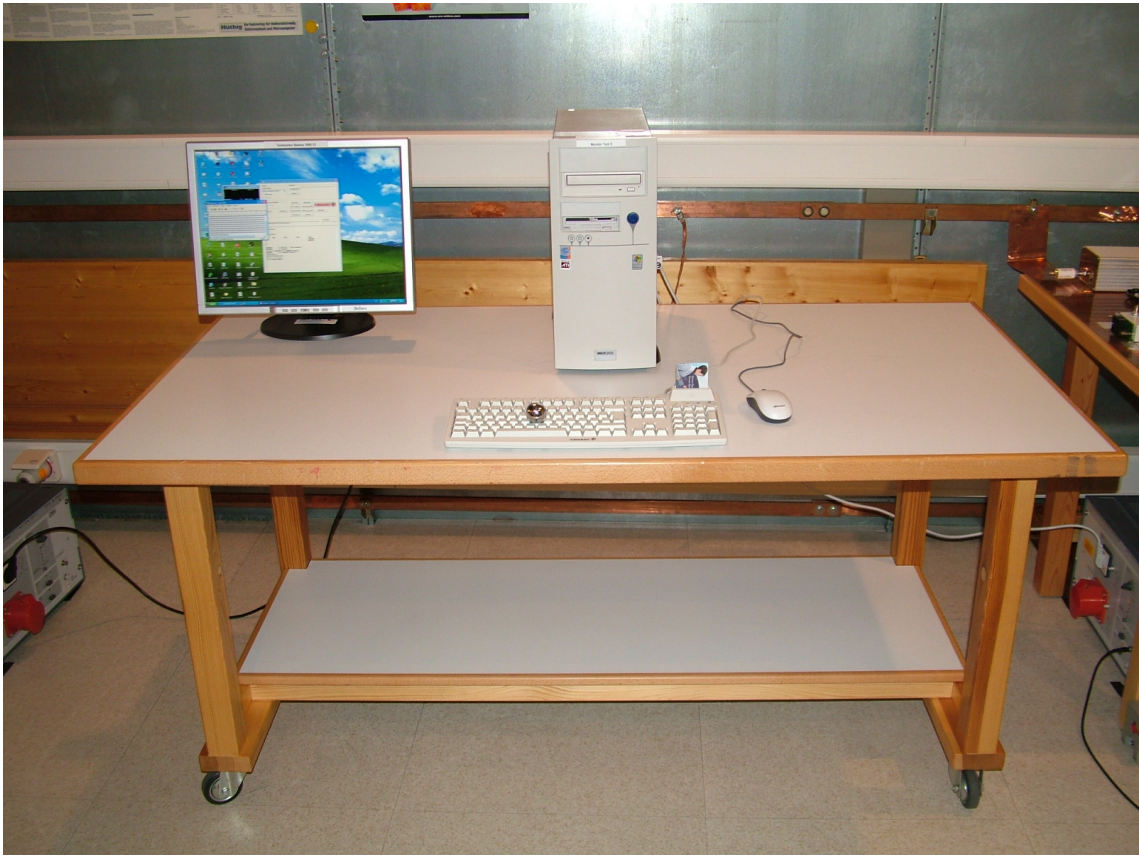
Picture 15-3: Conducted emission test setup

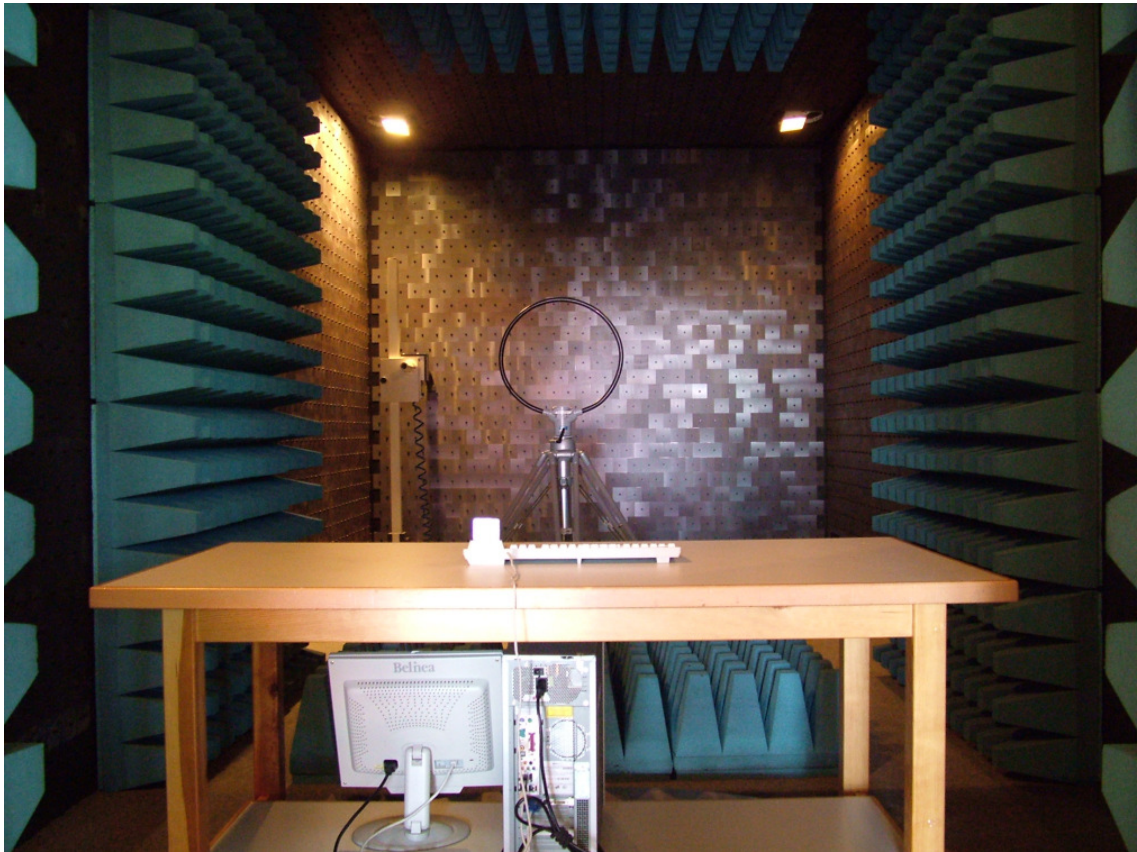
Picture 15-4: Occupied bandwidth test setup

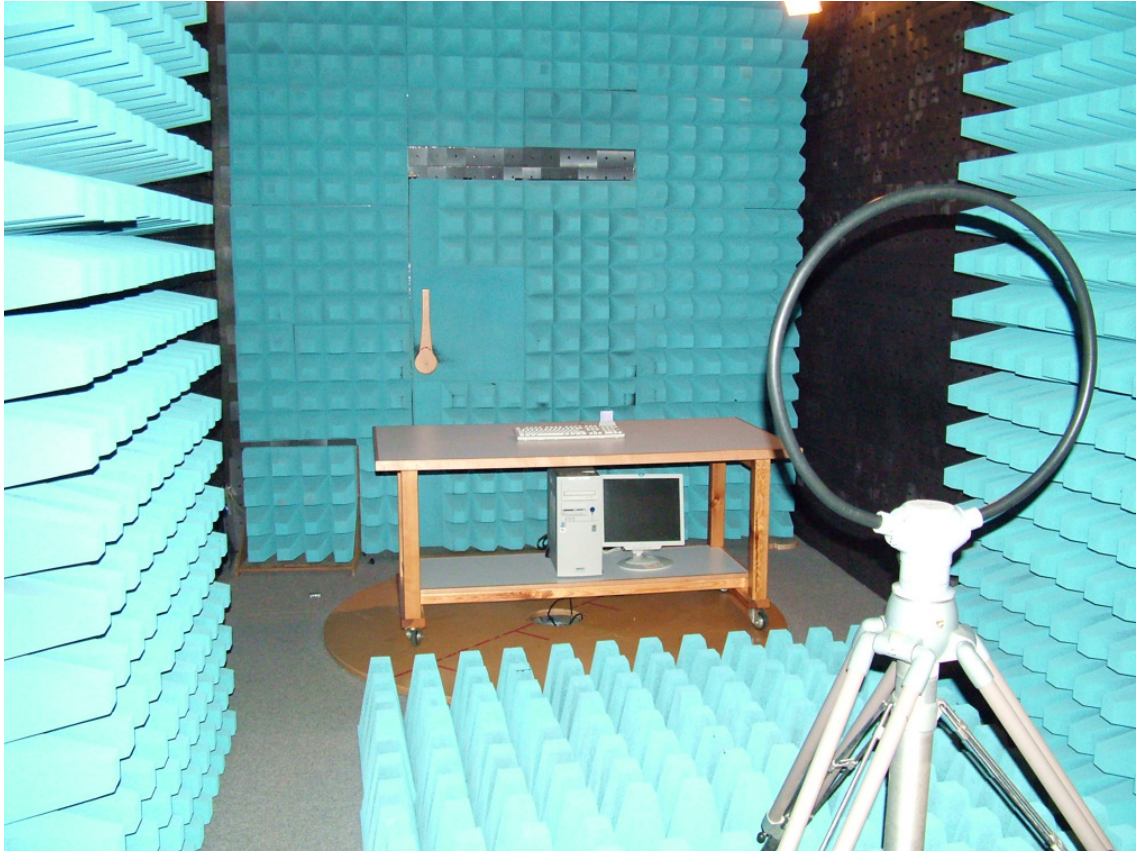
Picture 15-5: Occupied bandwidth setup

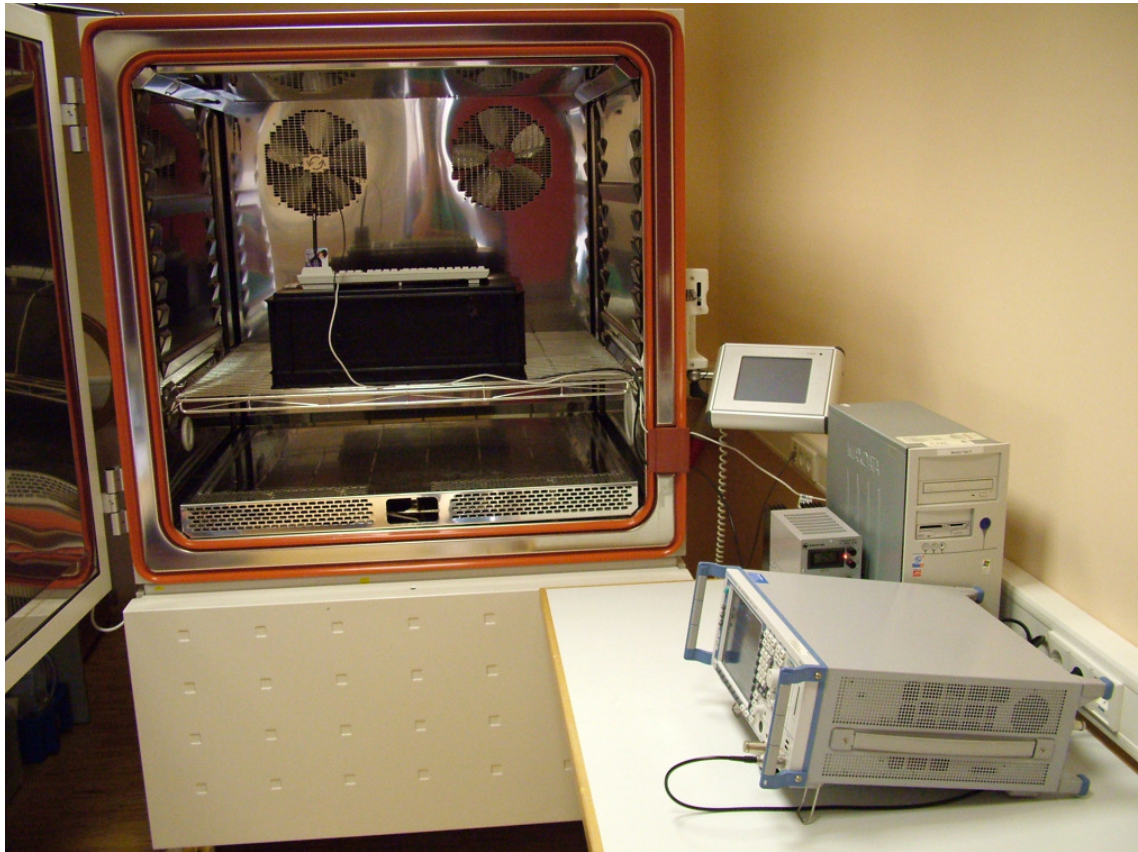
Picture 15-6: Carrier frequency stability test setup
