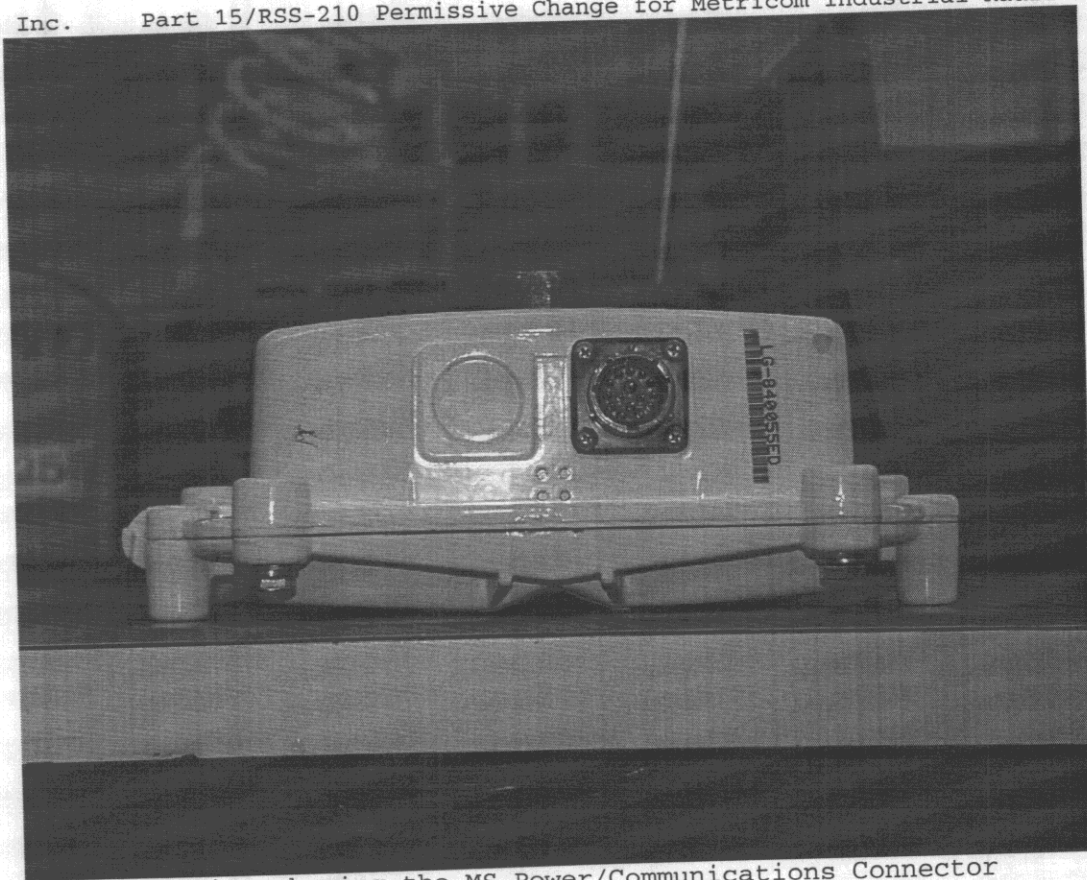
End view showing the MS Power/Communications Connector

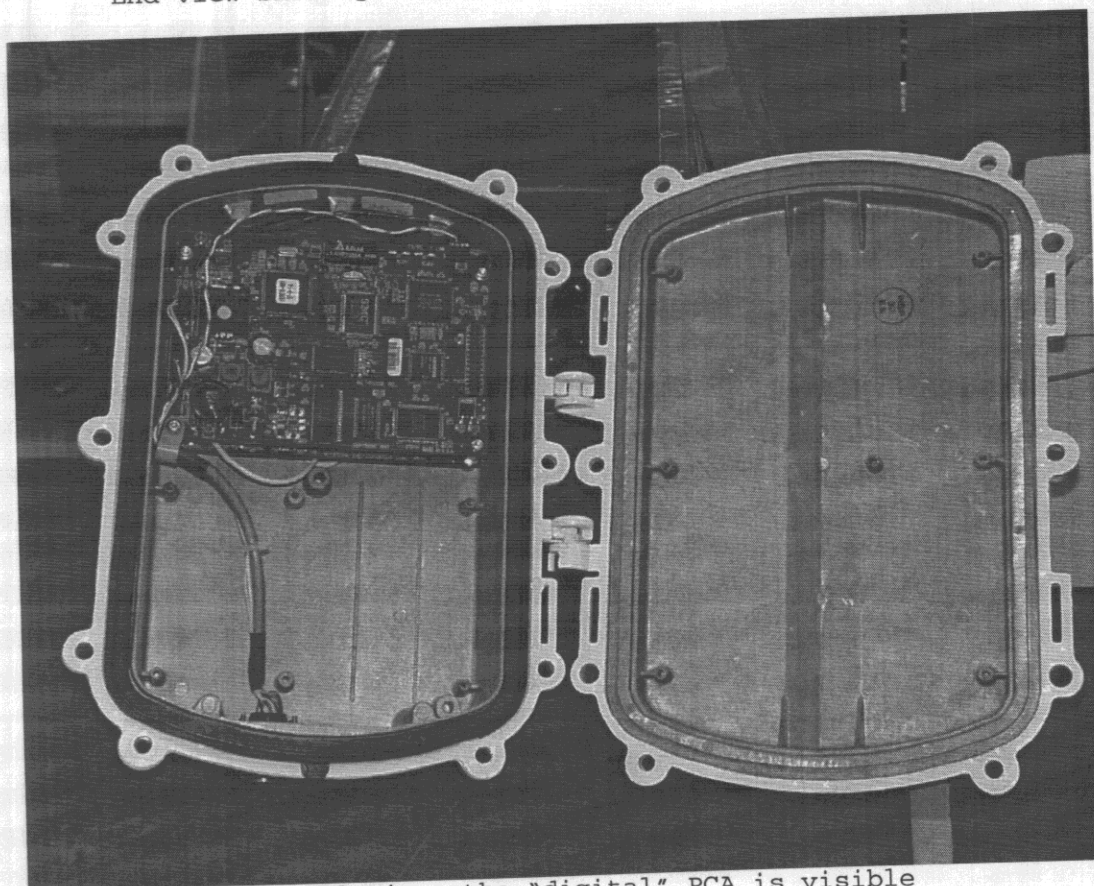
Internal view, the "digital" PCA is visible

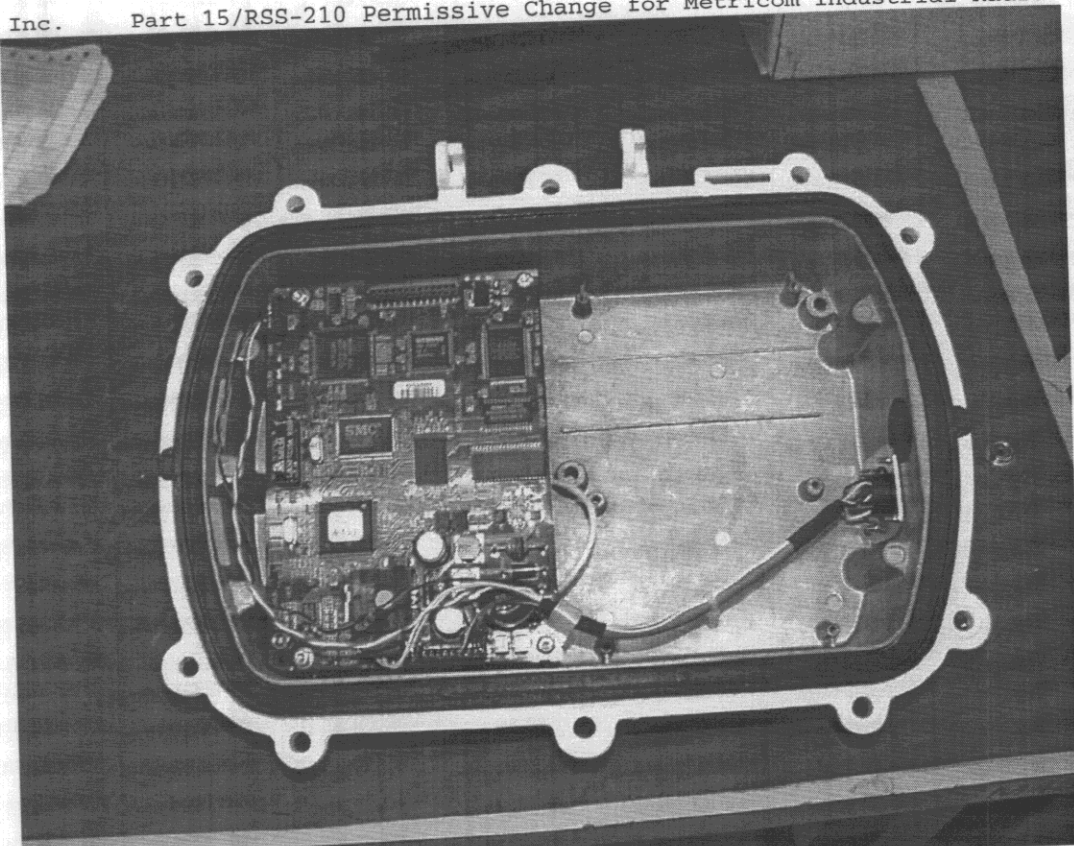
Internal view, showing Digital PCA & Other half of housing removed

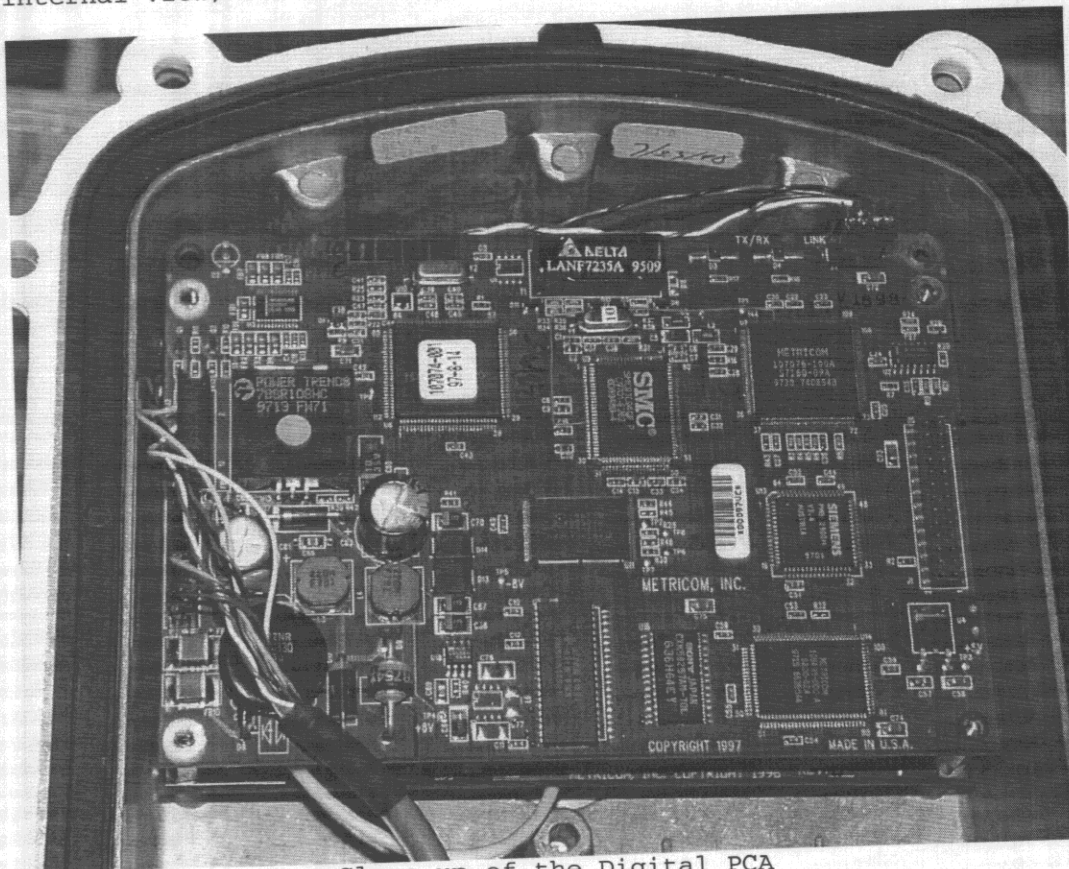
Close-up of the Digital PCA

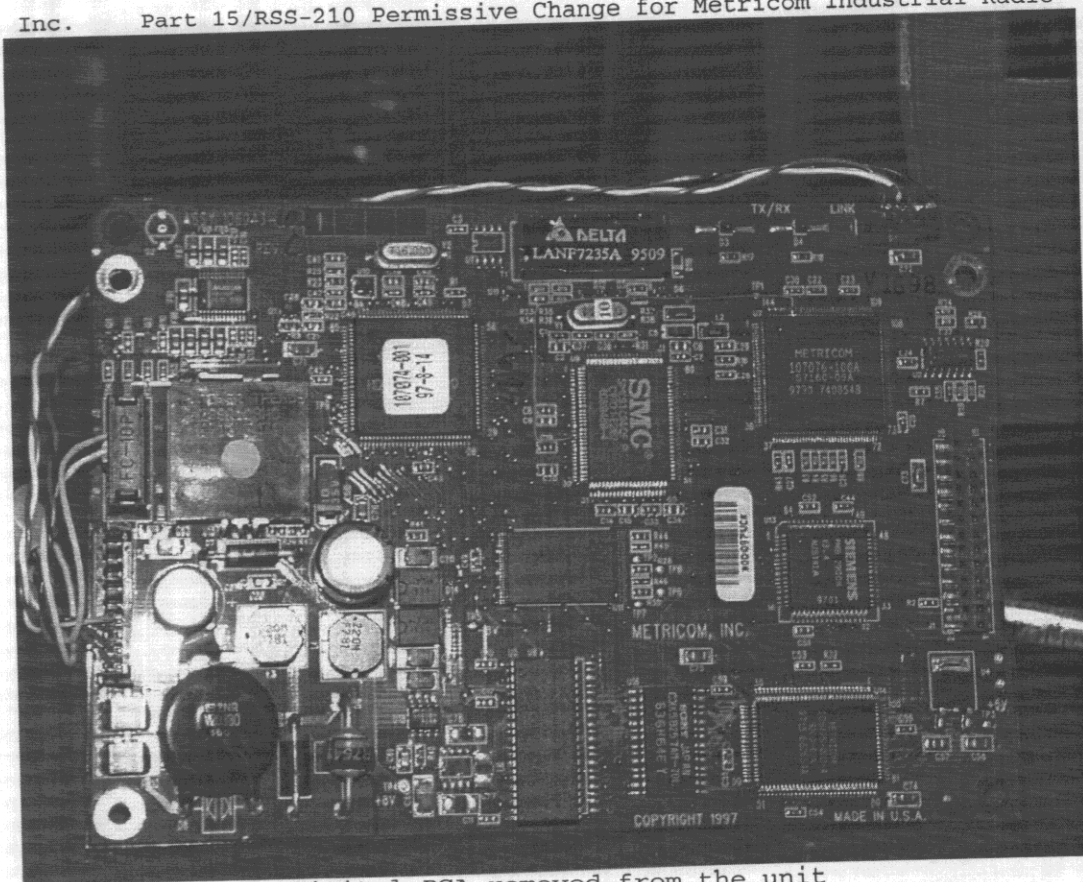
Digital PCA removed from the unit

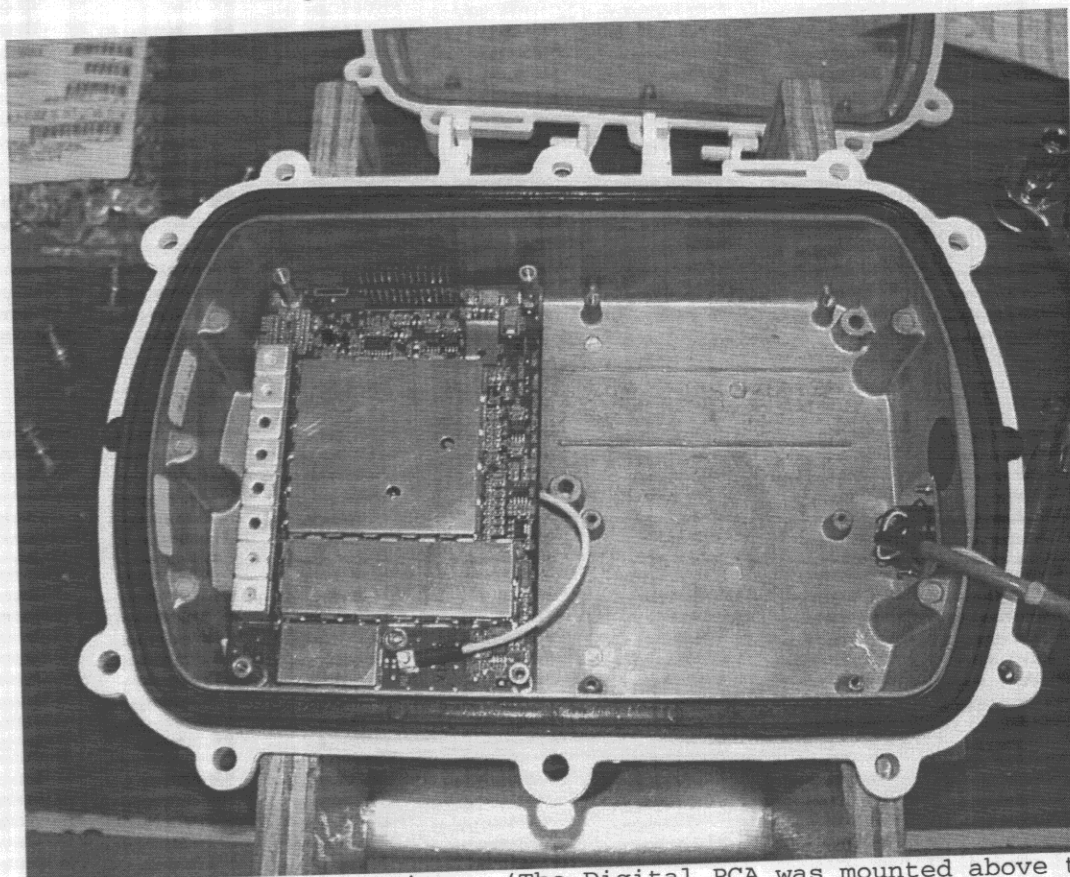
RF PCA is now visible in the housing . (The Digital PCA was mounted above the RF PCA)

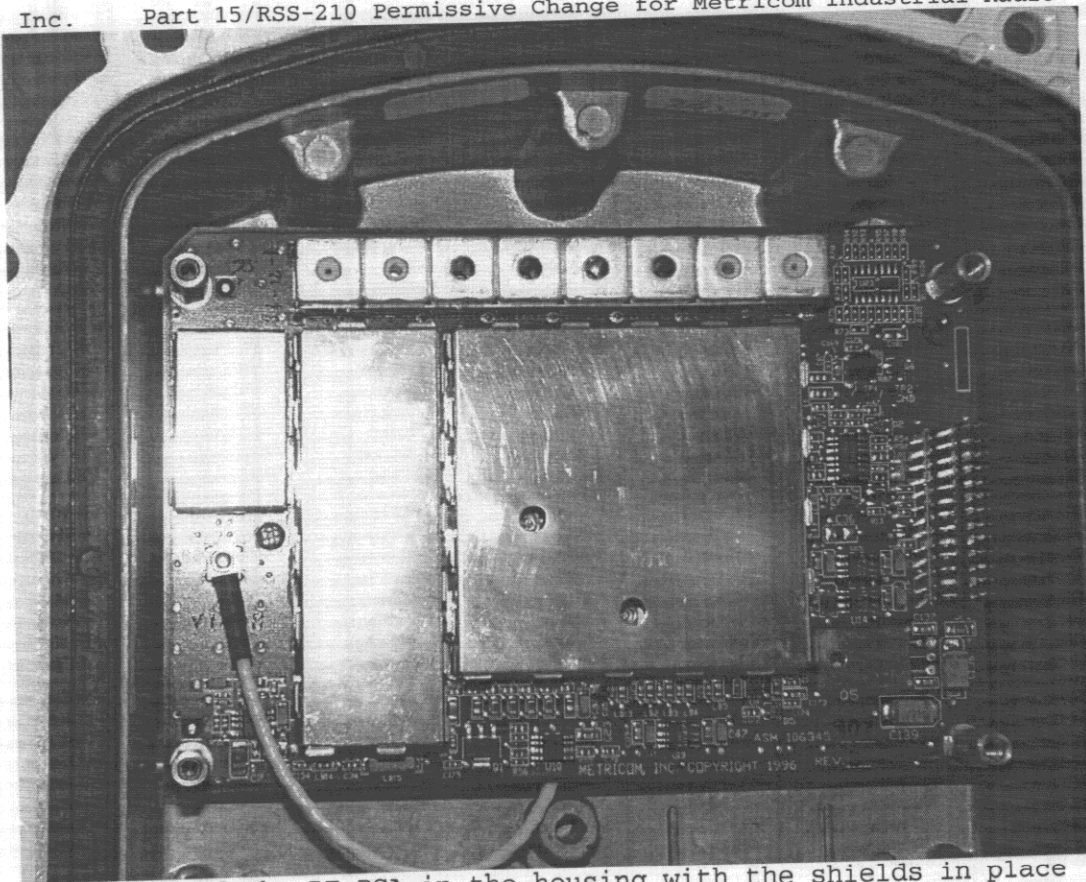
Close-Up of the RF PCA in the housing with the shields in place

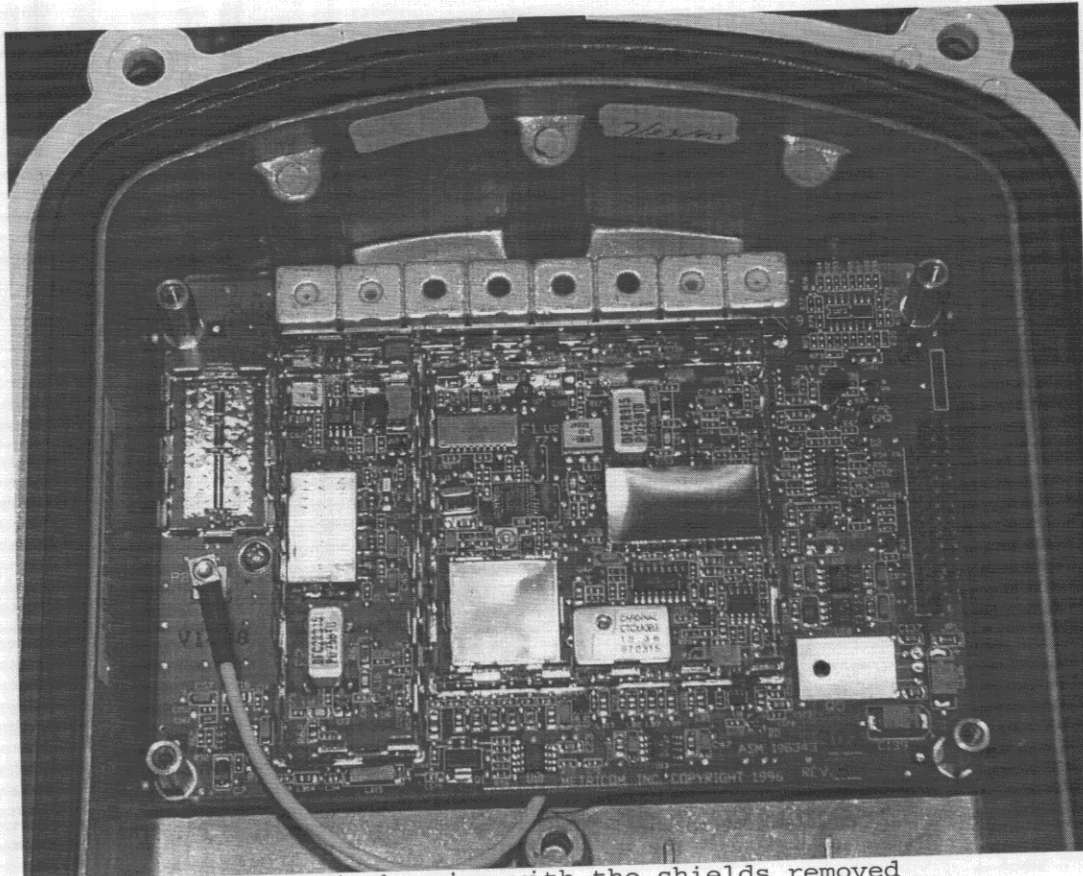
RF PCA in housing with the shields removed

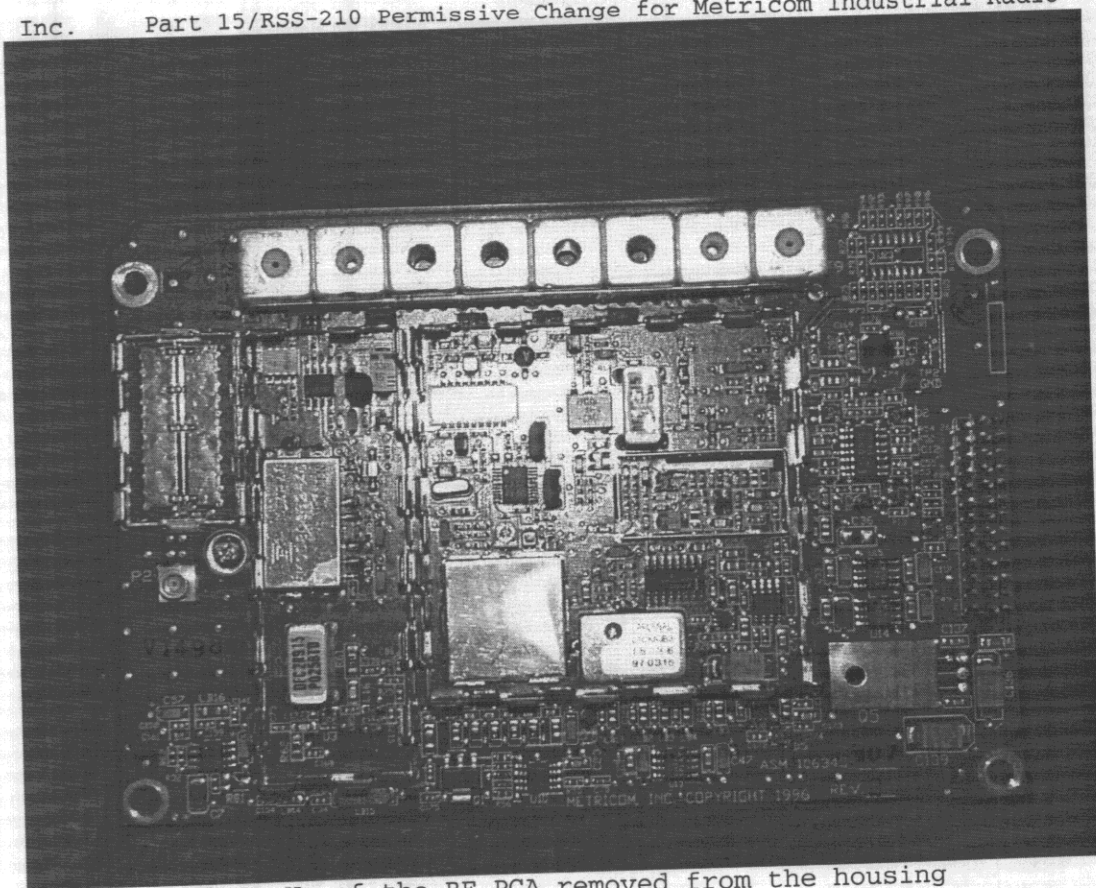
Close-Up of the RF PCA removed from the housing

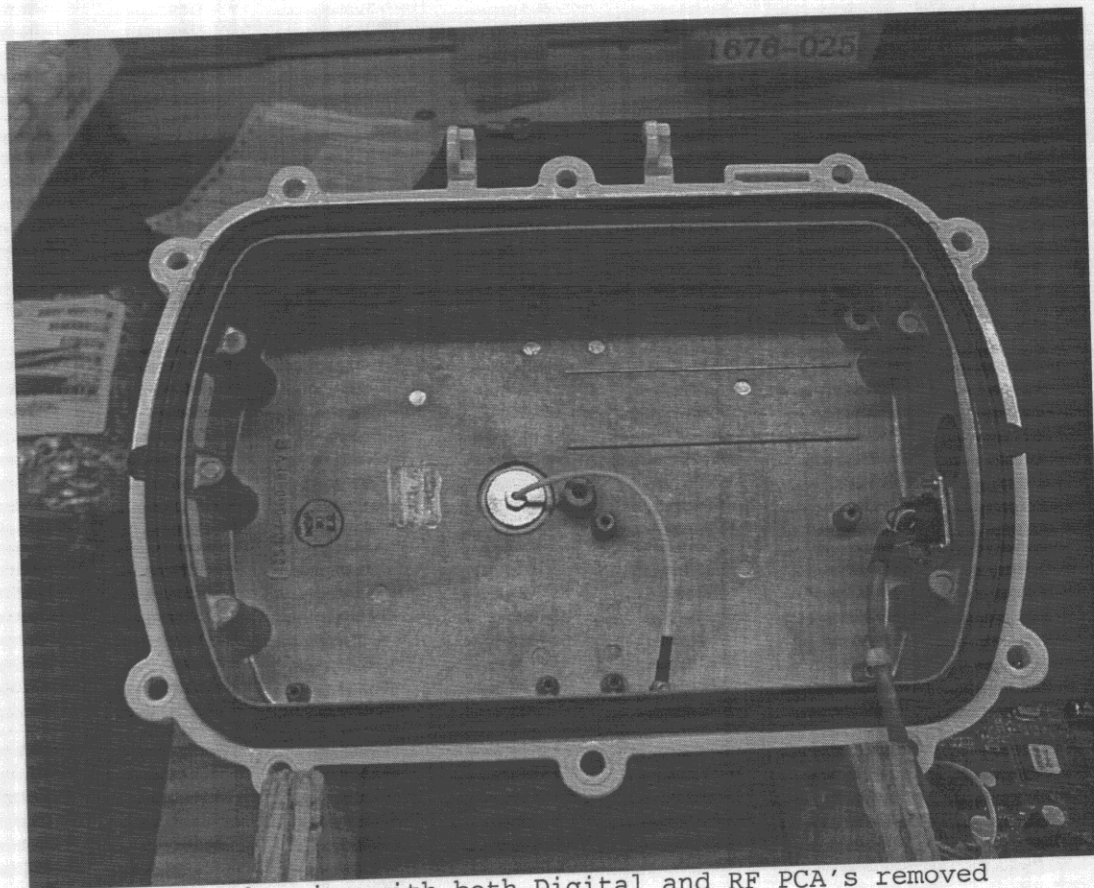
Empty housing with both Digital and RF PCA's removed
