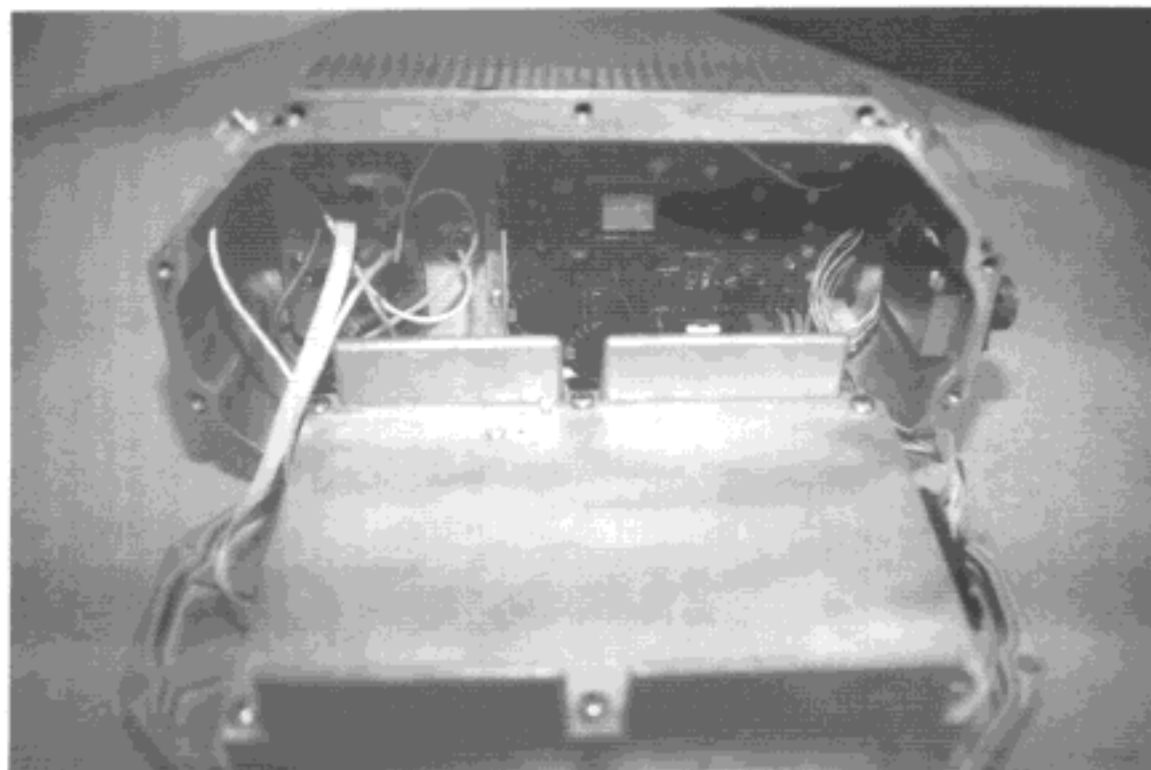
COVER REMOVED, PWR SWY & ANTENNA SWITCH VISIBLE

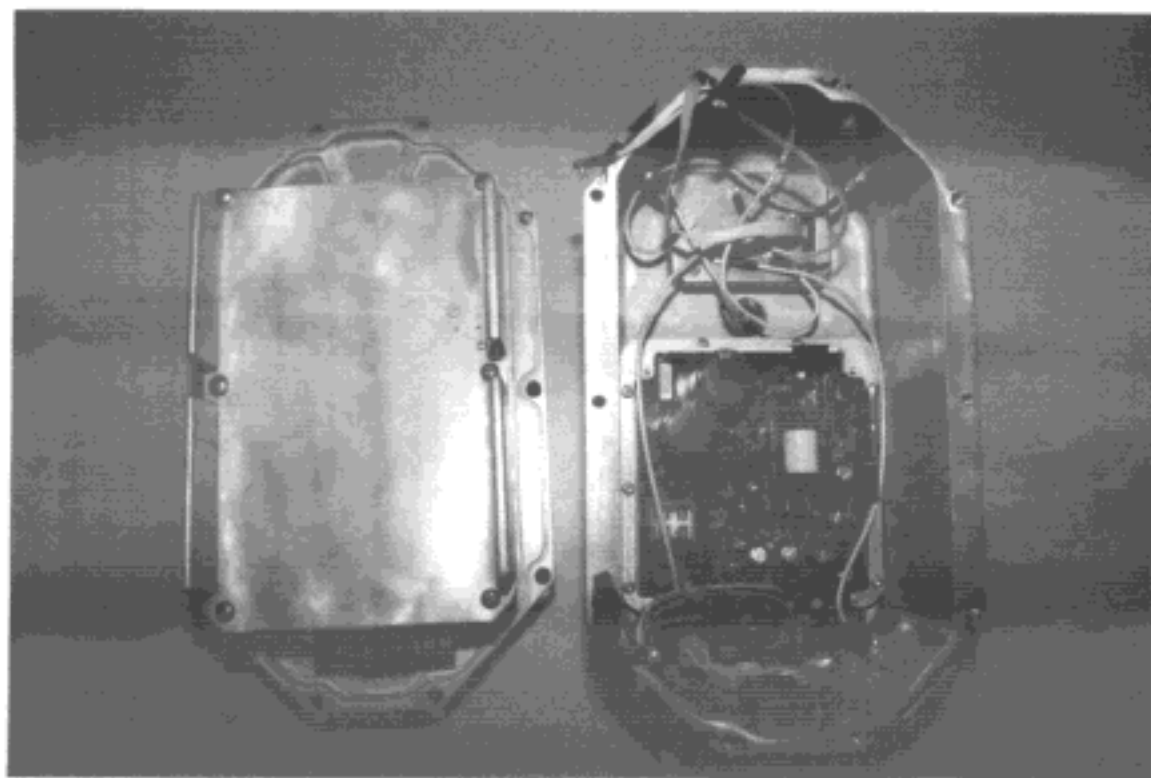
COVER REMOVED, CABLES DIS-CONNECTED

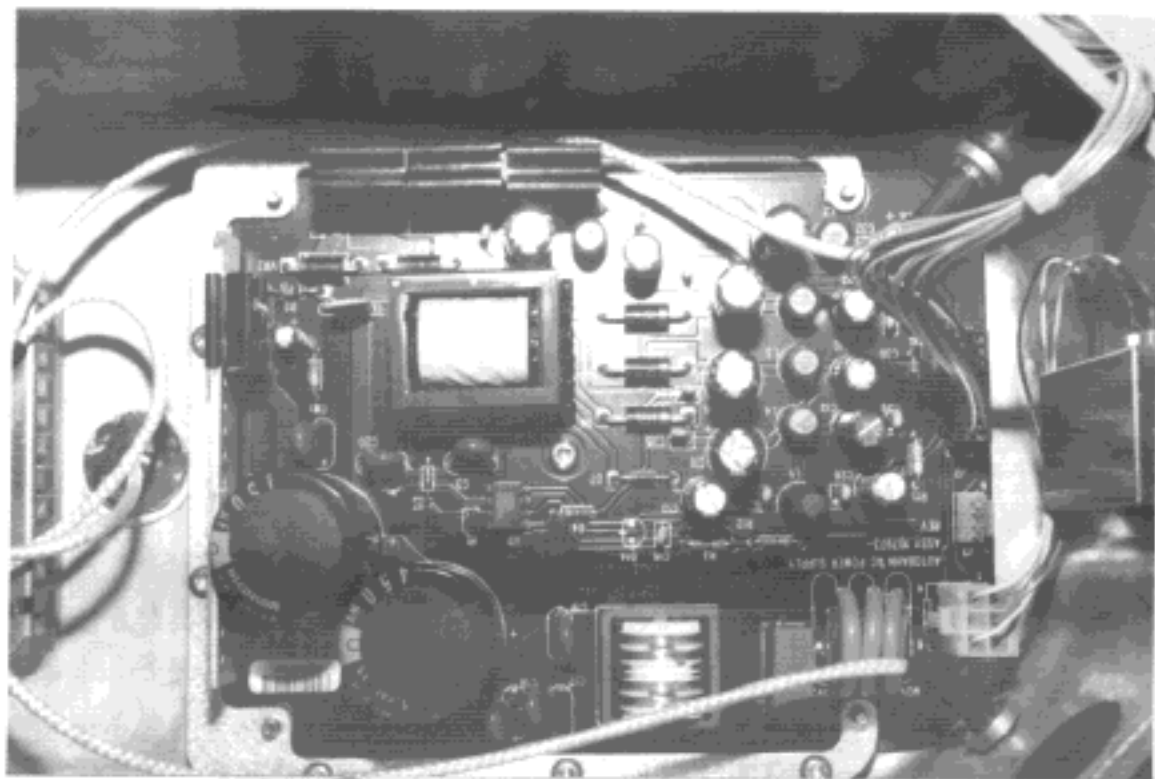
CLOSE UP, POWER SUPPLY

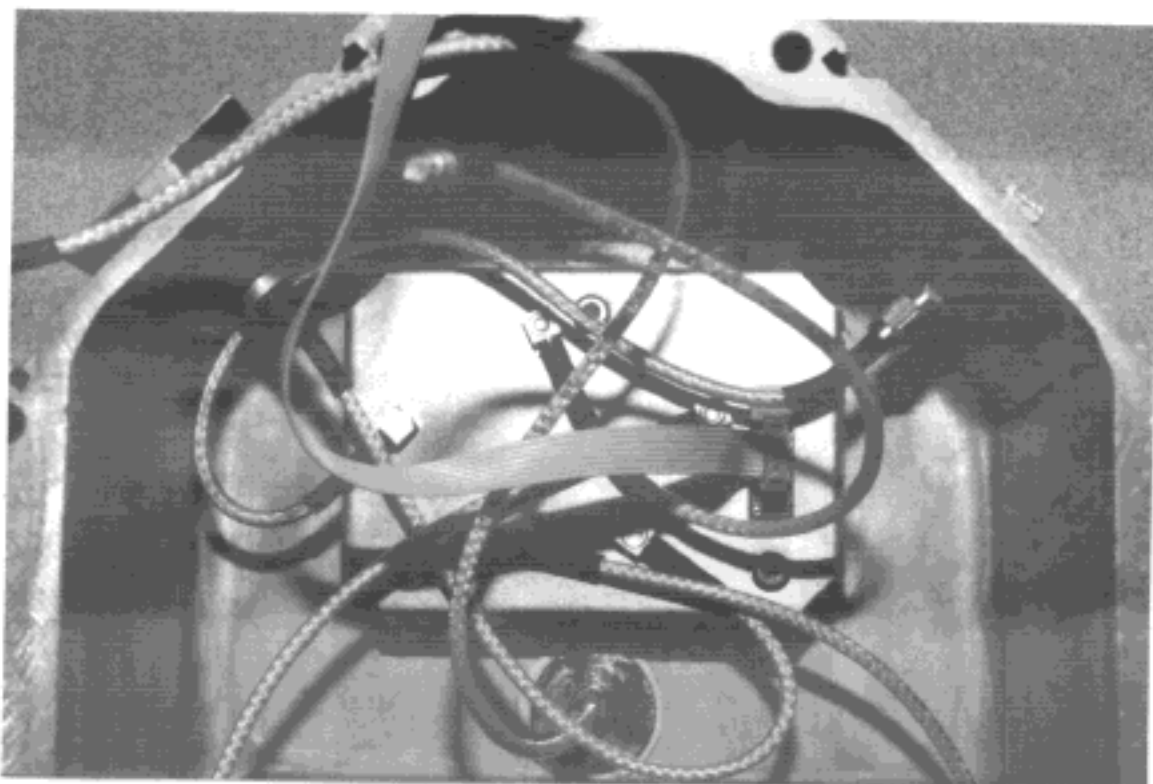
CLOSE UP, ANTENNA SWITCH ASSEMBLY

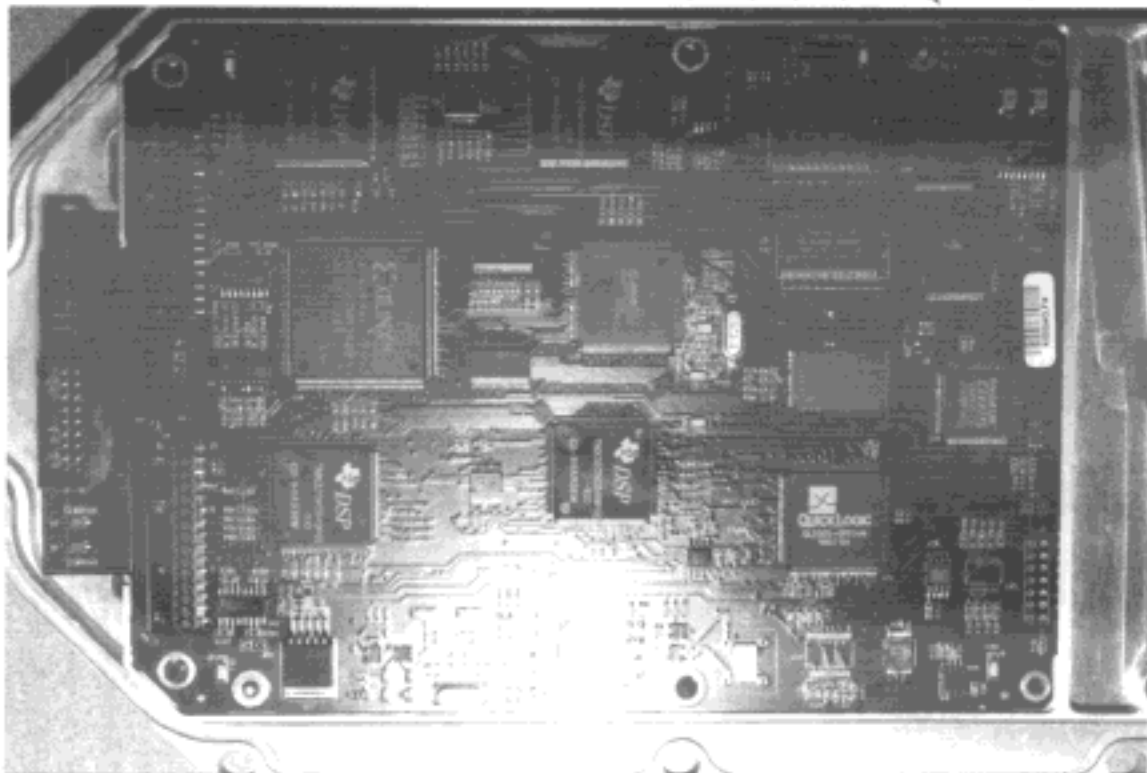
DIGITAL PCA & 8.4 GHz COVER REMOVED, 8.4 GHz RF PCA

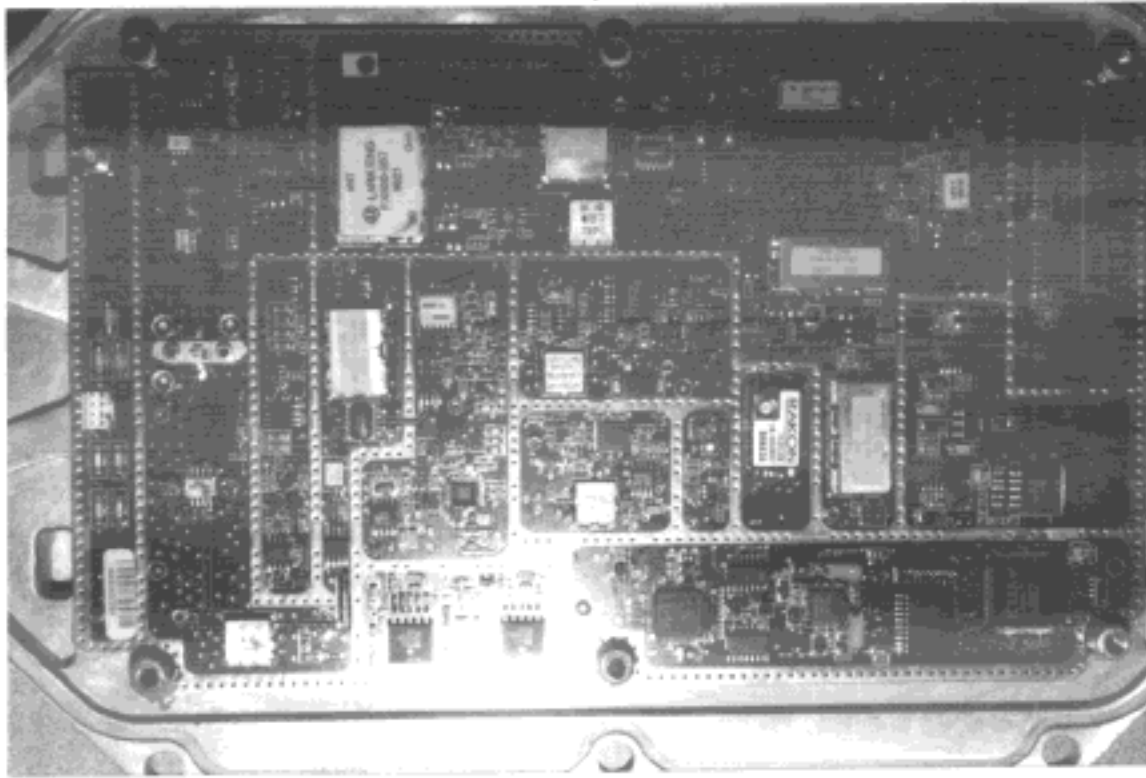
CLOSE-UP, 2.4 GHZ PCA

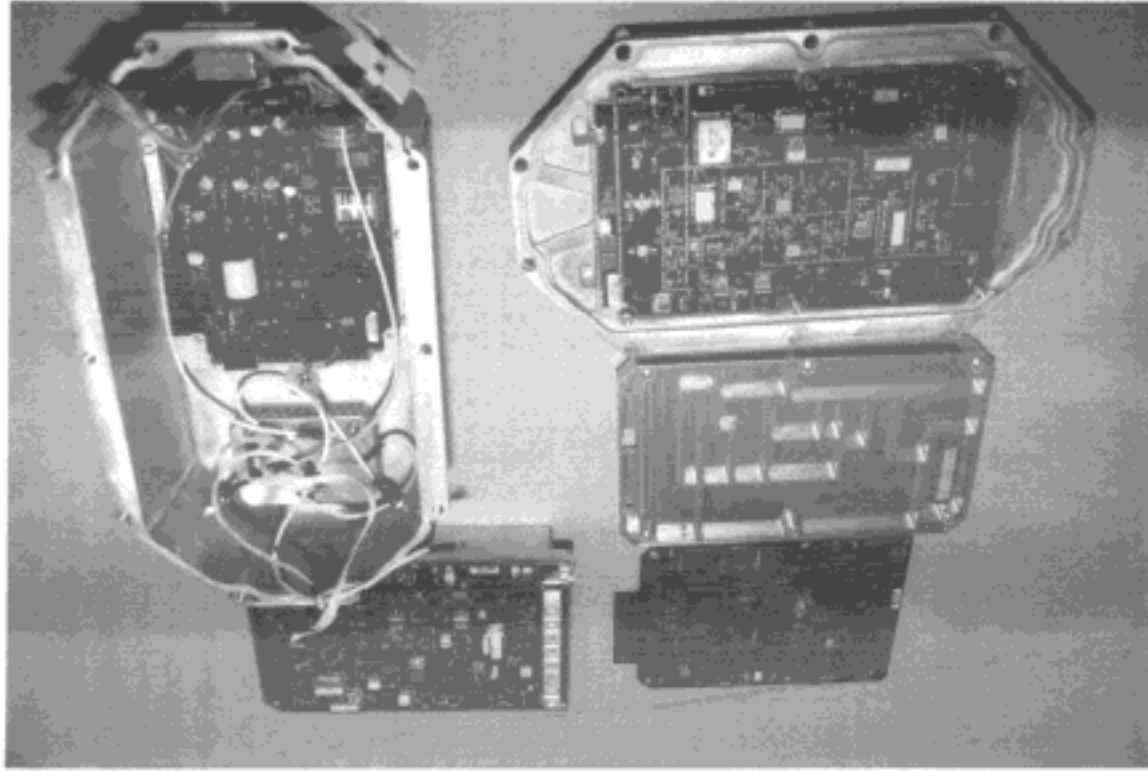
DIS-ASSEMBLED TEST RADIO

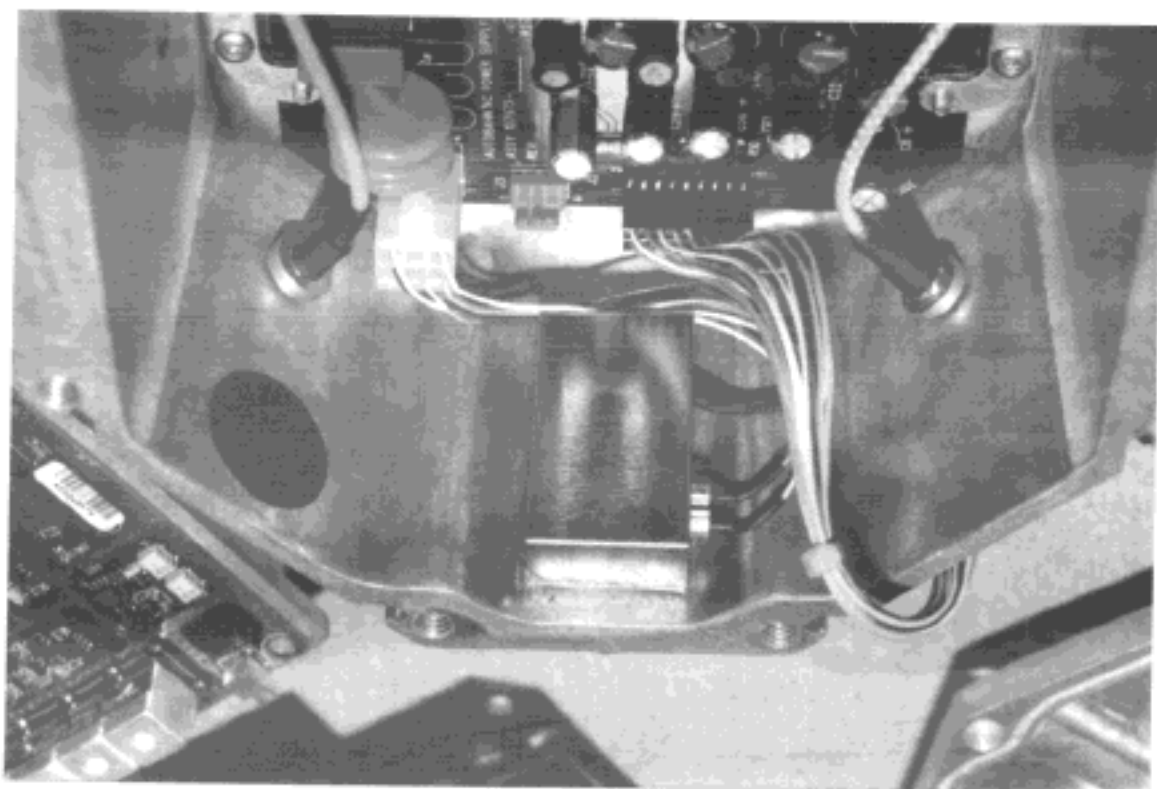
FILTER ADDED TO INSIDE OF RADIO @ MS CONNECTOR  
TO REDUCE EMISSIONS. THIS WILL BE REMOVED  
ASAP & A PERMISSIVE CHANGE FILED (7-2-97 *SL*)
