Radiated Emission Measurement

Condition : FCC_part 15E RE_Above 1GHz_PK

EUT : W6R22209-22106

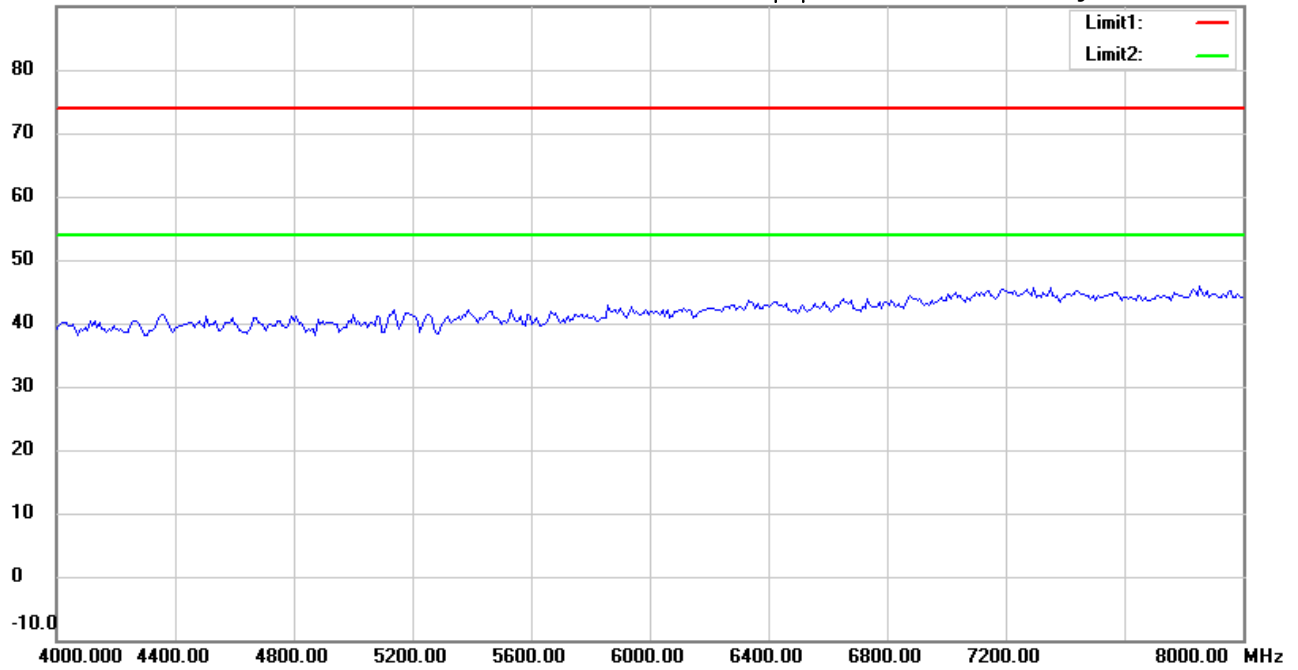
Site : Chamber

Condition : FCC_part 15E RE_Above 1GHz_PK

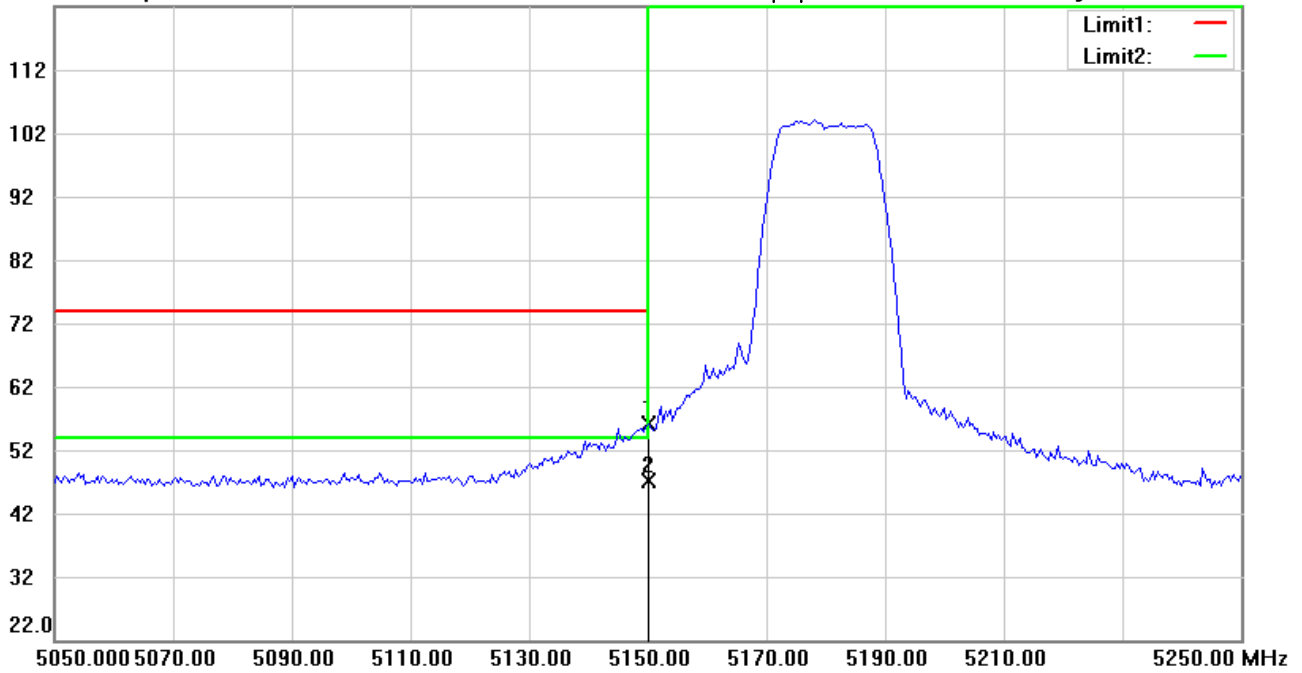
Site : Chamber

Condition : FCC 15.407 PK (Bandedge)(B1_5150_5250)

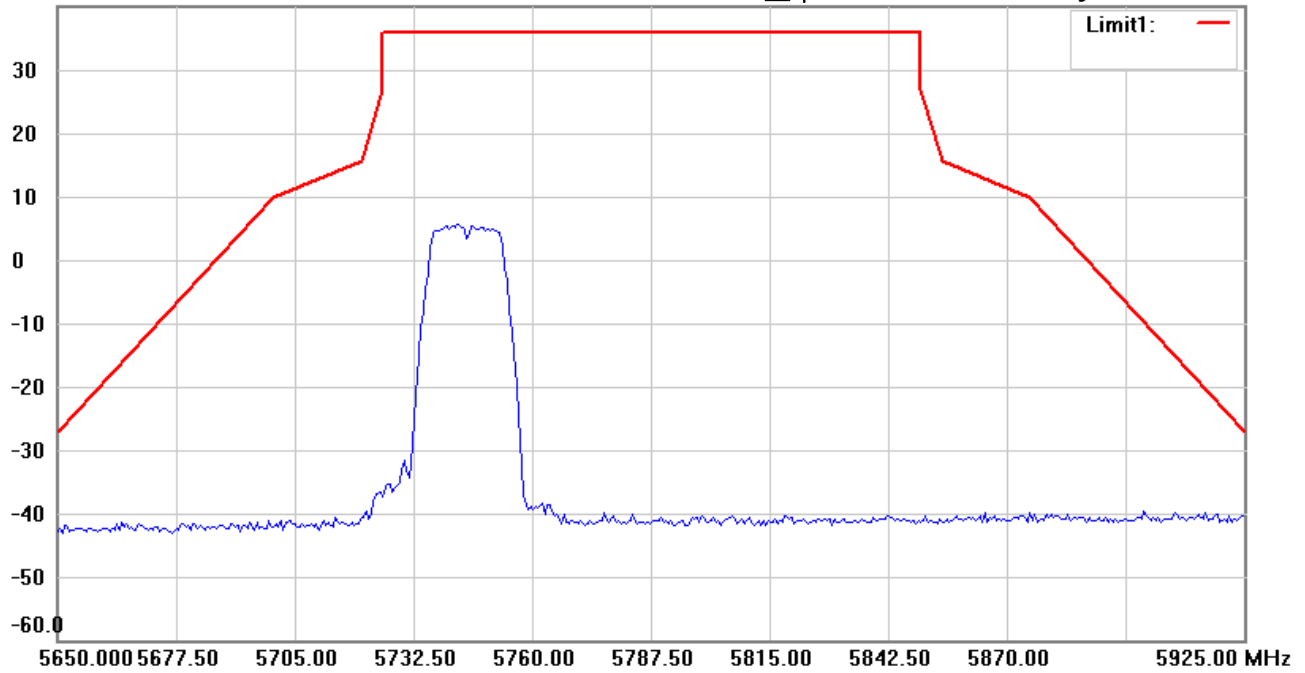
Site : Chamber

Condition : FCC_5G Band4 Mask
