Technical Comments and Response 1:

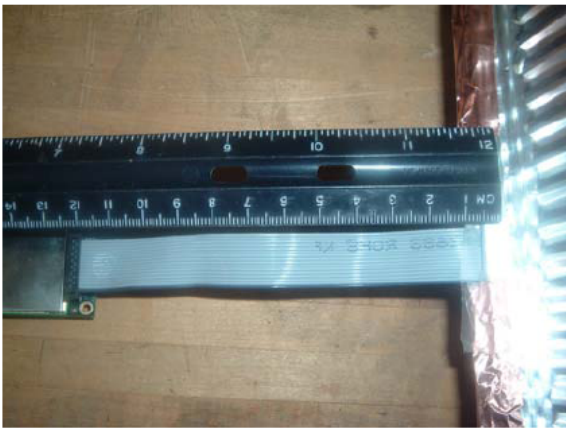
The board that is shown during the bench testing is the EUT. The EUT was external to the tin enclosure. The intentional radiated test setup is similar to what you see for bench testing. The tin enclosure houses the Evaluation board for the EUT. The board that is shown during the bench testing is the EUT. The EUT was external to the tin enclosure. The intentional radiated test setup is similar to what you see for bench testing. The tin enclosure houses the Evaluation board for the EUT.

The distance between the EUT and enclosure is greater than 10cm.

Unintentional radiated emissions testing was conducted first and showed no need for the evaluation board to be shielded, it was during the intentional radiated testing that we found the evaluation board needed to be shielded. This is why all radio test setups show the tin enclosure while radiated spurious emissions do not show this.
